**Progress Report 2012-2016: Hangman Creek Fisheries Enhancement  
Restoration Summary**

**BPA Project # 2001-032-00**

**Kinkead, B.A. and T.J. Biladeau, T. J. Coeur d'Alene Tribe, Plummer, ID 83851**

**May 2017**

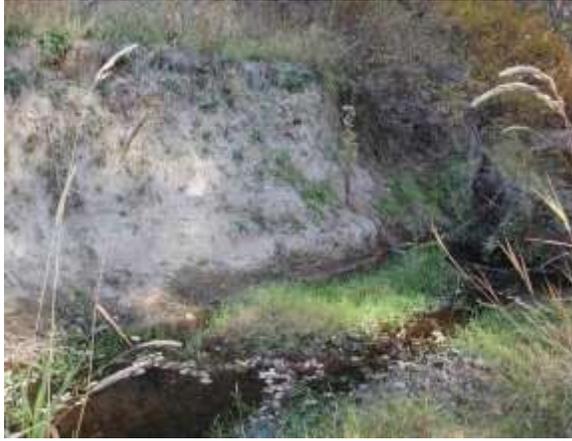
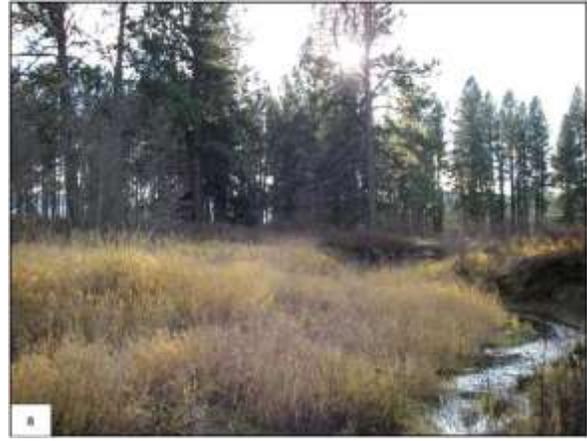
*Picture 1A & 1B. Sheep Creek, tributary of Hangman Creek. Channel and riparian conditions prior to restoration.*

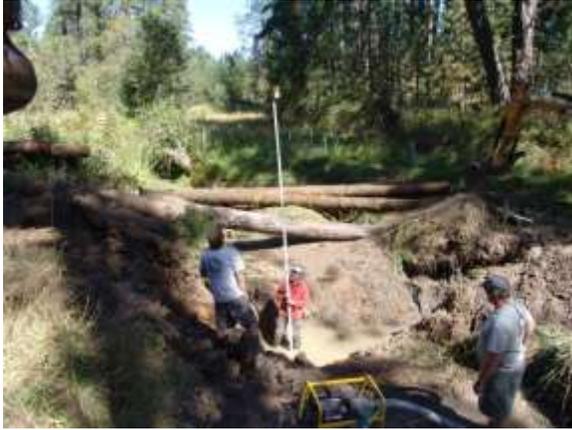
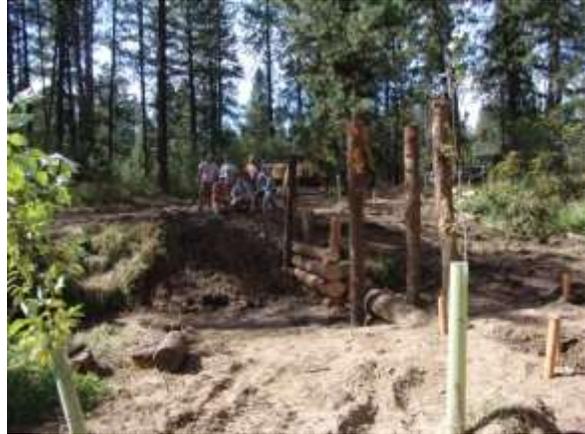
*Picture 2A & 2B. Initial step for choke structure installation is placing a scour log and surveying in a sill log as shown here, along with completed structure.*

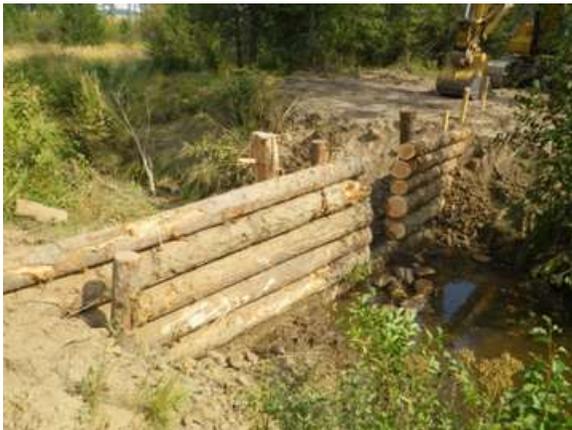
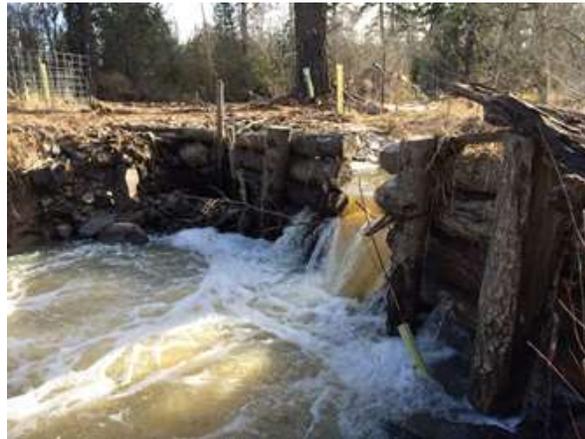
*Picture 3A & 3B. Completed choke structure in Sheep Creek where beaver have maintained a dam post-construction.*

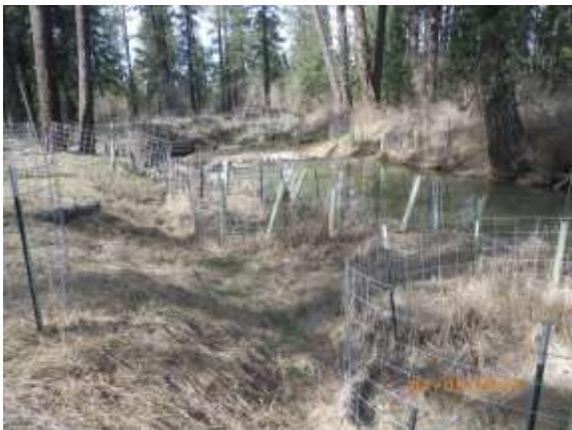
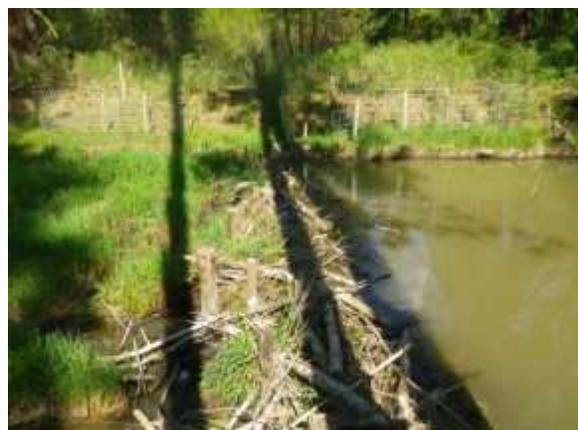
*Picture 4A & 4B. Supported beaver dams incorporating upright 4" diameter poles and 12" diameter logs.*

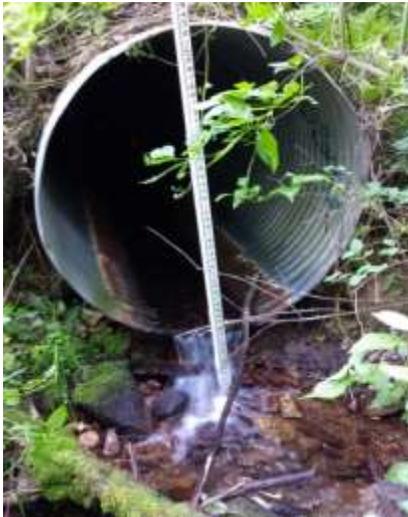
The culvert on the MF Indian Creek was suspected of being a fish barrier due to the differences of fish sampled above and below the culvert. Analysis identified it as a fish passage barrier for juveniles as well as adults by Kinhead and Firehammer (2012). Measurements were taken and analyzed using methods described by Hendrickson et. al (2008). The width/depth ratio of the culvert and channel did not match, as well as an outlet drop with a lack of water depth below limiting fish passage for both juveniles and adults (Picture 5).

*Picture 5. Culvert prior to replacement: Slope 3.6%, Diameter 54", Outlet Drop 1.1ft,*

A relief ditch for a temporary pipe was constructed to take all the flow away from construction prior to removal of the existing 54" pipe was replaced with a 60 ft. 71" X 47" arched-pipe at 3% gradient to improve fish passage (Picture 6A & 6B). The culvert was countersunk to allow natural substrate to accumulate within the culvert.

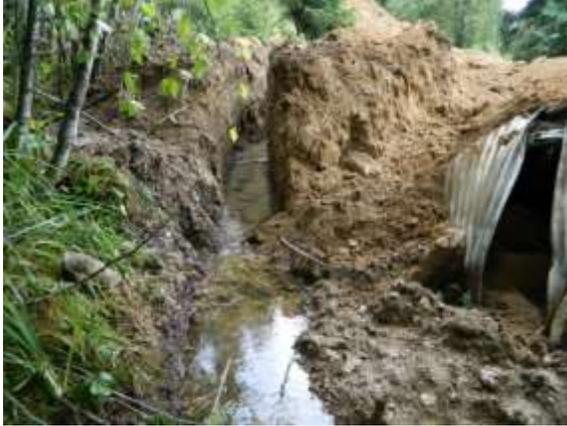
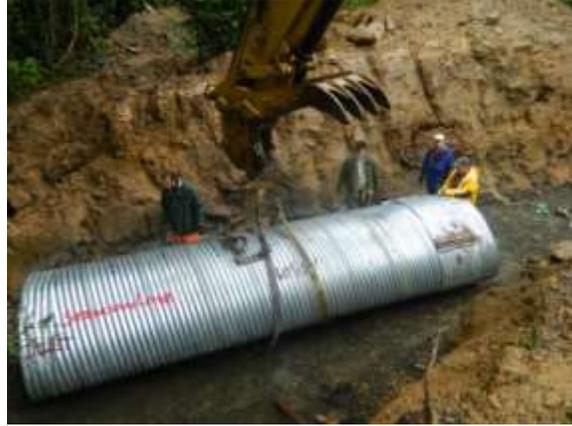
*Picture 6A & 6B. Construction activities and Installation of new culvert in Indian Creek, 2014.*

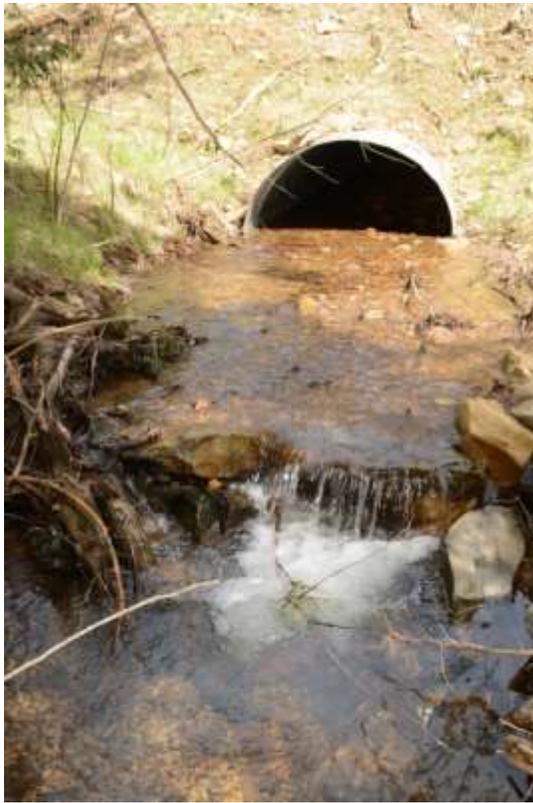
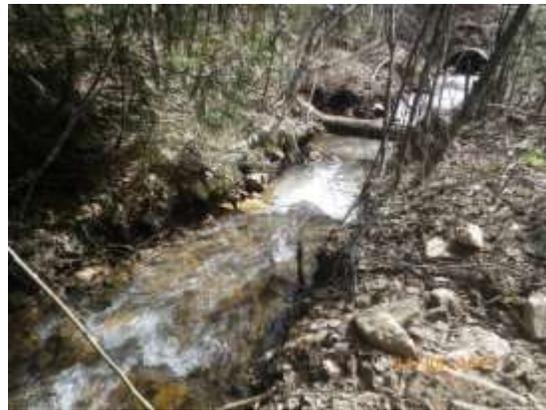
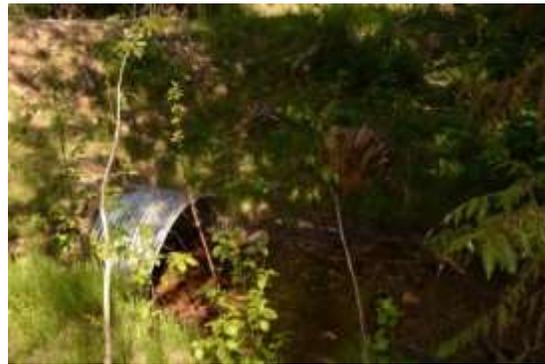
*Picture 7A, 7B, & 7C. Indian Creek culvert after installation using a 60' arch-pipe and incorporating rock grade-control directly upstream and downstream. Lower-right photo shows planted riparian vegetation the following spring.*

Installation of 4 rock and LWD grade control structures were constructed to stabilize the entrance and exit of water from the new culvert (Picture 7A, 7B, & 7C).

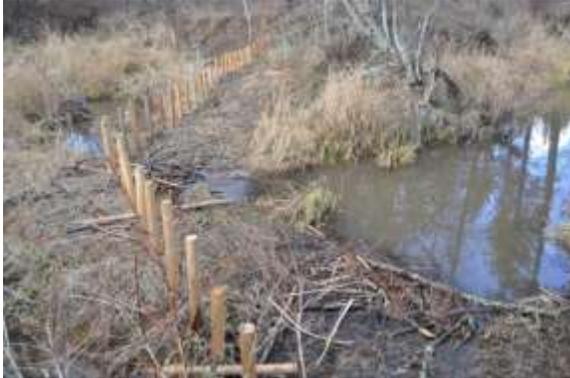
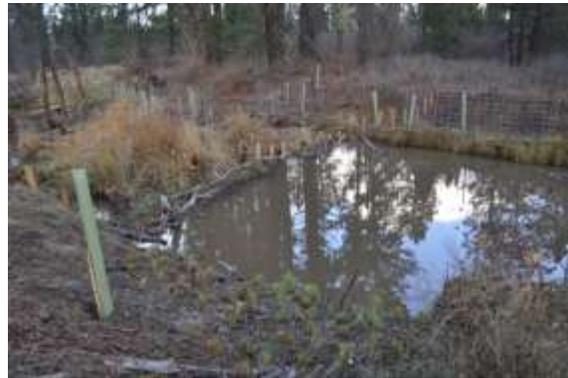
Existing beaver dams were reinforced with 4 inch diameter poles driven into dams using a hydraulic post pounder along the entire bankfull profile. Six total dams were reinforced with 4 on Sheep Creek and 2 on Mission. Monitoring indicates that 2 were destroyed by high flows, 2 were slightly damaged, and two were intact after one year (Picture 9A & 9B).

*Picture 9A & 10B. Beaver dam support poles installed in Sheep and Mission Creeks, 2013.*

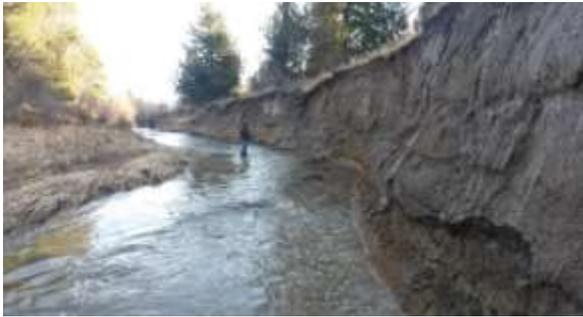
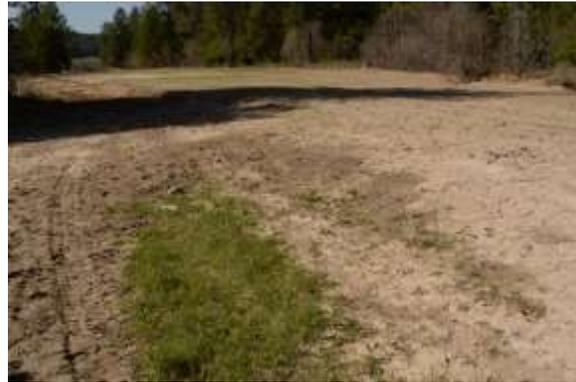
*Pictures 14A & 14B. Portion of the channelized ditch which have since been filled and abandoned.*

In both phases 1 & 3 of reactivation, the channelized ditch immediately downstream of the relict stream was filled with borrow material excavated from the adjacent uplands. Over the last 7 decades, high rates of incision and lateral erosion have created a profound difference in streambed elevation and cross-sectional area between the channelized ditch and the relict channel (14A & 14B).

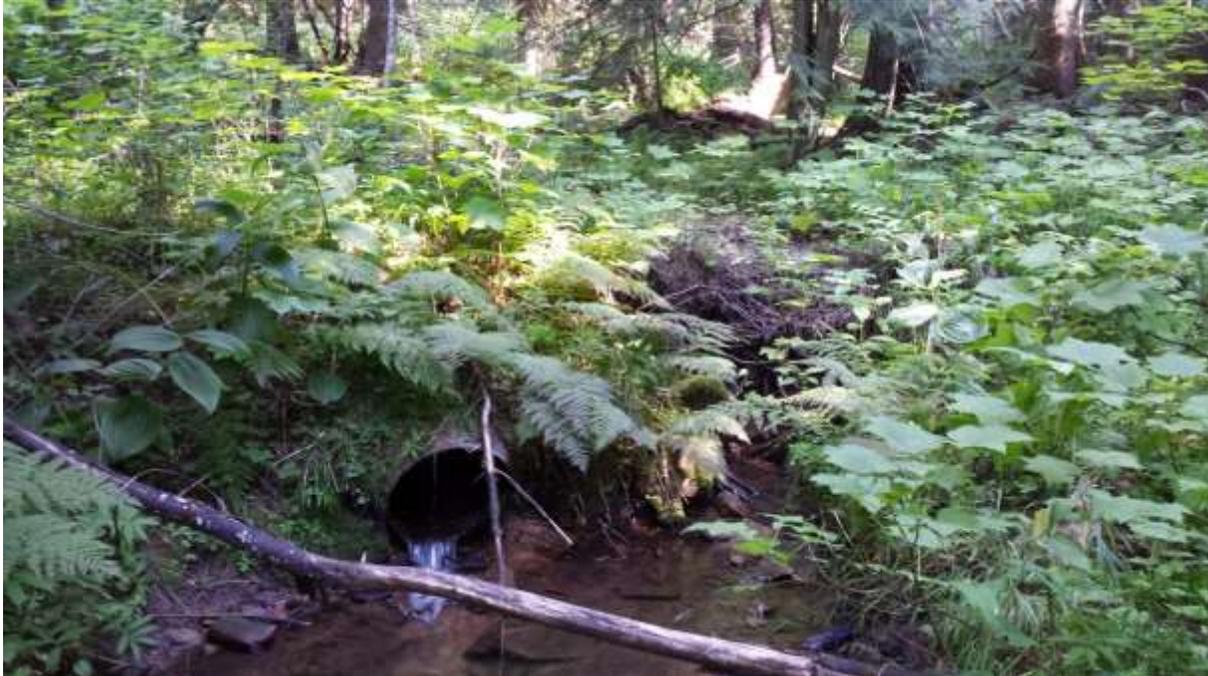
Spawning ground assessments conducted in 2014 found 561 ft<sup>2</sup> of potential spawning habitat in NF Indian Creek throughout 1.6 km of stream. However, an undersized culvert located 1.0 kilometers from the mouth was likely blocking access to 245.5 ft<sup>2</sup> (44%) of potential spawning habitat. Due to the lack of capacity through the culvert, it was also evident that runoff flows were over-topping the road and producing a source of sediment input to the stream (Picture 27).

Picture 27. Undersized culvert prior to removal in NF Indian Creek.

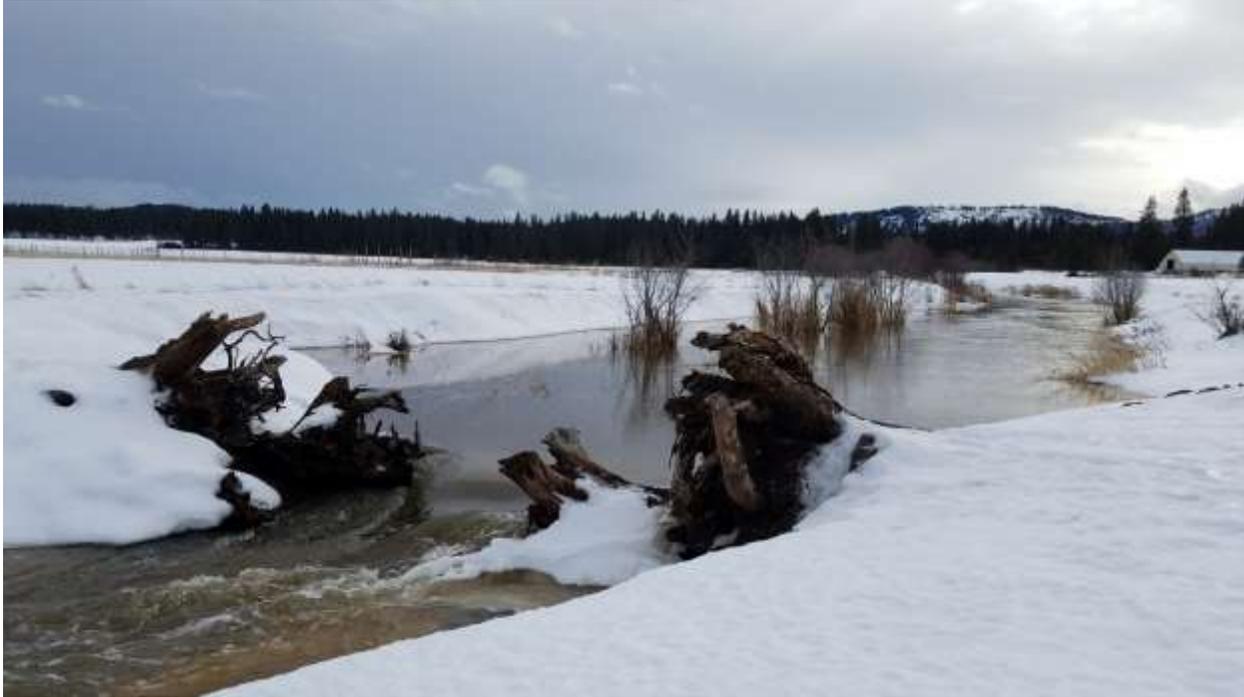
The engineered log jam is designed to pass flows equivalent to a bankfull, or 1.5 year interval flow (Picture 28). The remaining flow will be diverted across the floodplain and throughout a mature wetland/forest community. Along with the reactivated relict channel, this will result in the reconnection of 162 ha of floodplain and wetland ecosystem. The engineered log jam is composed of logs, root wads, and rocks with a trapezoidal opening and a sill that will functionally increase the streambed elevation by 2.2 feet. The log jam will function independently for 2 years, after which the relict channel immediately downstream will be reactivated and it will then function as added roughness within the inundated area upstream of an earthen plug.

*Picture 28: Choke flow structure in winter 2016/7.*
