# **Implementation of Fisheries Enhancement Opportunities on the Coeur d'Alene Reservation**

**BPA Project # 1990-044-00**

**1/1/2015 – 5/31/2017**

**A. J. Vitale and S. H. Hallock**

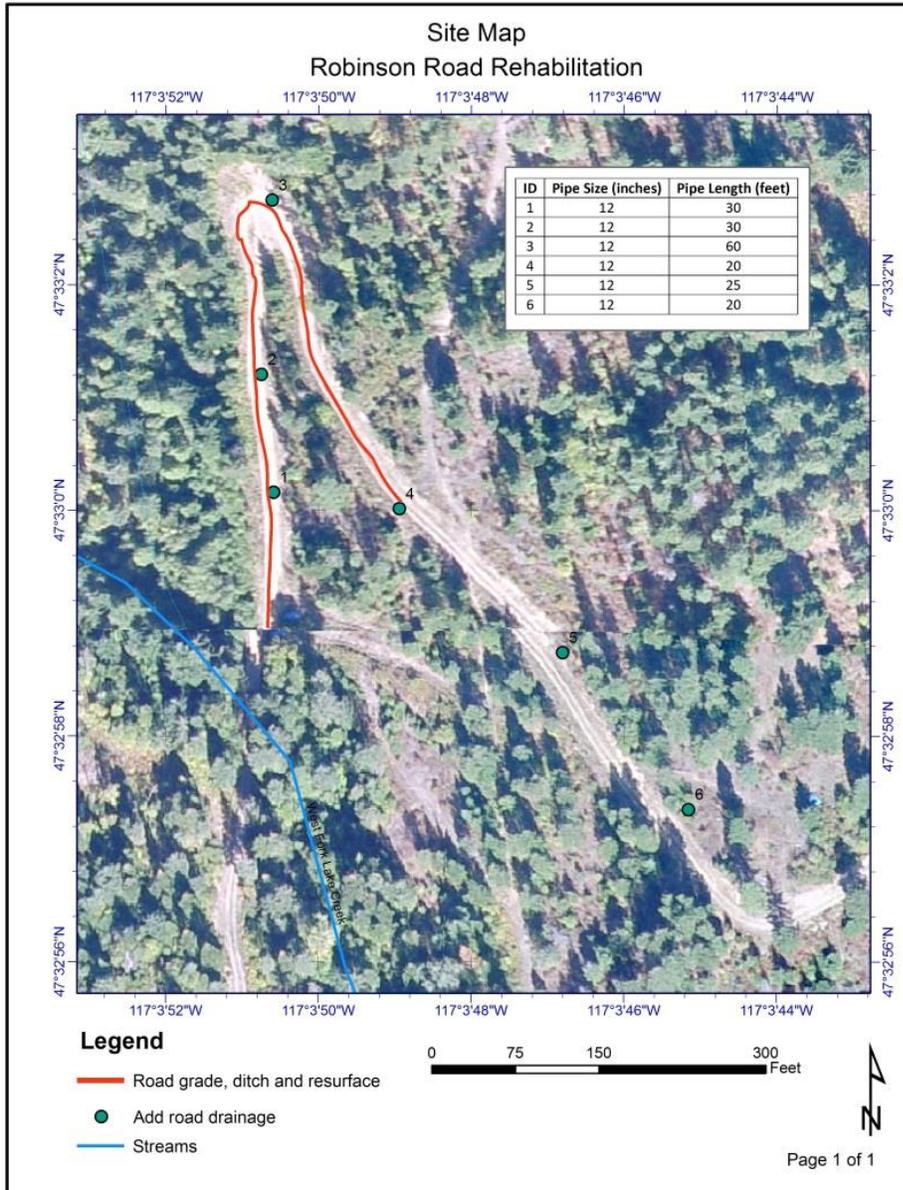
Figure 4. Approximately 527m of high gradient native surface road in the West Fork Lake Creek watershed was graded, ditched, drained and resurfaced in 2015.

A total of 527 meters of native surface road was graded and ditched using a Bobcat T-320 tracked skidsteer. Two types of rock were used to resurface the road; a base of courser 6” minus rock was placed first, followed by a surface cover of ¾” minus rock. A total of six 12” diameter culverts and two rolling dips were installed using a Cat 303 mini-excavator to cross drain the resurfaced road segments and prevent water accumulation in roadside ditches. Road improvements were completed for a total of 527 meters of native surface road. Runoff generated from an adjacent 100 meters of native surface road is intercepted by the improved road segments with the runoff safely redirected to a vegetated hillslope which provides sediment filtration over a distance of more than 67 meters before it reaches the WF Lake Creek. This additional realized sediment reduction was not estimated or included in the predicted results reported above.

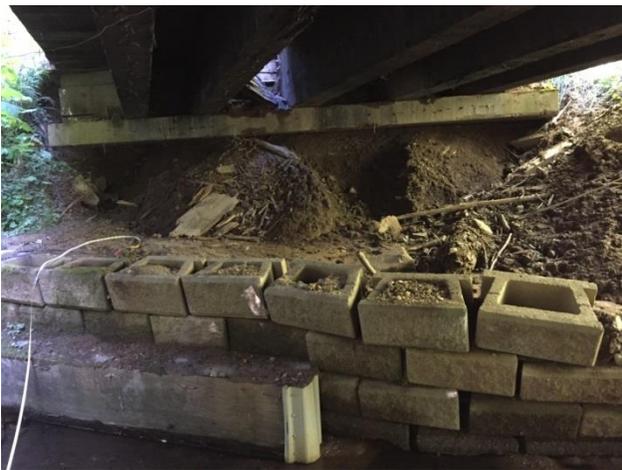
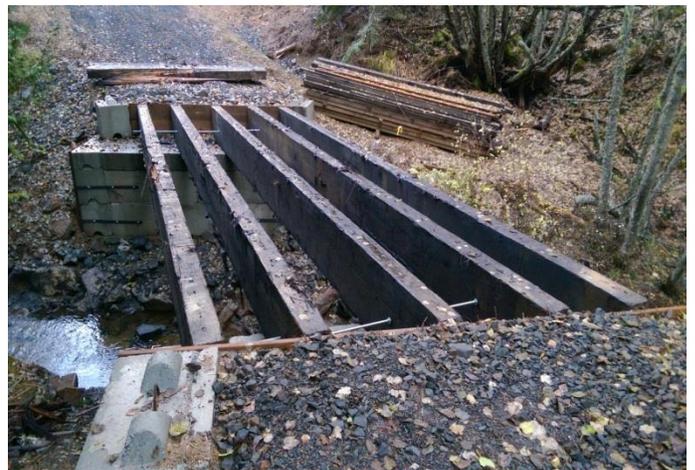
At this site a bridge with a 30-foot span was used to provide local access across the stream. A treated beam that was laid directly on the ground without a solid abutment or footing served as the only substructure supporting the girders and bridge deck. Surface water runoff directed and concentrated along the road approaches had eroded the soil under the bridge substructure, caused slumping of the natural slope leading to the stream, and resulted in annual contributions of sediment directly to the stream. The entire bridge had become increasingly unstable as runoff continued to exasperate this condition. Some past attempts at stabilizing the toe of the natural slope under the bridge using interlocking concrete blocks had been unsuccessful (Photo 1).

*Photo 1. (Left) The former bridge over Lake Creek had deteriorated to the point where using it was a hazard and sediment was delivered directly to the stream during frequent, low magnitude runoff events. (Right) The new bridge provides a stable stream crossing, eliminates sediment delivery to the channel and safely passes the largest flood.*

The bridge replacement was completed during two weeks in September. Two large Cat 320 excavators were used to remove the existing bridge, including the old footings, the failed erosion protection, and loose fill underneath the bridge. The greatest amount of time was spent preparing the new foundation for the bridge. Trenches were dug on both sides of the creek, lined with filter fabric, and then backfilled with a one foot deep layer of ¾" crushed rock to form the footing for the abutments. The backfilled rock was compacted with a Wacker RT82C trench roller and hand compactor. The bridge footing was leveled and adjusted to the correct elevation to meet the design specifications. Once this was completed, 40 E-Blocks - each weighing between 1900 – 3850 lbs. - were placed one by one in an interlocking configuration to form six

foot high retaining walls. At each corner of the structure, steel braces were fabricated and anchored to the concrete blocks to provide additional support. Given that groundwater was encountered during construction, 3 inch diameter perforated drainage pipe was placed at each footing to help divert water around the bridge foundation.

The existing treated beams that served as bridge girders were reused by setting them on top of the E-Block foundation. The beams were secured to the blocks with steel brackets and long  $\frac{3}{4}$ " diameter threaded rods that connected all the beams together to form a single platform to support the bridge decking. Rock rip-rap was placed underneath the new bridge and adjacent to the new footings for erosion control. Finally, the road was regraded to ensure all water would be diverted off the roadway before reaching the bridge. All disturbed areas were seeded with native grasses at a rate of 40 lbs/acre (18 kg/ha).

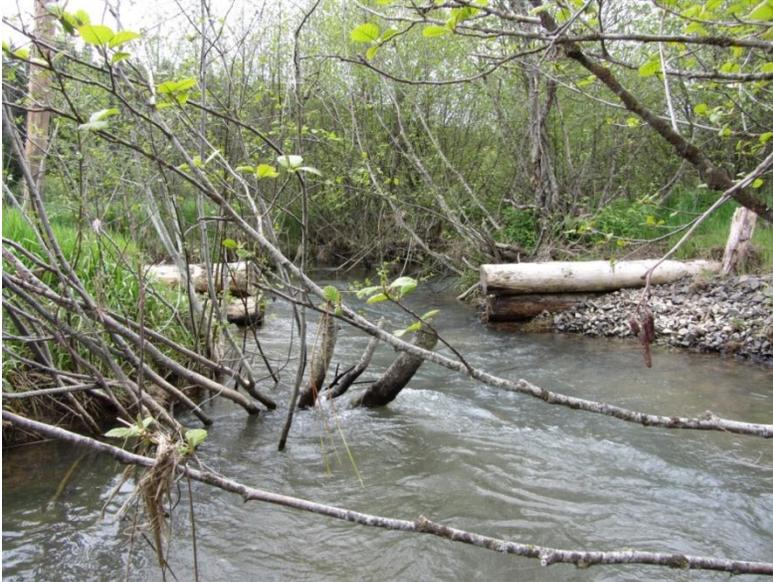
*Photo 2. Engineered “flow choke structures” constructed in Lake Creek use a combination of weir flow over a horizontal cross-log and lateral constriction by bank logs to provide desired water surface elevation controls.*

The remaining six structures were engineered “flow choke structures” in which the concept was to create increased backwater effects during floods such that the valley floor would become connected annually. The structures affect approximately 650 m of habitats in WF Lake Creek and an additional 105 m of Upper Lake Creek by increasing residual pool depth and volume at base flow conditions. Each of the structures consisted of a horizontal log spanning the channel to form a simple weir and several horizontal bank logs to constrict high flows, with sufficient depth to permit passage of floating debris at the bankfull level (Photo 2).

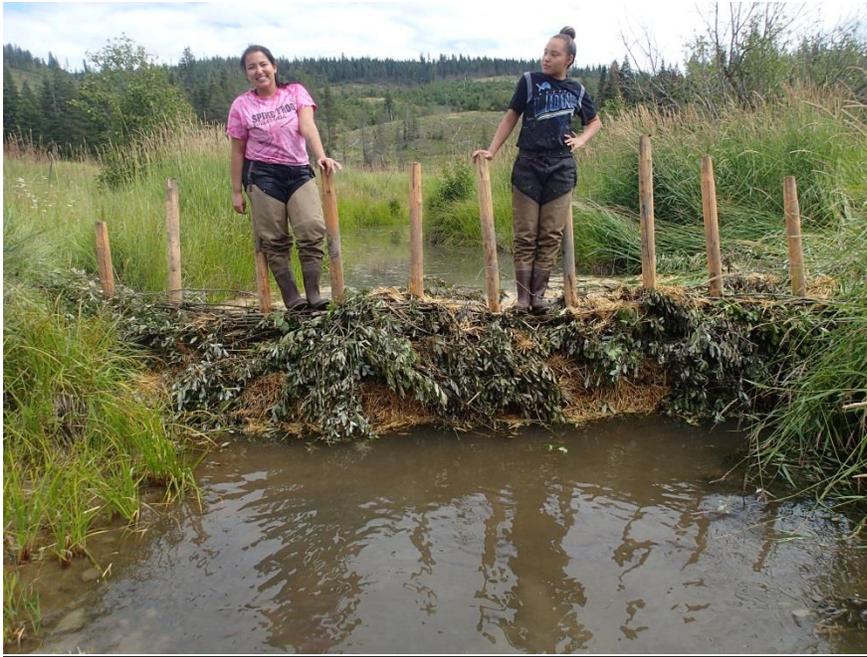
*Photo 3. Starter dams were established in a total of 14 locations during 2015 and 2016, wherein a line of wooden posts was installed using a hydraulic post pounder, followed by weaving branches in between the posts and incorporating straw and mud to create a semi-permeable structure mimicking a natural beaver dam.*

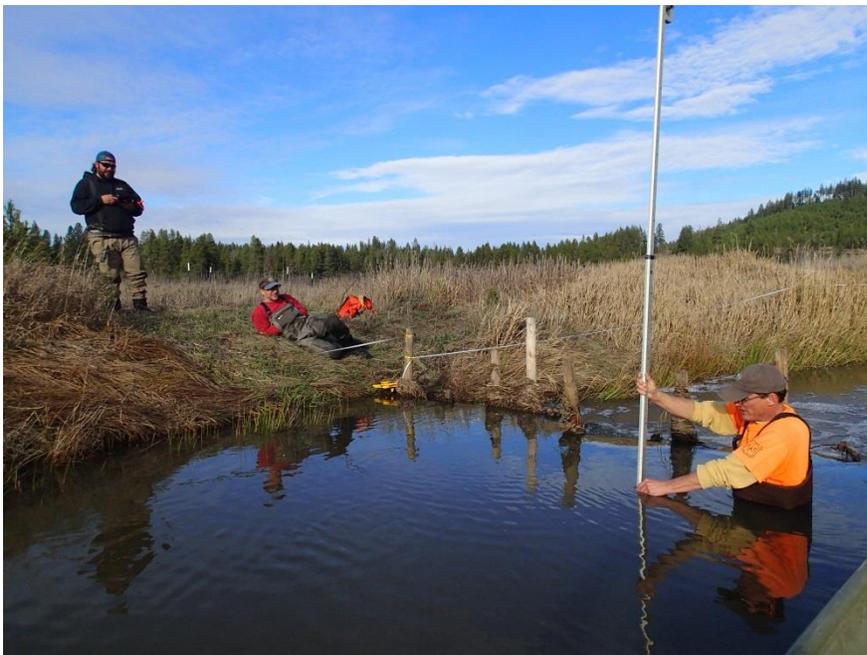
*Photo 4. Beaver Dam Analogs (BDAs) installed in 2016 maintained a high degree of integrity during summer low flows while elevating stream water levels and the surrounding ground water table through the growing season. Opportunities for establishing riparian plant communities are being tested in these areas with improved wet site conditions.*

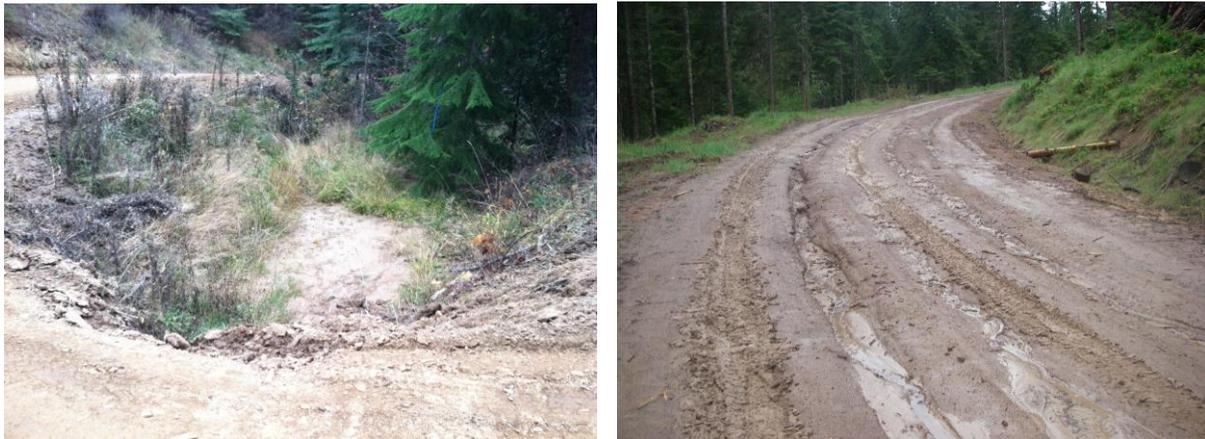
Photo 5. Sediment transported to an unnamed tributary to Windfall Creek prior to resurfacing (left panel). Road segment along Windfall Pass road prior to resurfacing (right panel).

Road resurfacing was completed on 2,574 meters of native surface road along the upper sections of Windfall Pass Road (Figure 6). Prior to resurfacing, road segments were re-graded and ditches repaired. Two rock sources were used to resurface the road. A base of courser 6" minus rock (3204 CY) was placed first, followed by a surface cover of ¾" minus rock (2746 CY). A roller and a grader were used to complete this work.

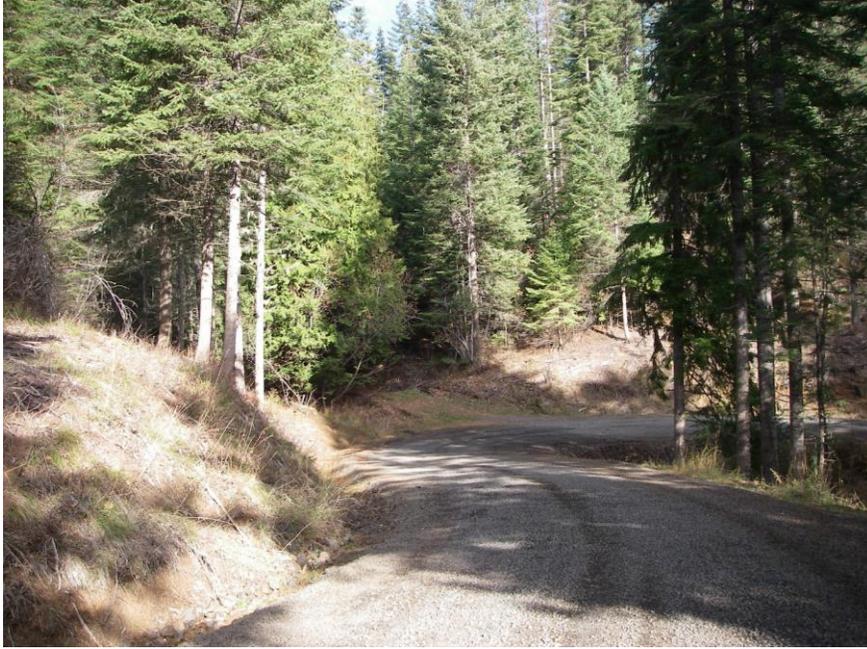
*Photo 6. Resurfaced section of Windfall Pass in October 2016.*

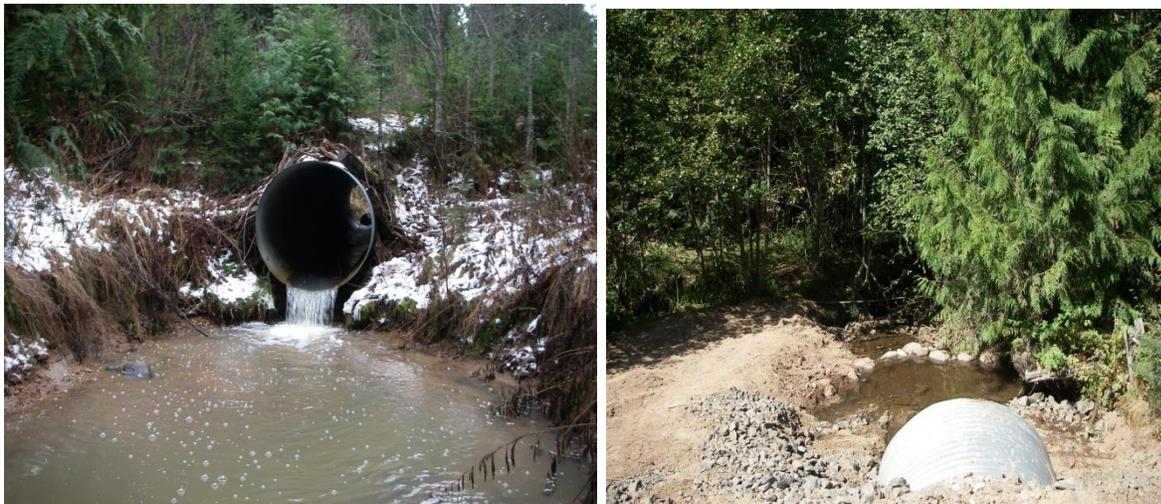
Problem Description: Schoolhouse Creek is an important spawning and rearing stream for resident and adfluvial westslope cutthroat trout in the Benewah watershed. This stream crossing was identified as an adult and juvenile fish barrier in the Forest Road and Fish Passage Assessment completed in 2008 (Duck Creek Associates 2009). The existing 60” diameter culvert was undersized and perched 0.35 m above the stream channel where bankfull width is 3.38 m. A prioritization process completed by the Fisheries program ranked the replacement of this stream crossing as a high priority. The project will restore connectivity with the upper Whitetail Creek watershed, including access to 833 meters of potential rearing and spawning habitats with a drainage area of 422 ha.

*Photo 7. The former Schoolhouse Creek stream crossing was identified as a fish barrier (left panel). The new Schoolhouse Creek culvert is shown after construction in September 2016. Note the newly created floodplain bench (right panel).*

Phase 1: Replace existing culvert. A Cat 320 excavator was used to remove the undersized culvert and install the new 77" x 52" arch pipe. Before installing the new pipe, bedding material consisting of 3/4" minus gravel was placed in the excavated pipe trench and compacted. The new pipe was delivered in 2 separate sections that were connected during construction. The used culvert was given back to the landowner for reuse. The existing roadbed was capped with imported gravel. Rock rip-rap was placed around the new pipe to help protect the inlet and outlet of the new pipe. Large cobbles and small boulders were hand placed in the pipe to help accumulate gravel and create fish habitat.

Phase 2: Install ground control and reshape the stream. One drop structure was installed to connect the upstream and downstream stream reaches. This structure will create grade control as well as provide fish habitat downstream of the new culvert. We also reshaped the stream channel on the downstream end of the project reach so that it had access to a floodplain bench.
