**Implementation of Fisheries Enhancement Opportunities on the  
Coeur d'Alene Reservation  
Habitat Restoration Report**

**BPA Project # 1990-044-00**

6/1/2017 – 12/31/2019

Coeur d'Alene Tribe, Plummer, ID, 83851

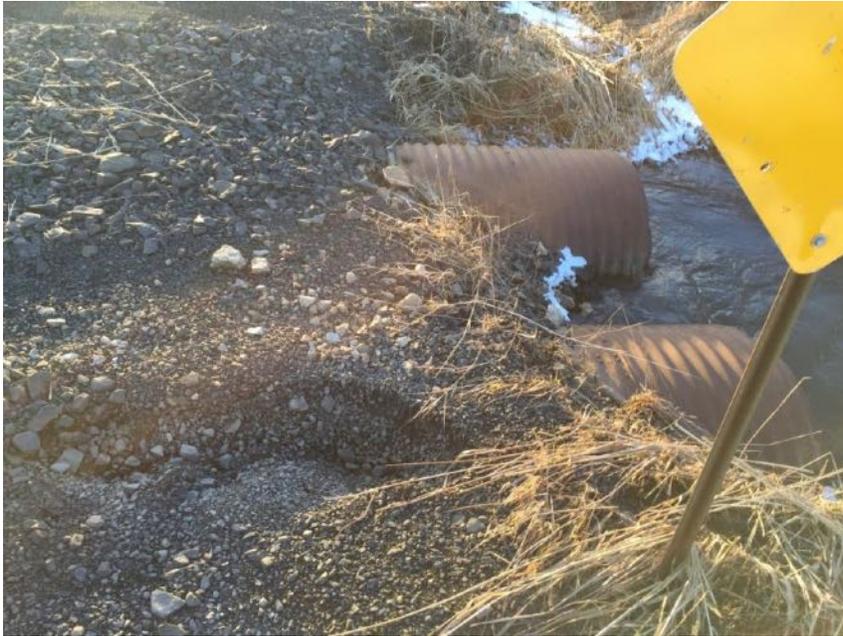
**Problem Description:** Bozard Creek is an important spawning and rearing stream for resident and adfluvial westslope cutthroat trout in the Lake Creek watershed. This project will replace two 48" pipes with a bridge structure that has an inner span of 19' (Photo 1). This stream crossing frequently flooded, depositing sediment into Bozard Creek. This project will reduce sediment transport into lower Bozard Creek by reducing the transportation of road gravels via flood waters. The new stream crossing will allow for passage of all size classes of trout. The project will ensure connectivity with the upper Bozard Creek watershed, including access to 6,855 meters of potential rearing and spawning habitats with a drainage area of 1,792 ha.

*Photo 1. Former culvert configuration at the Bozard Creek stream crossing, spring 2017. Damage from annual spring flooding can be seen as scour on the road surface.*

**Phase 2:** Install Bridge. A Geosynthetic Reinforced Soil Integrated Bridge System (GRS-IBS) was installed at the site. This system includes the use of geotextile material with soil lifts for the bridge foundation. One hundred ninety-two eco-blocks were used on the structure. The greatest amount of time was spent preparing the new foundation for the bridge. Trenches were dug on both sides of the creek and then backfilled with a 12” deep layer of crushed rock and compacted. Woven geo-textile fabric was placed between each “lift” to add additional strength to the foundation. Ecology Blocks were placed one by one in an interlocking configuration to form retaining walls. These walls were constructed starting at 12.5’ below the elevation of the bottom of the bridge in order to provide for scour protection against large floods. The steel bridge

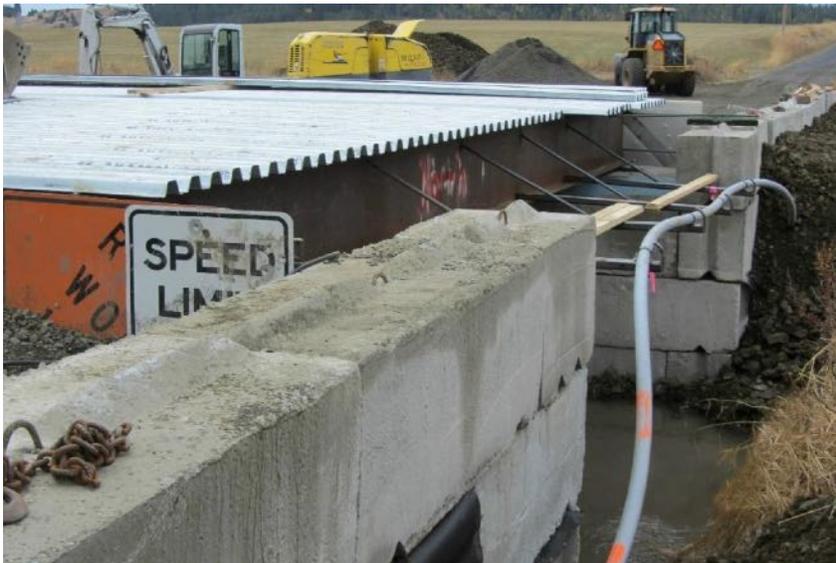
*Photo 2. New Bozard Creek bridge structure during the later stages of construction.*

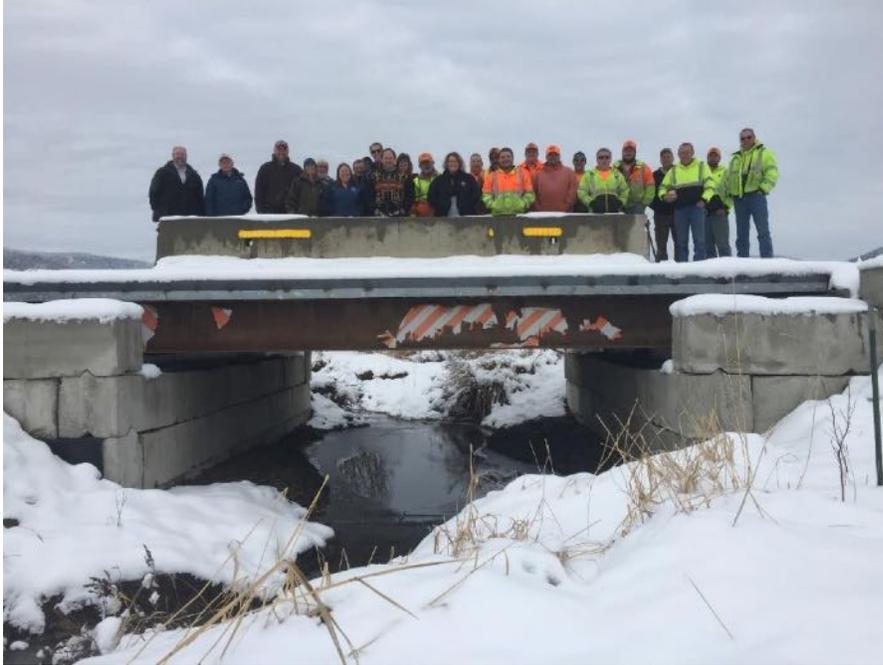
*Photo 3. Finished Bozard Creek bridge in November 2017.*

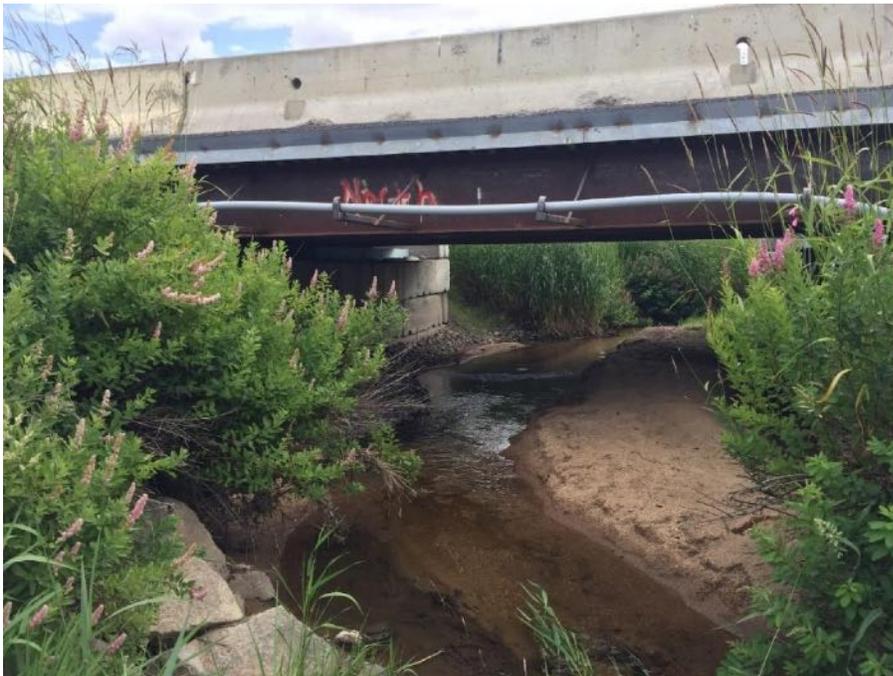
*Photo 4. Newly constructed Bozard Creek bridge in summer 2018. Notice the new floodplain bench that is forming under the structure.*

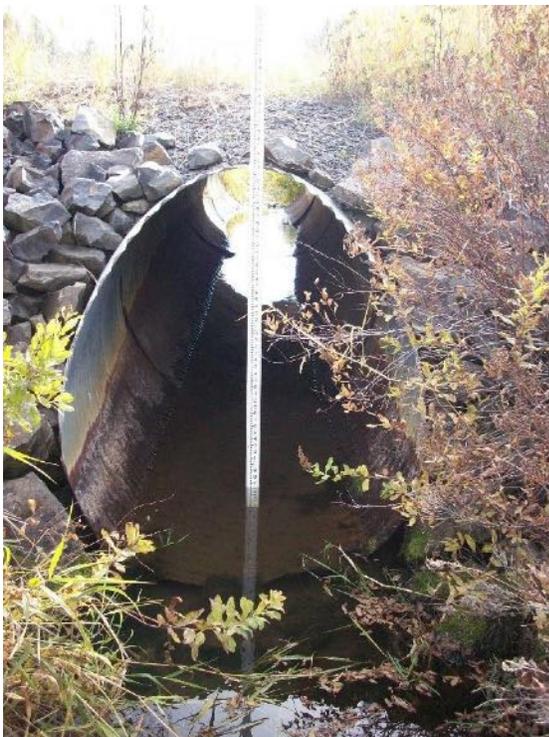
Problem Description: Lake Creek is an important spawning and rearing stream for resident and adfluvial westslope cutthroat trout in the Lake Creek watershed. This stream crossing was identified as an adult and juvenile fish barrier in the Forest Road and Fish Passage Assessment completed in 2008 (Duck Creek Associates 2009). The existing 64” diameter culvert was undersized (Photo 5). A prioritization process completed by the Fisheries program ranked the replacement of this stream crossing as a high priority. The project will restore connectivity with the upper Lake Creek watershed, including access to 2,526 meters of potential rearing and spawning habitats with a drainage area of 258 ha.

*Photo 5. The former Lake Creek stream crossing (64" pipe) was identified as a fish barrier.*

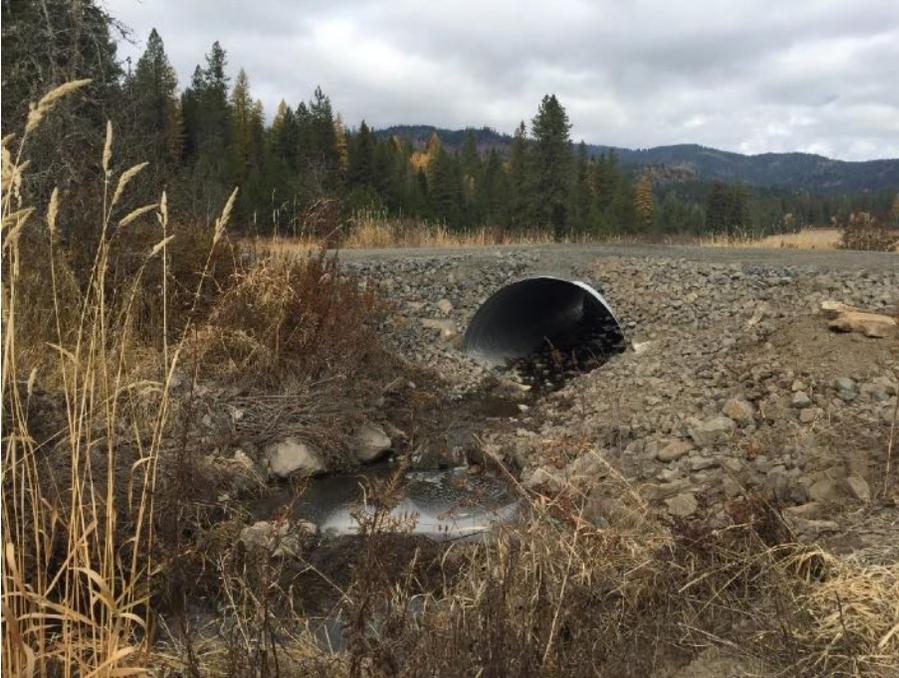
*Photo 6. Newly installed 112" x 75" arch pipe in October 2018.*

Phase 1: Replace existing culvert. A Cat 320 excavator was used to remove the undersized culvert and install the new 112” x 75” arch pipe (Photo 6). Before installing the new pipe, bedding material consisting of ¾” minus gravel was placed in the excavated pipe trench and compacted. The new pipe was delivered in 2 separate sections that were connected during construction. Rock rip-rap was placed around the new pipe to help protect the inlet and outlet of

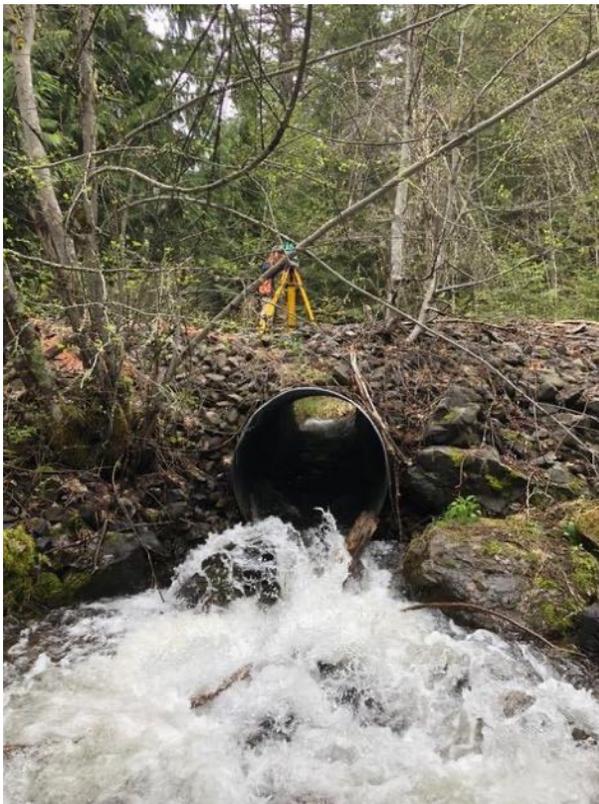
Problem Description: Upper Lake Creek is an important spawning and rearing stream for resident and adfluvial westslope cutthroat trout in the Lake Creek watershed. This stream crossing was identified as an adult and juvenile fish barrier in the Forest Road and Fish Passage Assessment completed in 2008 (Duck Creek Associates 2009). The existing 48” diameter culvert was undersized and set at a 9% slope (perched 0.38 m above the stream channel where bankfull width is 2.43 m (Photo 7). A prioritization process completed by the Fisheries program ranked the replacement of this stream crossing as a high priority. The project will restore connectivity with the upper Lake Creek watershed, including access to 182 meters of potential rearing and spawning habitats.

*Photo 7. The former upper Lake Creek stream crossing that was identified as a fish barrier.*

The design called for replacing the existing undersized pipe with a new 15' x 4.66' open bottom arch culvert that was 30 feet long. The culvert was placed on concrete footings that were 5' wide by 3.5' tall. Within the concrete footings was a rebar cage that was pre-assembled and brought to the site. Beneath the culvert, we simulated a stream channel following recommendations by the Washington Department of Fish and Wildlife. Twenty-five meters of stream channel was affected by this project. A total of 0.01 ha of wetland was disturbed during construction. Structural design work for the footings was completed by the landowner.

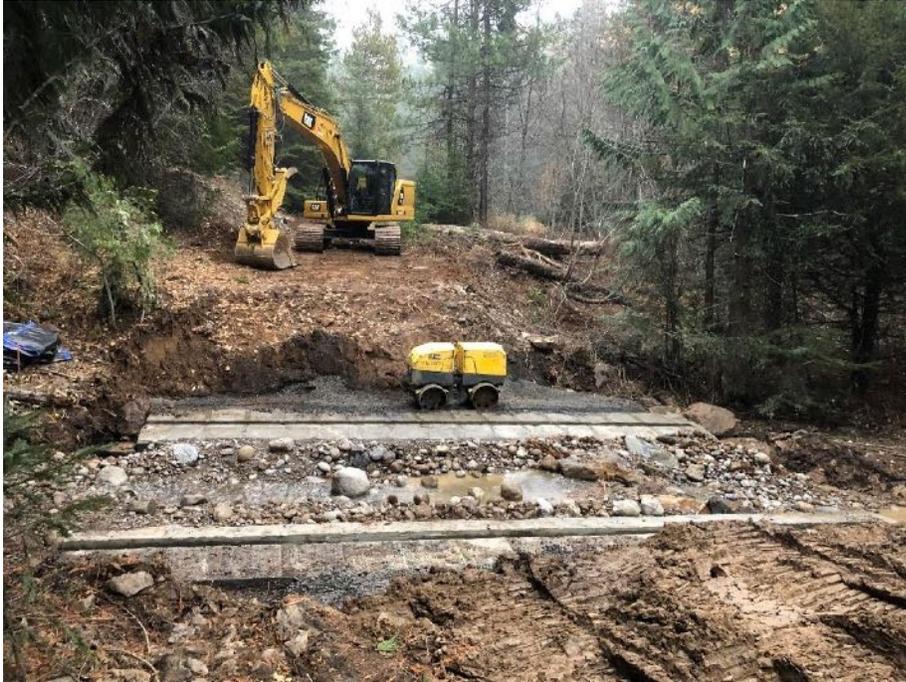
*Photo 8. A simulated streambed was constructed between the two concrete footings. The slotted channel in the concrete footings on either side of the streambed that will hold the new culvert in place is clearly visible in this photo.*

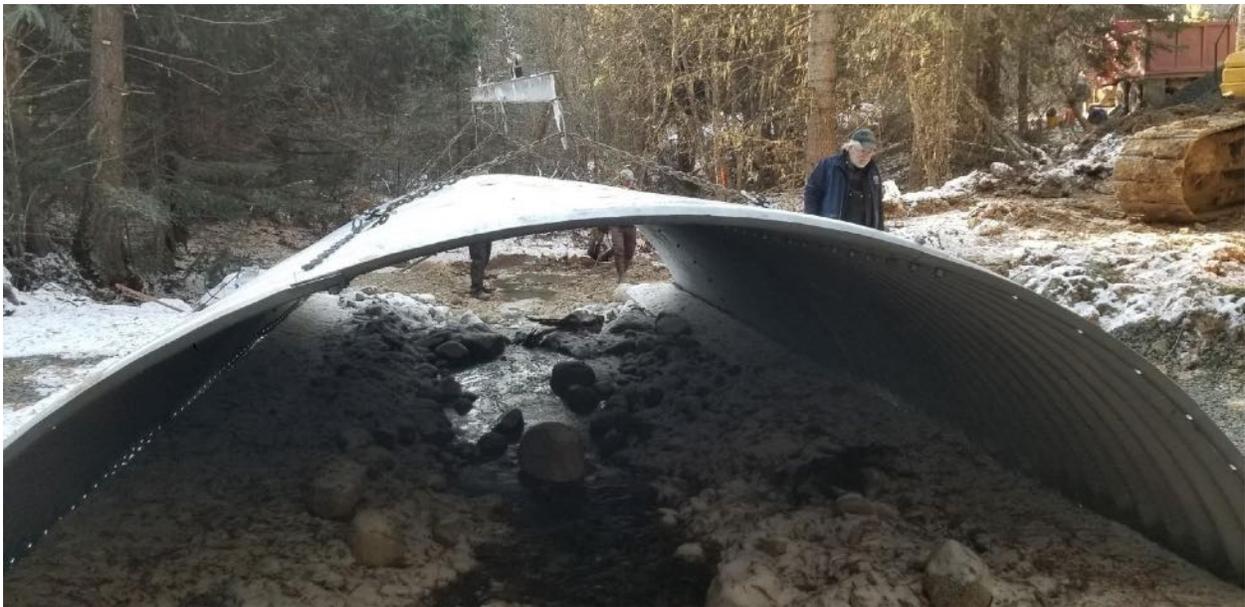
*Photo 9. The plate arch culvert was pieced together then lifted on to the concrete footings to finish the job of constructing the new passage structure.*

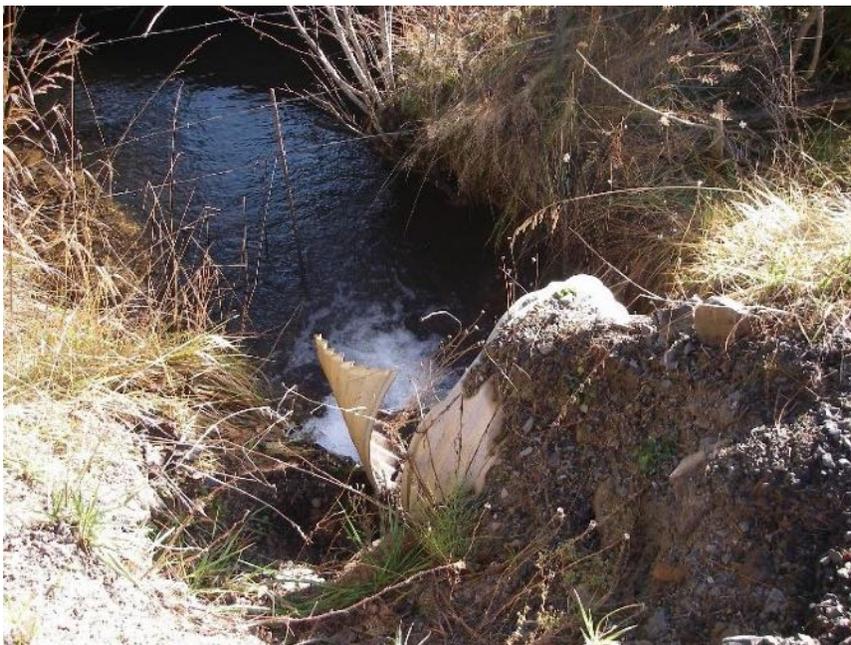
Problem Description: West Fork Benawah Creek is an important spawning and rearing stream for resident and adfluvial westslope cutthroat trout in the Benawah watershed. This stream crossing was identified as an adult and juvenile fish barrier in the Forest Road and Fish Passage Assessment completed in 2008 (Duck Creek Associates 2009). The existing 36” diameter culvert was undersized and perched 0.11 m above the stream channel (Photo 15). Bankfull width is 2.4 m. The outlet of the culvert was damaged which ranked the replacement of this stream crossing as a high priority. The project will restore connectivity with the upper West Fork Benawah Creek watershed, including access to 6,871 meters of potential rearing and spawning habitats with a drainage area of 668 ha.

*Photo 15. The former West Fork Benewah Creek stream crossing was identified as a fish barrier.*

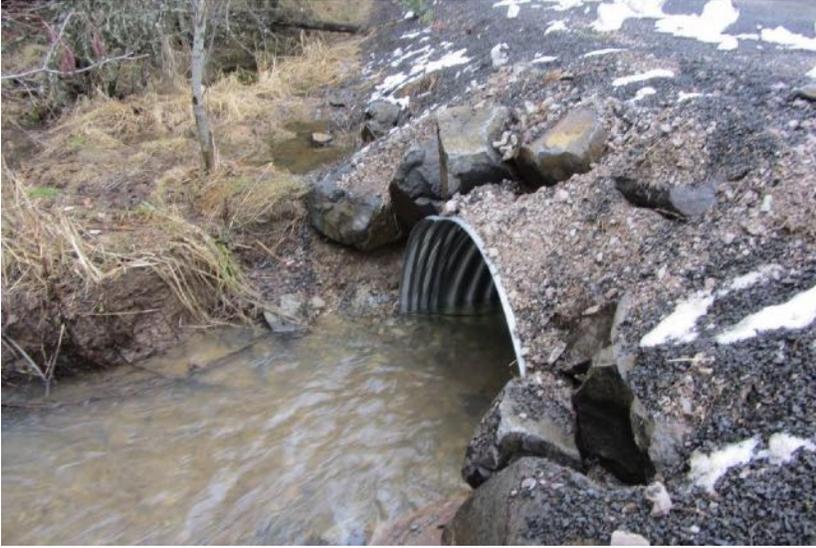
*Photo 16. The new West Fork Benewah Creek stream channel in spring 2018.*

Phase 1: Replace existing culvert. A Cat 320 excavator was used to remove the undersized culvert and install the new 83” x 57” arch pipe (Photo 16). Before installing the new pipe, bedding material consisting of ¾” minus gravel was placed in the excavated pipe trench and compacted. The new pipe was delivered in 2 separate sections that were connected during construction. Rock rip-rap was placed around the new pipe to help protect the inlet and outlet of

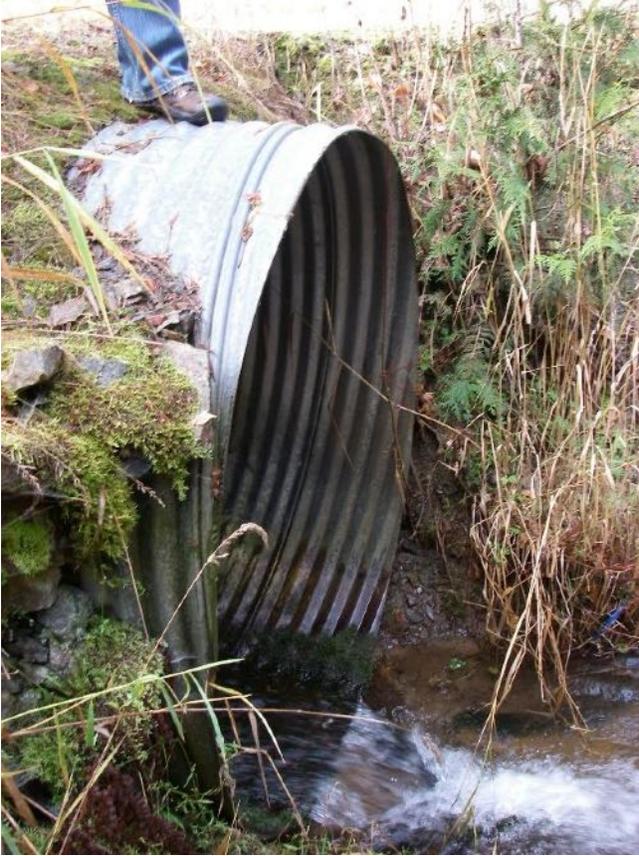
Problem Description: South Fork Benewah Creek is an important spawning and rearing stream for resident and adfluvial westslope cutthroat trout in the Benewah watershed. This stream crossing was identified as an adult and juvenile fish barrier in the Forest Road and Fish Passage Assessment completed in 2008 (Duck Creek Associates 2009). The existing 60” diameter culvert was undersized and perched 0.27 m above the stream channel (Photo 17). Bankfull width is 4.66 m. A prioritization process completed by the Fisheries program ranked the replacement of this stream crossing as a high priority. The project will restore connectivity with the upper South Fork Benewah Creek watershed, including access to 3,958 meters of potential rearing and spawning habitats with a drainage area of 712.24 ha.

*Photo 17. The former South Fork Benewah Creek stream crossing before replacement.*

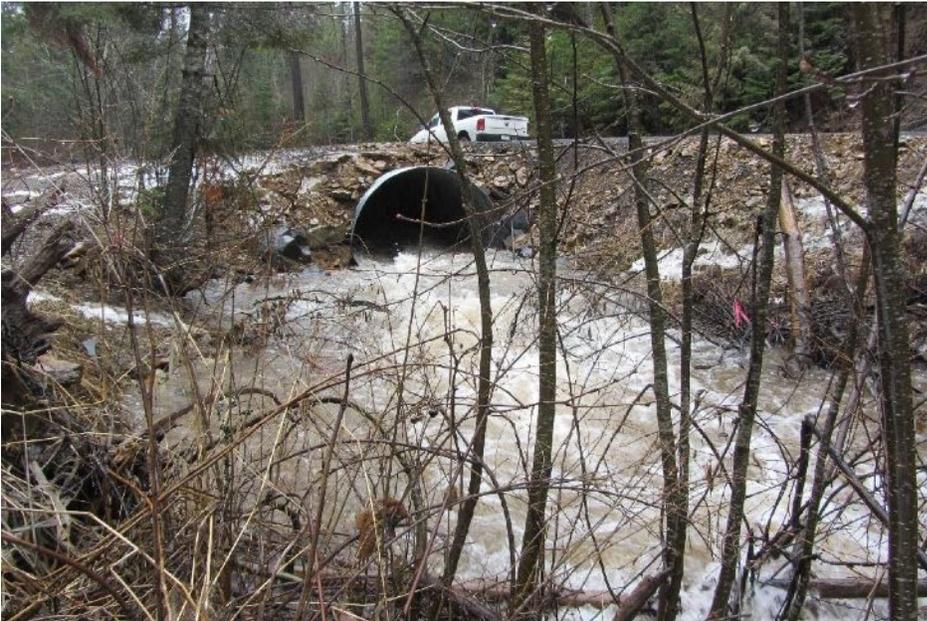
*Photo 18. The new South Fork Benewah Creek culvert in 2018 during high flows.*

Phase 1: Replace existing culvert. A Cat 320 excavator was used to remove the undersized culvert and install the new 96" x 67" arch pipe. Before installing the new pipe, bedding material consisting of ¾" minus gravel was placed in the excavated pipe trench and compacted. The new pipe was delivered in 2 separate sections that were connected during construction. Rock rip-rap was placed around the new pipe to help protect the inlet and outlet of the new pipe. Large cobbles and small boulders were hand placed in the pipe to help accumulate gravel and create fish habitat. Photo 18 shows the new pipe during high flows.

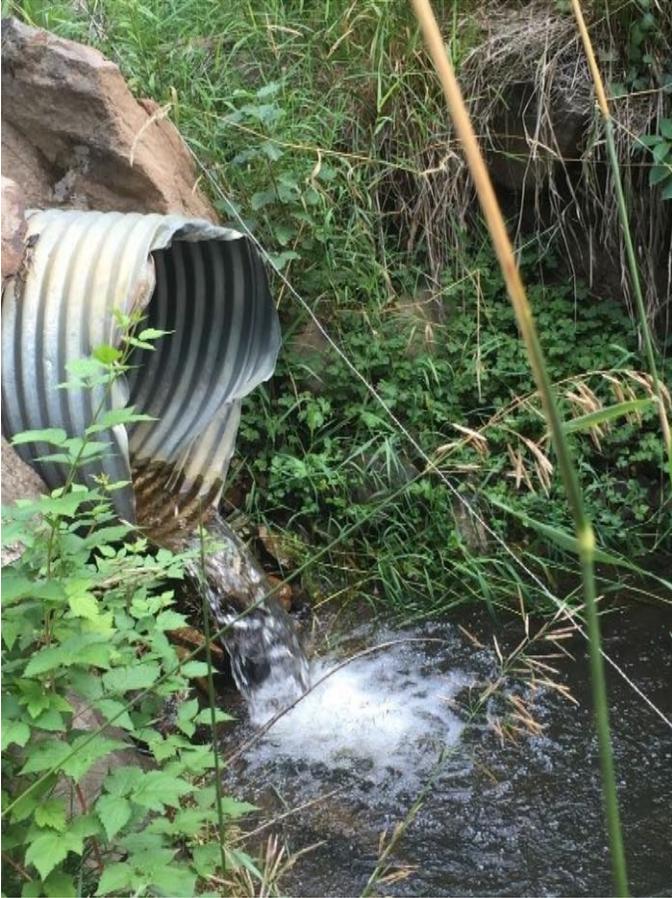
*Photo 19. The lower Bull Creek stream crossing that was identified as a fish barrier.*

Lower Bull Creek: the design called for replacing the existing undersized 36" diameter pipe with a new 87" x 63" x 36' arch pipe that more closely matched the bankfull channel width. The new pipe was countersunk to provide natural substrate in the bottom of the culvert and eliminate the outlet **drop (Error! Reference source not found.)**. One grade control structure was placed ownstream of the structure. Twelve inch baffles were installed in the pipe at the inlet, middle, and outlet of the pipe to hold in stream gravel. Twenty-four meters of stream channel was affected by this project. A total of 0.01 ha of wetland was disturbed during construction.

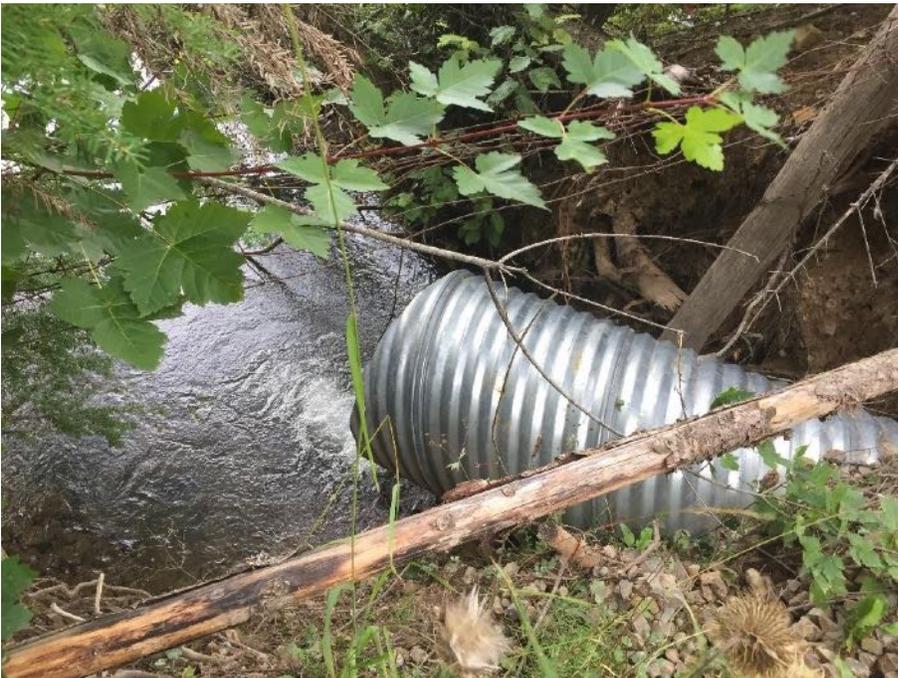
*Photo 20. The upper Bull Creek stream crossing that was identified as a fish barrier.*

Phase 1: Replace existing culverts. A Cat 320 excavator was used to remove the undersized culverts and install the new pipes. Before installing the new pipes, bedding material consisting of  $\frac{3}{4}$ " minus gravel was placed in the excavated pipe trench and compacted. The new pipe was delivered in 2 separate sections that were connected during construction. Rock rip-rap was placed around the new pipe to help protect the inlet and outlet of the new pipe. Large cobbles and small boulders were hand placed in the pipe to help accumulate gravel and create fish habitat.

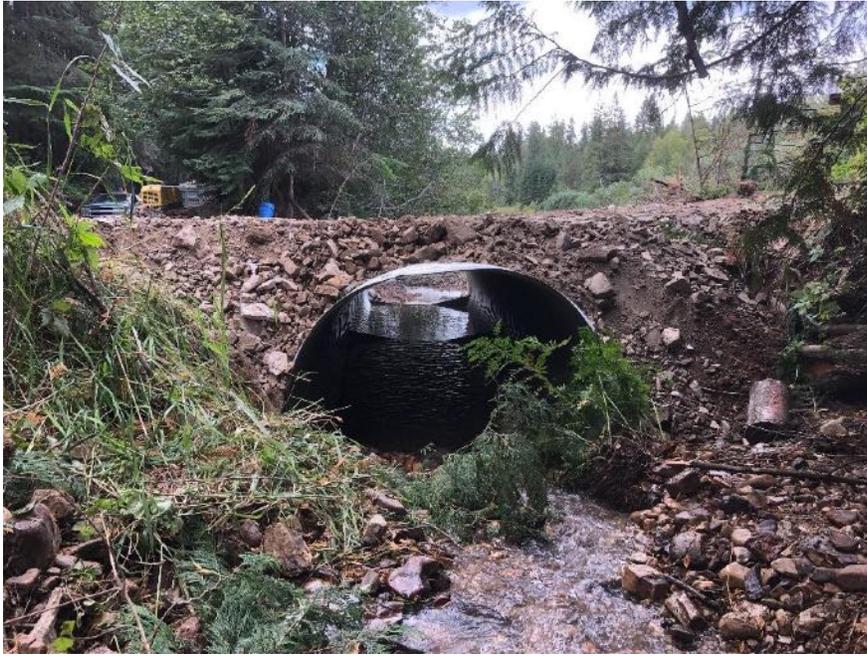
*Photo 21. The upper Bull Creek stream crossing after replacement*

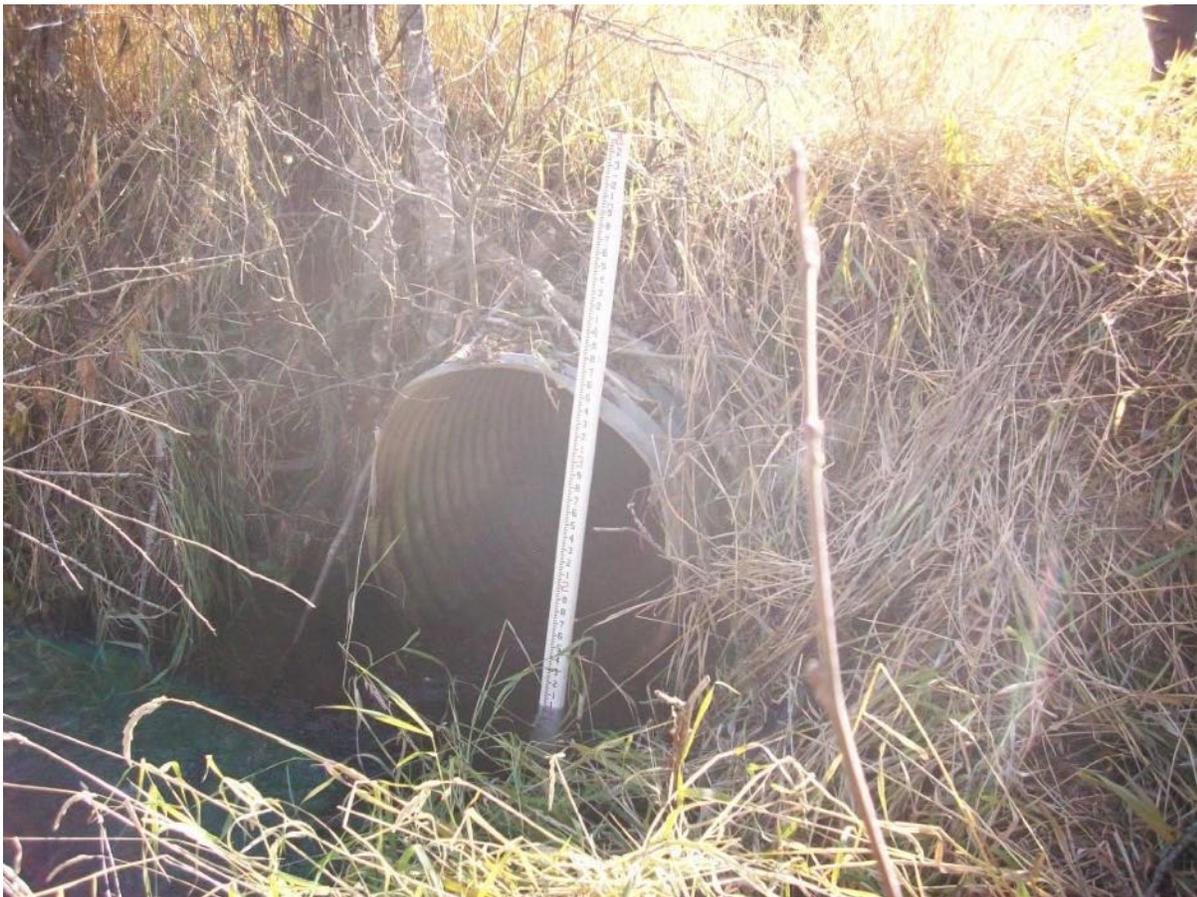
*Photo 24. The former Alder Creek stream crossing that was identified as a fish barrier. This pipe was undersized.*

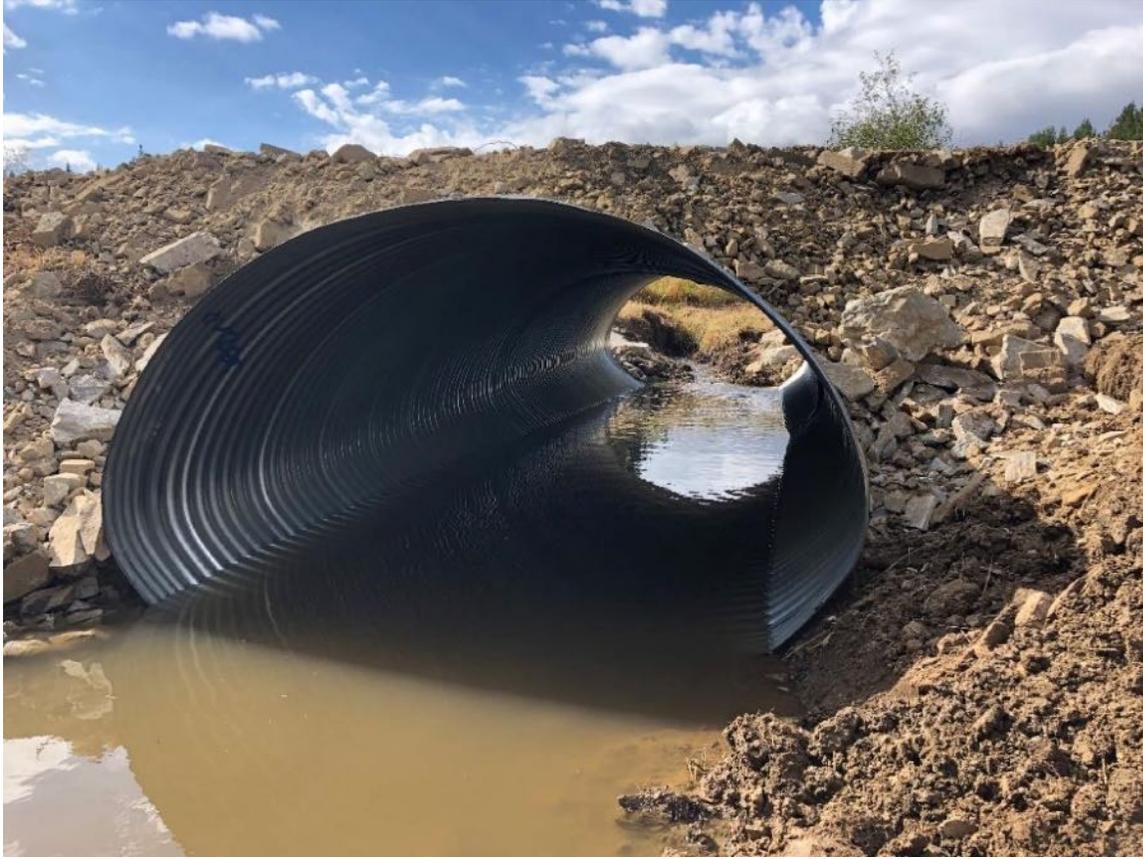
*Photo 25. The new Alder Creek culvert is shown after construction in September 2018.*
