# Progress Report 2010-2011: Hangman Creek Fisheries Restoration

**BPA Project # 2001-032-00**

5/1/2010 - 04/30/2012

Kinkead, B.A., and T. J. Biladeau, Coeur d' Alene Tribe, Plummer, ID, 83851

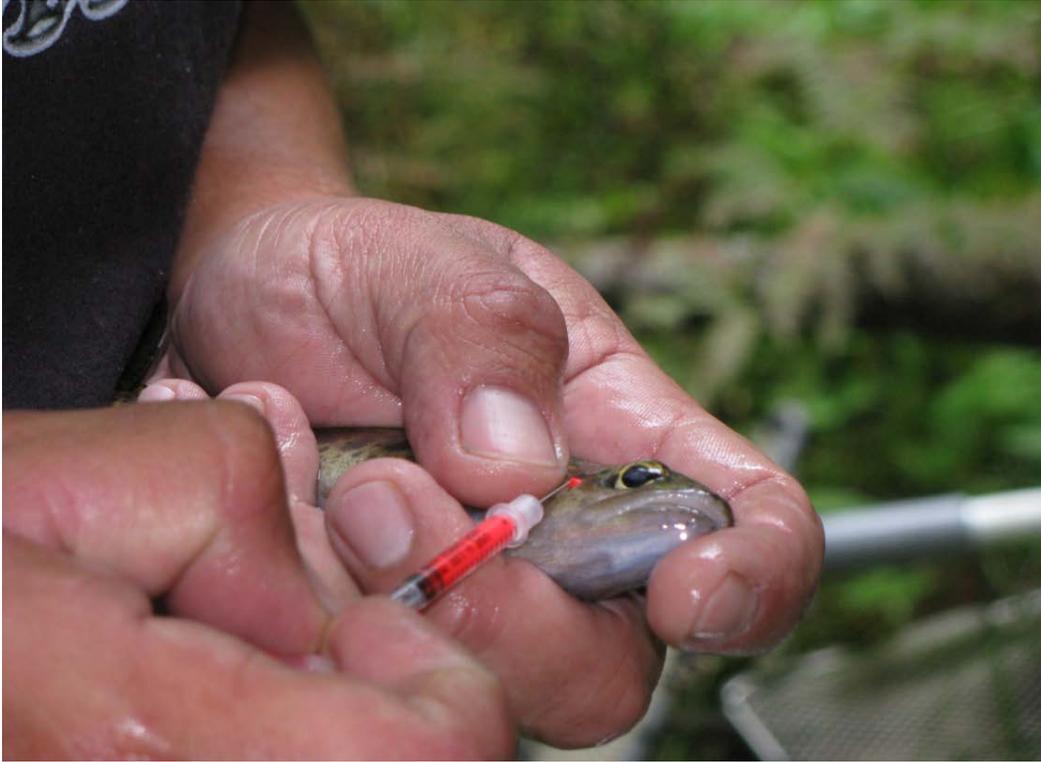
Picture 1. Processing of fish in 2008-9 consisted injection of Visible Implant (VIE) which were color and location coded to track an individual's movement in the watershed.

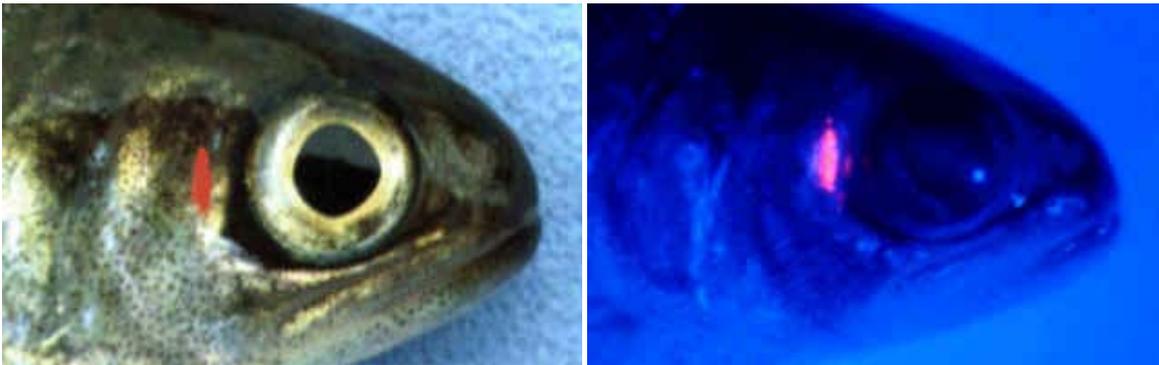
Picture 2. VIE tagged coho salmon (*O. kisutch*) smolt under ambient light and with UV light.

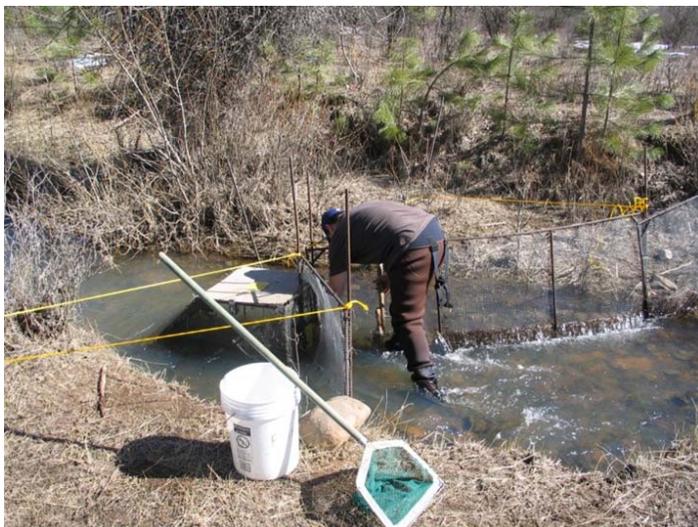
Picture 3. Standard upstream trap used at Nehchen and Indian Creeks.

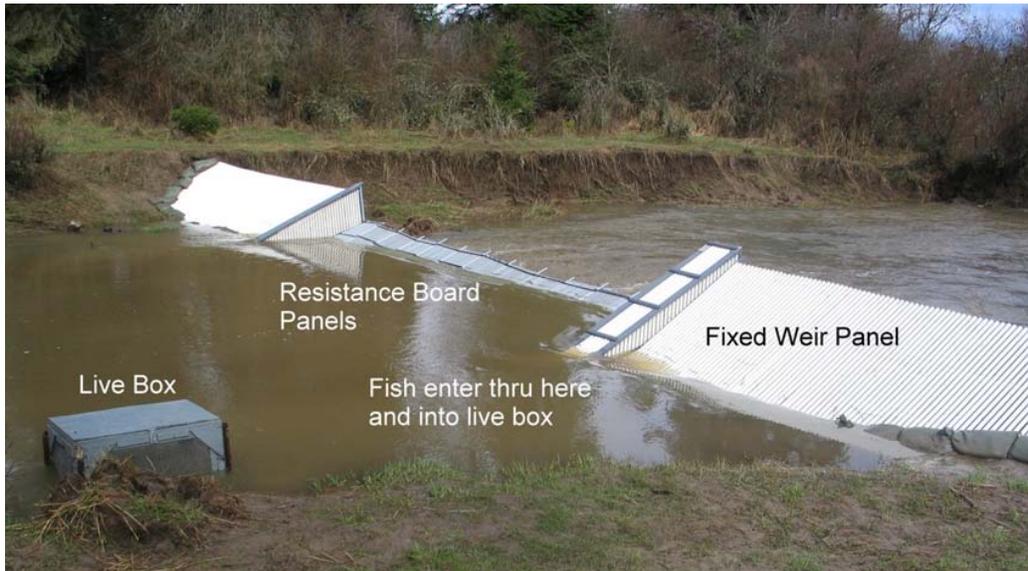
Picture 4. Resistance Board Weir used in Hangman Creek from early March until mid June.

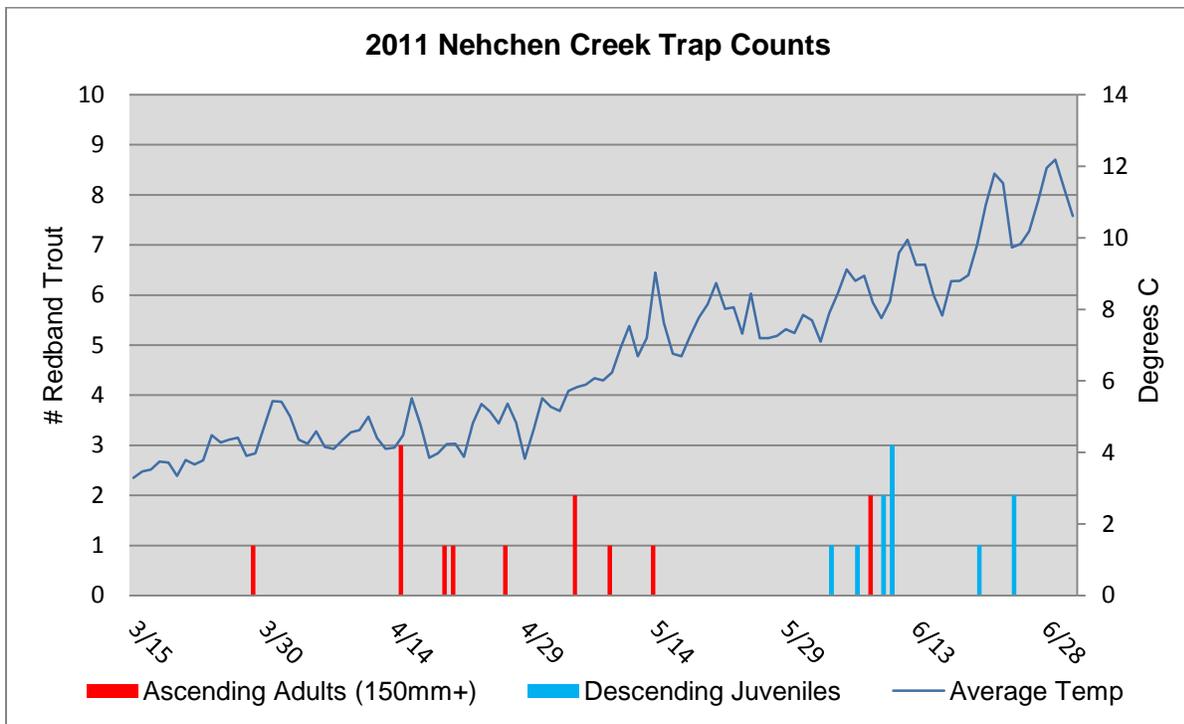
Figure 10. Nehchen Creek trap counts of redband trout with average daily temperature showing timing of ascending adults and descending juveniles in 2011.

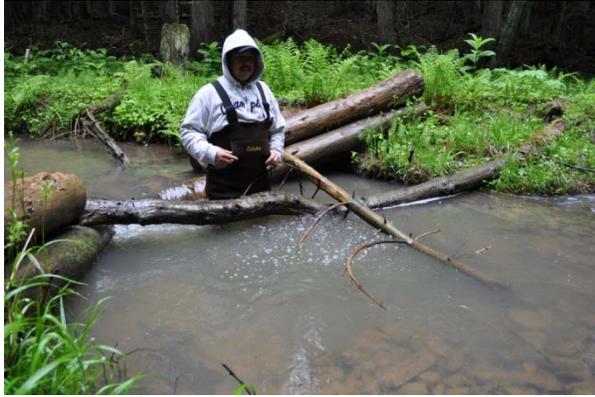
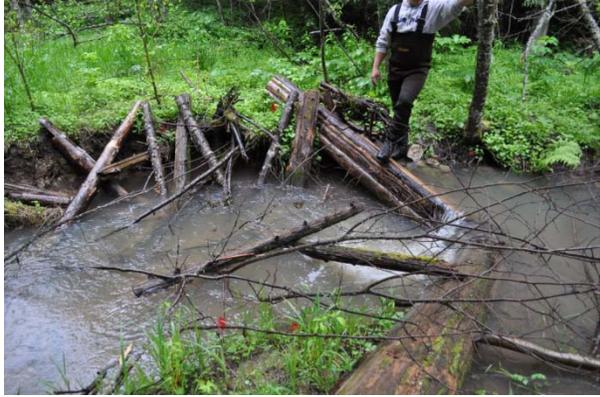
Picture 5. Cross veins were by far the most successful technique to create pools below and behind the structures (left panel), and in combination with vertical logs to protect raw banks (right panel).

Description of Treatment: The large woody debris project was initiated in 2008 and completed in spring of 2010. There now are two separate 500 foot treated reaches identified as Indian Reach 2B and 2C (Figure 7, Figure 18, and Figure 19). The primary strategy for this restoration project was to treat the most impacted reach (2B and 2C), by adding stable wood for pool forming processes, along with secondary goals of decreasing erosion and creating a mosaic of stored fine sediments and sorted gravels for spawning. The riparian zone was already well established with

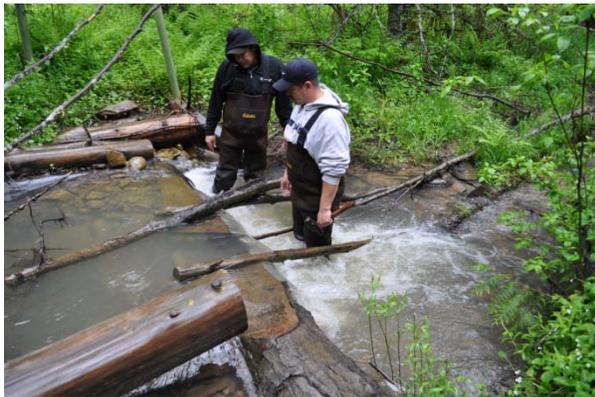
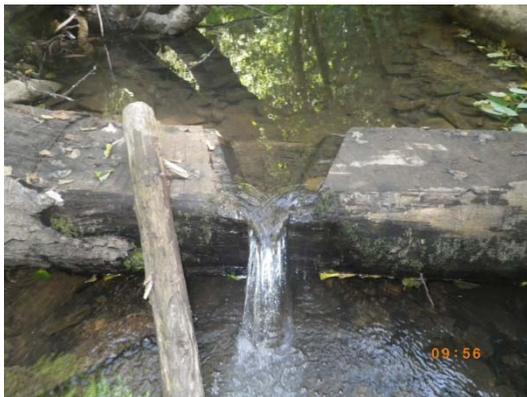
Picture 6. Check dams were used to facilitate channel aggradation (left panel), as well as provide plunge and dammed pool habitat (right panel).

Picture 7. The 125 foot-long incised section of channel with 4.0 feet of raw bank was rehabilitated with a large check dam (previous picture) to facilitate channel aggradation with two j-hooks, one cross vein and vertical logs in the background and horizontal log placements in the foreground, resulting in 1.0 ft of aggradation with continuous pool habitat.

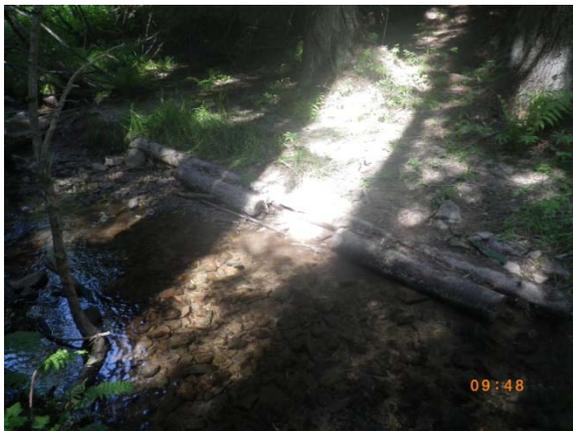
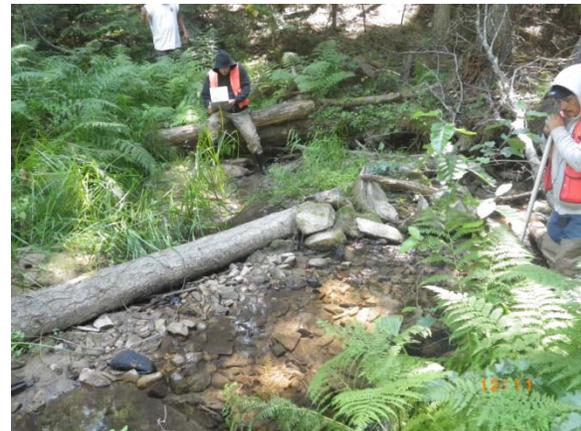
Picture 8. Channel alteration techniques using split log structures to armor banks at elk trails (left panel), and log in mid channel to narrow a wide and shallow section (right panel).

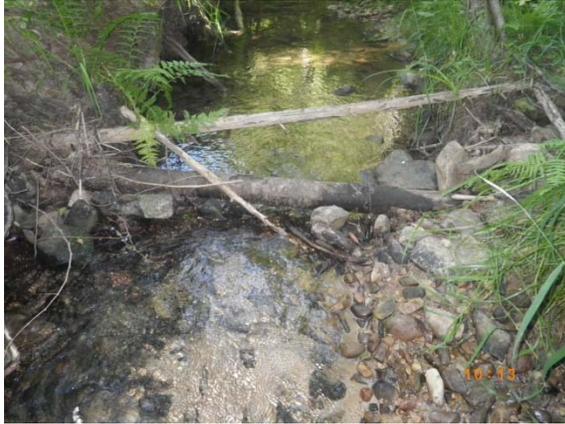
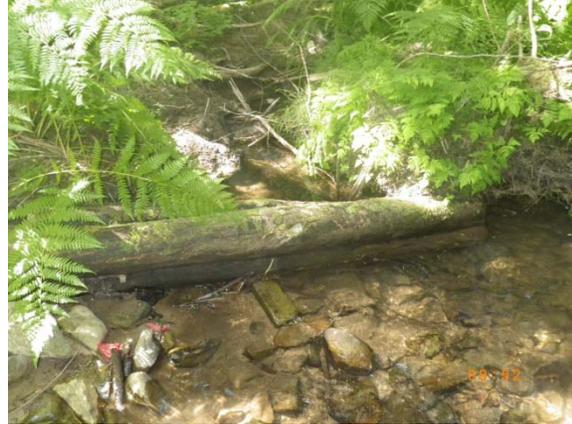
Picture 9. The least successful LWD techniques were the low level check dams where scour sometimes occurred under the log (left panel), and side channel plugs which directed some, but not all flow into the main channel (right panel).

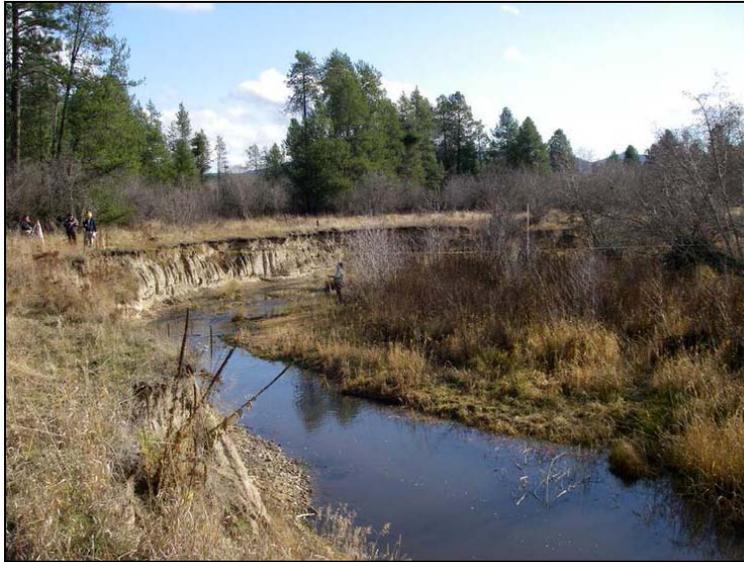
Picture 10. Hangman Creek, Reach 11, riparian and channel conditions in 2005.

Anthropogenic impacts have resulted in an incised channel lacking a connection between the stream and associated riparian habitat. Rosgen channel typing surveys (Kinkead and Firehammer 2011) found the bankfull height to be below sloughing banks (Picture 10). The reach is currently managed to exclude grazing and dryland farming, but impacts upstream from dryland farming and active forest management result in a flashy hydrograph. Reed Canary grass (*Phalaris arundinacea*) and other noxious weeds such as tansy ragwort (*Senecio Jacobaea*) dominate the riparian area, with some alder (*Alnus incana*), Pacific ninebark (*Physocarpus capitatus*), and Mackenzie willow (*Salix mackenzieana*). Uplands consist of a mixed forest and meadow with Hawthorne (*Crateagus monogyna*) as the dominate shrub. Beaver inhabit the area but are unable to build stable dams due to the paucity of larger building materials. Beaver surveys summarized in this report indicate a lack of larger building materials needed to build stable dams.

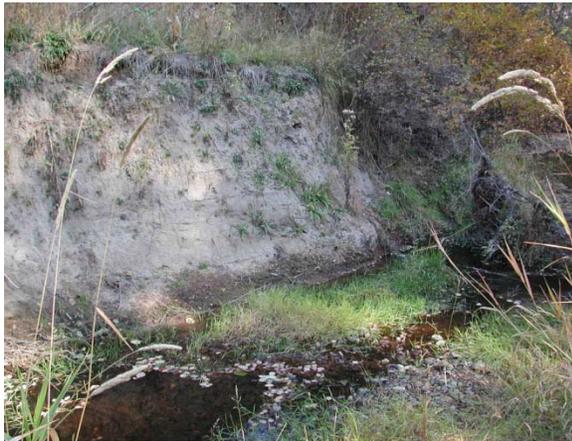
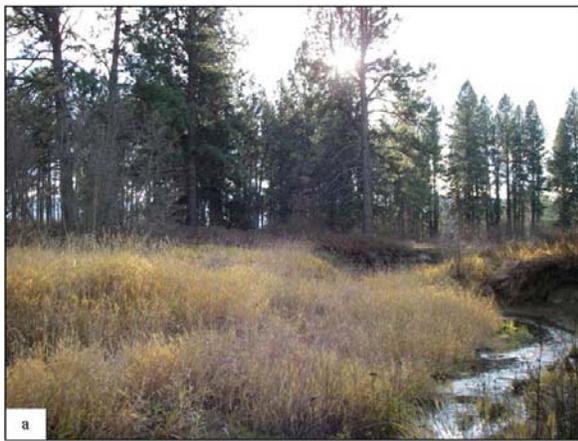
Picture 11. Sheep Creek, tributary of Hangman Creek. Channel and riparian conditions

Present riparian conditions were described by R2; “Although riparian forests throughout the lower Sheep Creek drainage are all degraded or absent to a significant degree relative to historic conditions with reed canary grass dominating, existing remaining riparian vegetation can be used as a reference system upon which to base the vegetation composition of the restoration design. Currently, the Sheep Creek riparian corridor supports forest fragments of Ponderosa pine, western white pine, black cottonwood, gray alder, Douglas fir, black hawthorn, lodgepole pine, aspen, and grand fir. Shrub species include snowberry, Pacific ninebark, ocean spray, spirea, red osier dogwood, mountain alder, and willows. Wetland herbaceous species include slender sedge, lenticular sedge, small-winged sedge, Nebraska sedge, beaked sedge, Baltic rush, common rush, daggerleaf rush, slender rush, and small-fruited bulrush.”

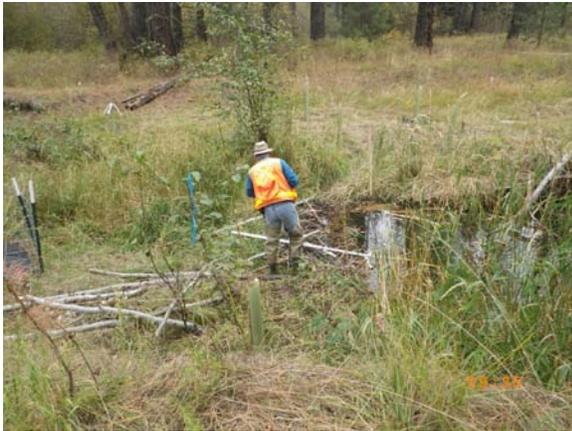
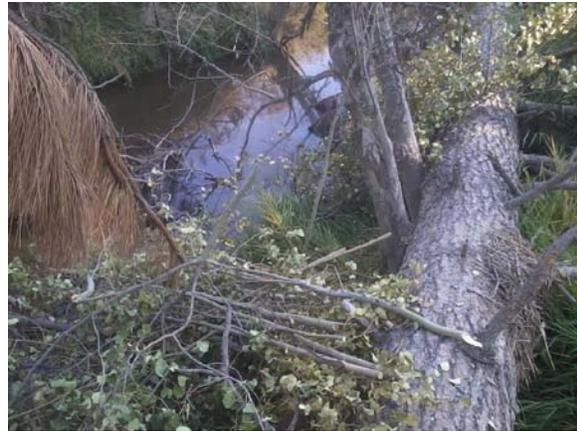
Picture 12. Hardwood clipping left on Sheep Creek to supplement beaver food and dam building supplies in 2011.

Hardwood clippings consisting of mostly aspen along with some cottonwood and alder were cut and placed at existing beaver dams in 2011 to supplement food and building supplies. A total of 6,100 ft<sup>3</sup> of dam building materials were provided in 3 general locations, with 3 specific dam locations on each stream reach (Picture 12). This amounts to an equivalent of 1,151 pieces of 2 inch diameter by 10 feet long, roughly enough materials to build twenty dams four feet high, ten feet long, and fifteen feet wide. Materials were offered on Mission Creek R4, Sheep Creek R2, and Hangman Creek R11 (Figure 17). Brush offerings were made in May, July and September of 2011. The initial offering disappeared the first night on Mission and Sheep Creek with all

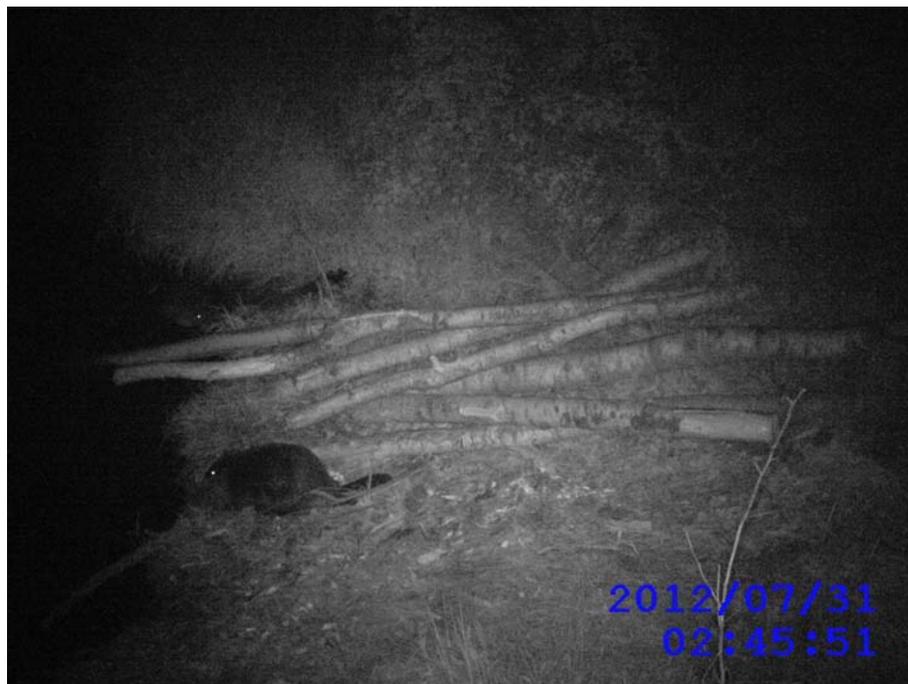
Picture 13. Beaver utilizing aspen cuttings left on bank on Sheep Creek.

sizes utilized. A 6 foot tall dam was repaired on Sheep Creek within 24 hours of the offering. Utilization of brush by beavers in July and September were more selective with all pieces <2” diameter taken within 48 hours, while the larger pieces 2 – 4” diameter were picked up within 2 weeks

Picture 13). Most of the clippings appeared to be used for food rather than dam building.

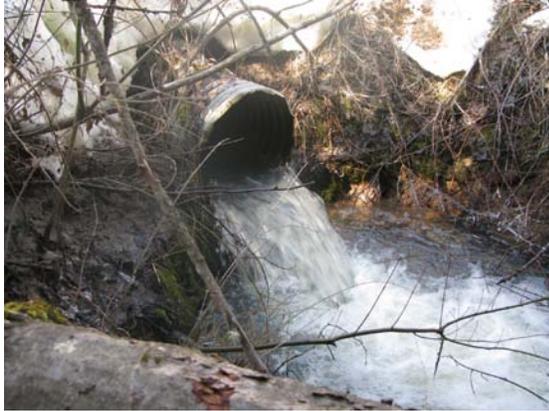
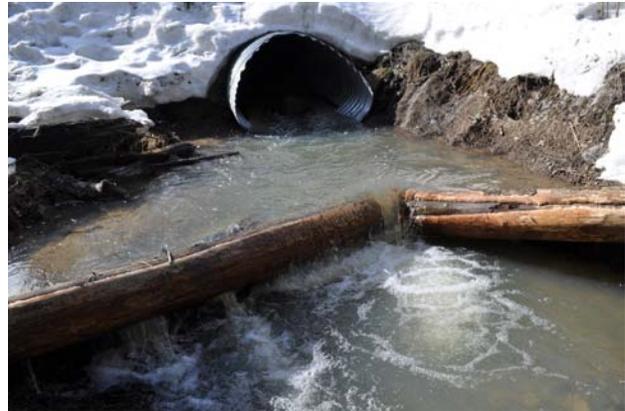
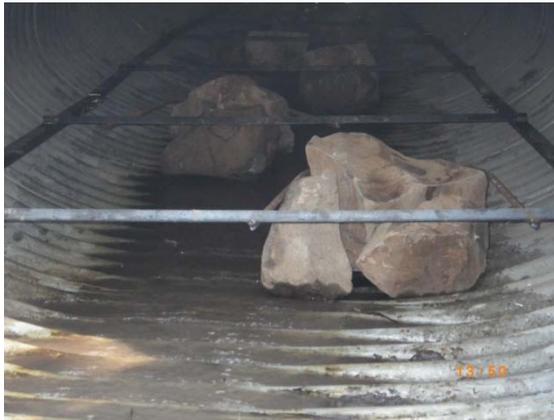
Picture 14. Bunnel Creek culvert replacement. 24” pipe (left panel) replaced with a 60” pipe, and LWD structures to facilitate a step pool sequence below the culvert (right panel). Rebar rings and rock were incorporated to facilitate fish passage through the culvert (bottom panel).

**NOTE:** Culverts with fish ladders must be maintained over time in order to ensure they do not become blocked by debris and that the large rocks placed along the cross members remain in the culvert.
