Progress Report 2017-2019: Hangman Creek Fisheries Enhancement Restoration Summary

BPA Project # 2001-032-00

5/1/2017 - 12/31/2019

Kinkead, B.A. and T.J. Biladeau, Coeur d'Alene Tribe, Plummer, ID 83851

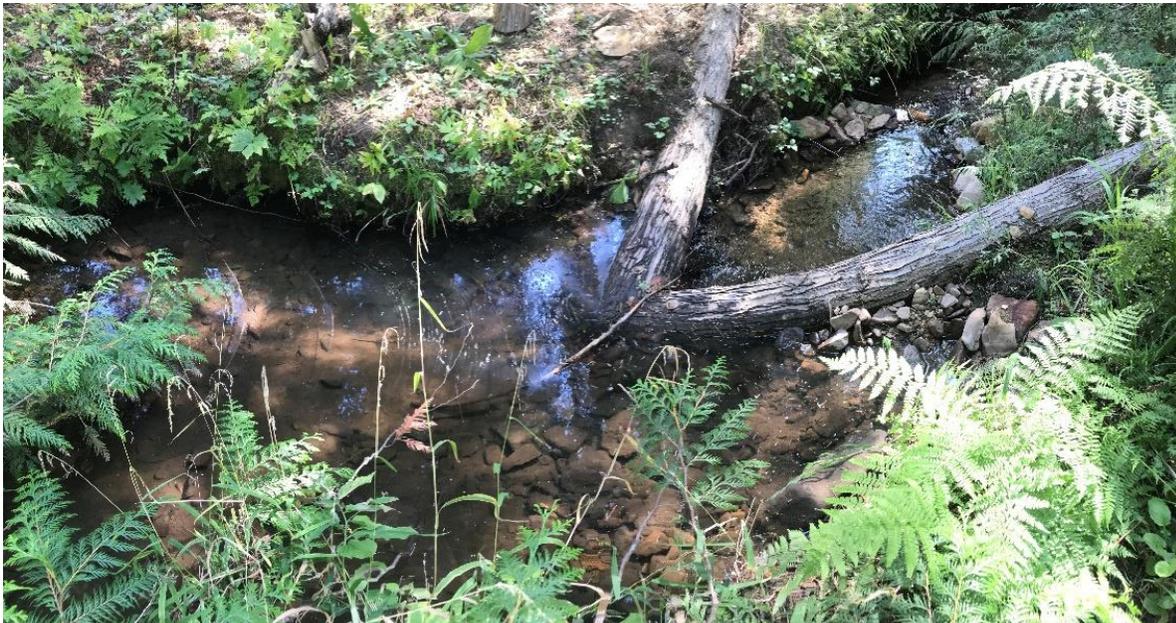
Picture 1. MF Indian Creek Rkm 4.6, typical log cross-vein installed to improve pool habitat and sort substrate sizes.

The large woody debris project was initiated in 2018. The primary strategy for this restoration project was to treat reaches lacking in pools, by adding stable wood for pool forming processes, along with secondary goals of decreasing erosion and creating a mosaic of stored fine sediments and sorted gravels for spawning. The riparian zone is already well established with alder and forbs, and the goal of construction was to limit disturbance while placing large woody debris. Accordingly, all wood was placed without heavy equipment, and logs were moved in using a portable log hauler on rubber wheels. The channel was not dredged and banks were seldom excavated with hand tools to place the logs at proper angles. Six log cross-vanes and four j-hooks were constructed throughout upper Indian Creek. These LWD structures are only intended to function until the recruitment of conifers improves.

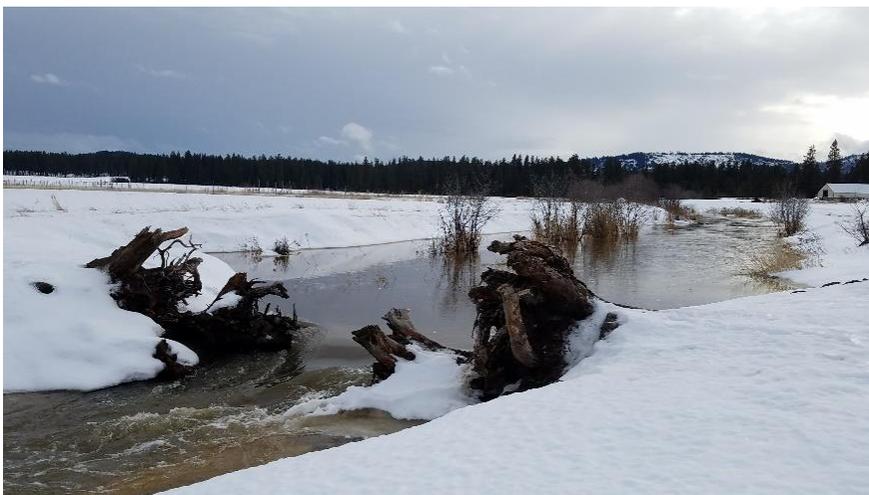
Picture 2. Lower Sheep Creek during winter 2016/7 through the choke flow structure built in 2016.

In 2007, the Coeur d'Alene Tribe Natural Resources Program initiated a project near the mouth of Sheep Creek to reroute the stream through a 3.8 km reach of relict channel. This has resulted in a new location of the mouth of Sheep Creek; entering Hangman Creek approximately 3.5 kilometers downstream of the current location. However, an engineered channel 550 meters in length was necessary to complete the reactivation project. In order to help maintain this channel, stream flows above and beyond bankfull capacity are diverted using an engineered log jam constructed 310 meters upstream of the engineered channel (Kinkead and Biladeau 2017) (Picture 2). However, this engineered channel lacked any structure to form pools necessary for fish to utilize for migration upstream.

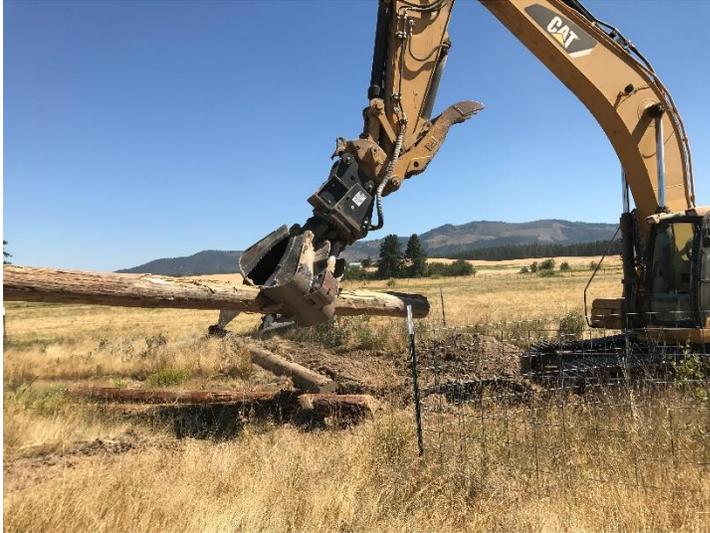
Picture 3. Construction of cross-vanes on engineered channel of Sheep Creek prior to re-activation.

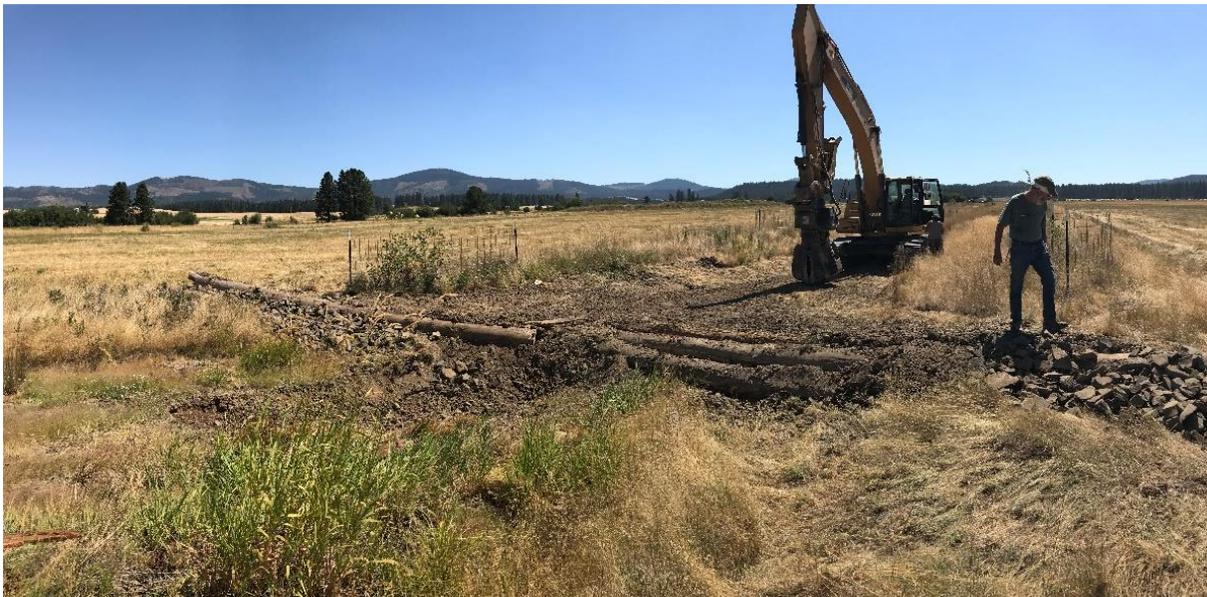
Picture 4. Completed Construction of cross-vane on engineered channel of Sheep Creek prior to re-activation, with cultural monitoring on site.

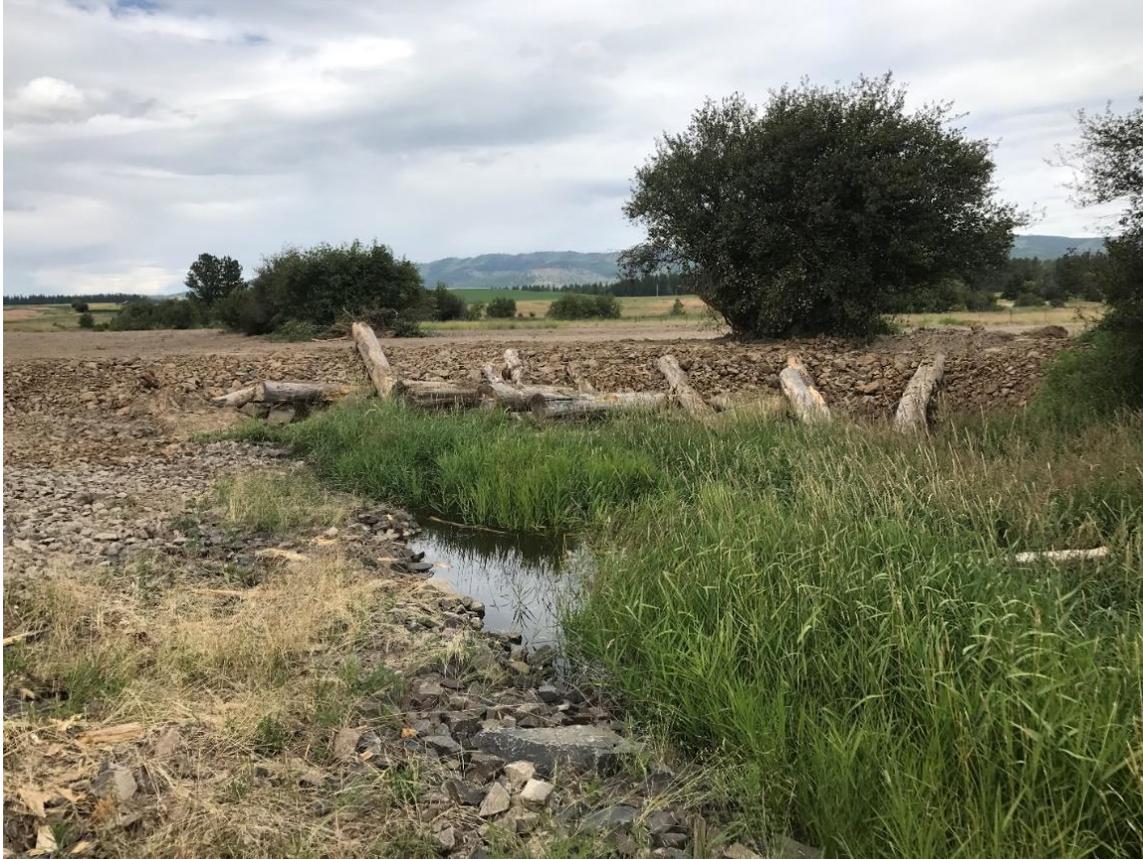
Picture 5. Channel plug constructed in 2018 to divert flow out of straightened man-made channel into relict channels.

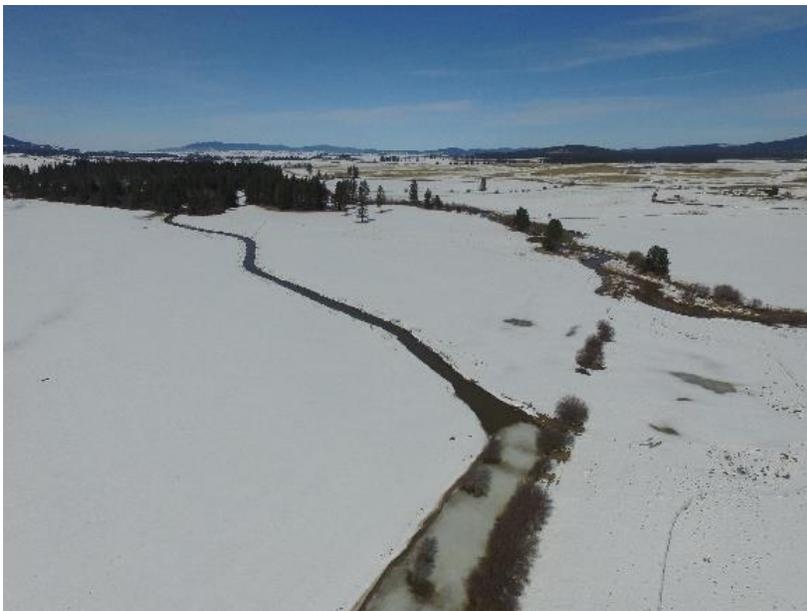
Picture 6. Activated channel on Sheep Creek, 2019.

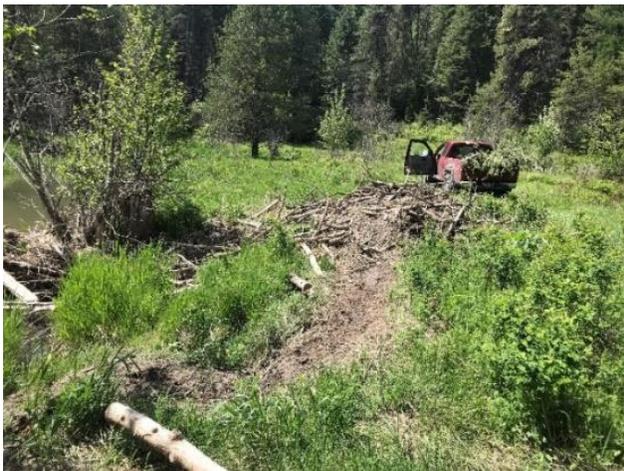
Picture 7. Aspen cuttings left at beaver lodge.

An estimated 173m³ of hardwood clippings, consisting of mostly aspen along with cottonwood and alder, were cut and placed at existing beaver dams to supplement food and building supplies at three general locations; Sheep SH02, Hangman HA11, and Hangman HA13 in 2017. In 2018 Sheep Creek was eliminated in order to focus efforts in Hangman Creek within the k’wne’ ‘ulchiyark’ ‘wmtsut project area. Within these 3 stream reaches, an equivalent of 1,151 pieces of two-inch diameter by 10 feet long hardwood pieces were provided, roughly enough materials to build twenty dams four feet high, ten feet long, and fifteen feet wide. By 2019 the total estimated volume of 173 m³ of dam building materials was increased to 283 m³ aspen cuttings throughout all phases of the k’wne’ ‘ulchiyark’wmtsut area due to the increased presence of beaver and their impacts on newly planted riparian vegetation (Picture 7 & Picture 8)

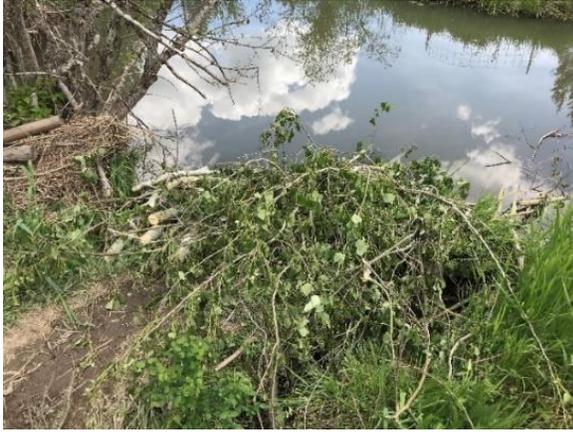
Picture 8. Typical size range of aspen cuttings provided to beaver.

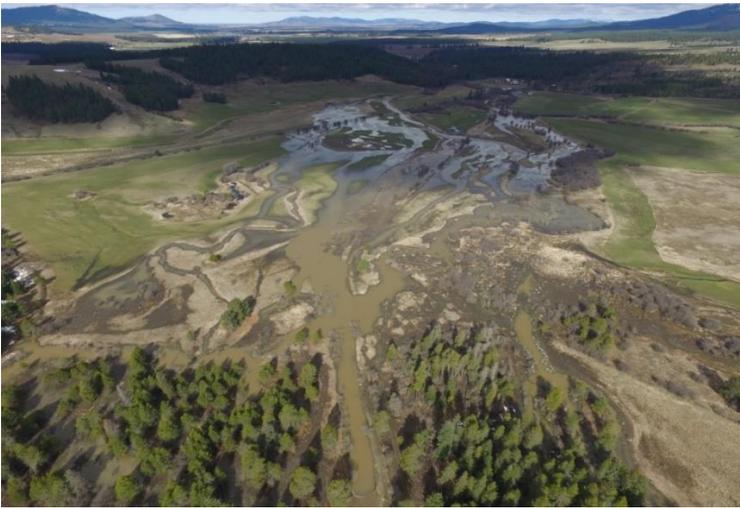
Restoration efforts were initiated in 2014 in this reach of Hangman Creek, and although much of the major construction activities were completed prior to this reporting period (Kinkead and Biladeau, 2017), repairs and additional channel work were necessary to maintain and improve floodplain connectivity throughout the project area. In 2016, approximately 300 meters of straightened channel was filled with native material in order to reactive an adjacent relict channel and restore connection to the surrounding floodplain (Kinkead and Biladeau, 2017). Subsequent flood events resulted in damage to the fill material which threatened to negate restoration efforts (Picture 9 and Picture 10).

Picture 9: Flood waters flowing down fill area in spring 2017.

During the summer of 2017 heavy equipment was used to repair the partially washed out earthen plug and to construct two additional berms intended to deflect over-land flows away from the fill material. Additionally, the rock berm at the downstream extent of the earthen plug was repaired and reinforced (Picture 10). Upon completion of the repairs, additional emergent wetlands (shallow ponds) were created upstream the berms (Picture 11) and (Picture 12).

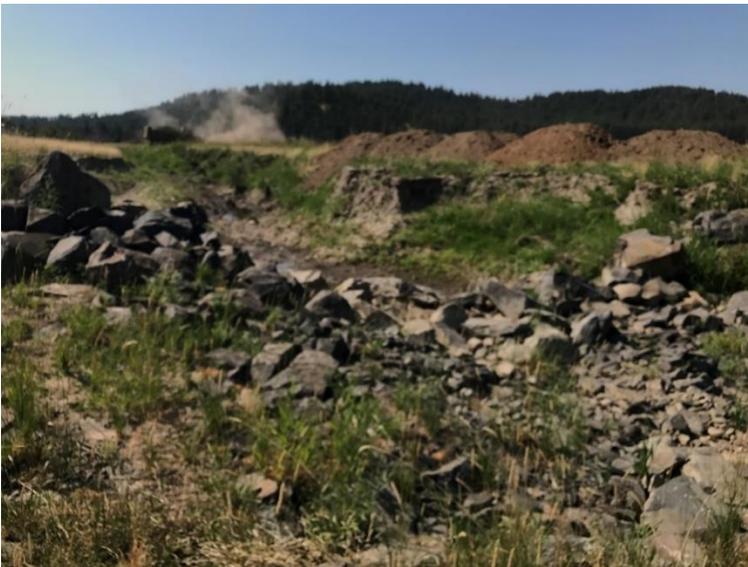
Picture 10. Breached berm at bottom of Phase 3 prior to repair in 2017.

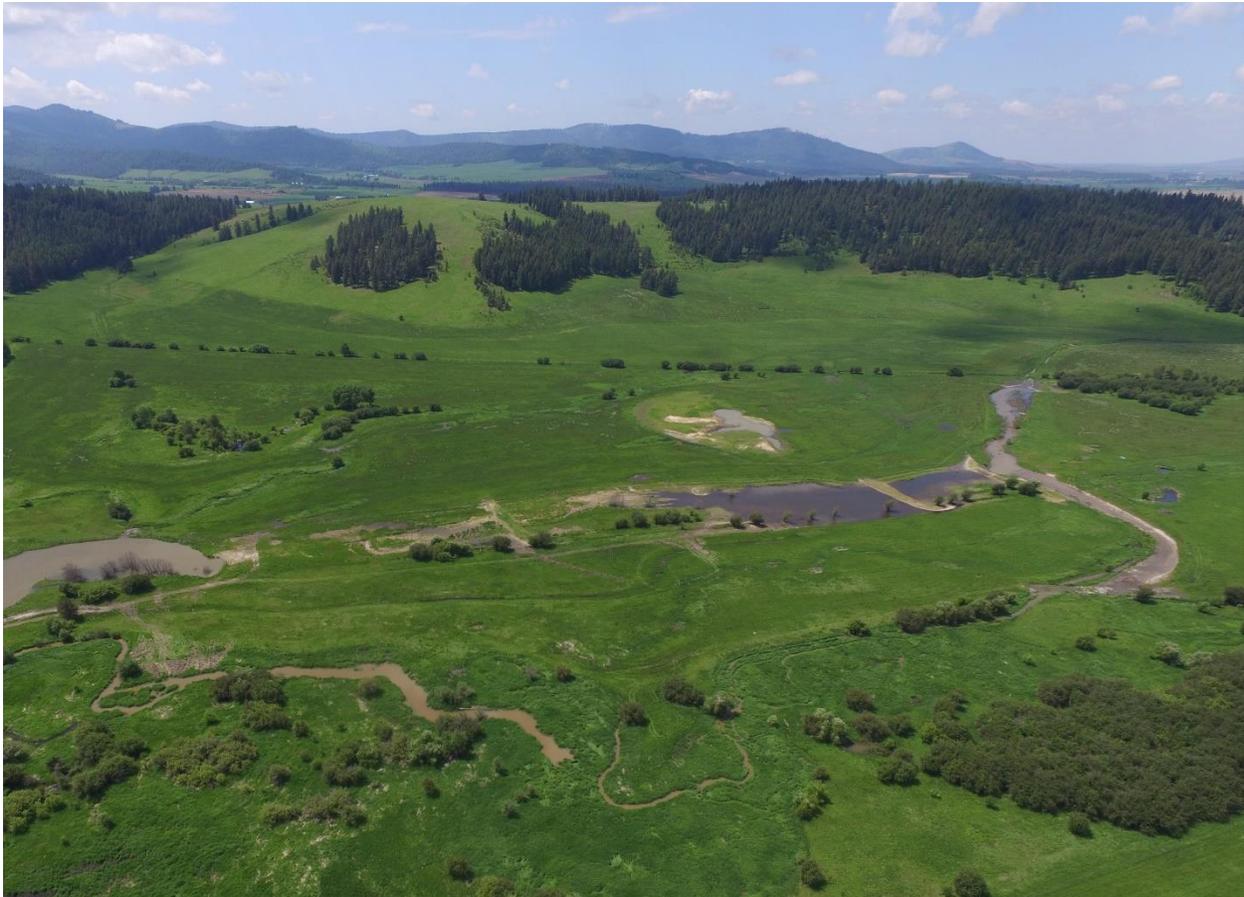
Picture 11. Aerial view of repairs showing 3 berms and the resulting shallow ponds, spring 2018.

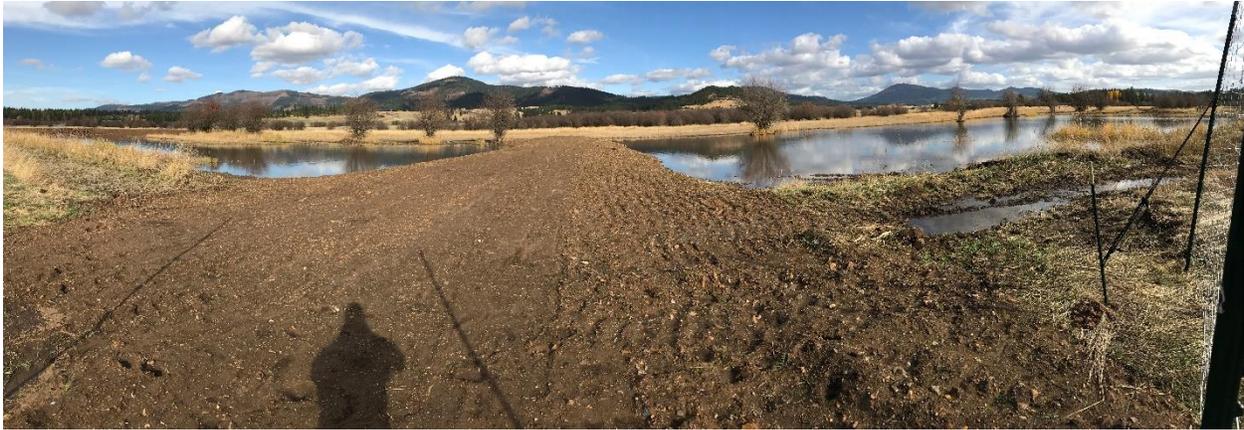
Picture 12. Repairs in the fill area of Phase 3 consisted of two additional berms creating 3 ponds.

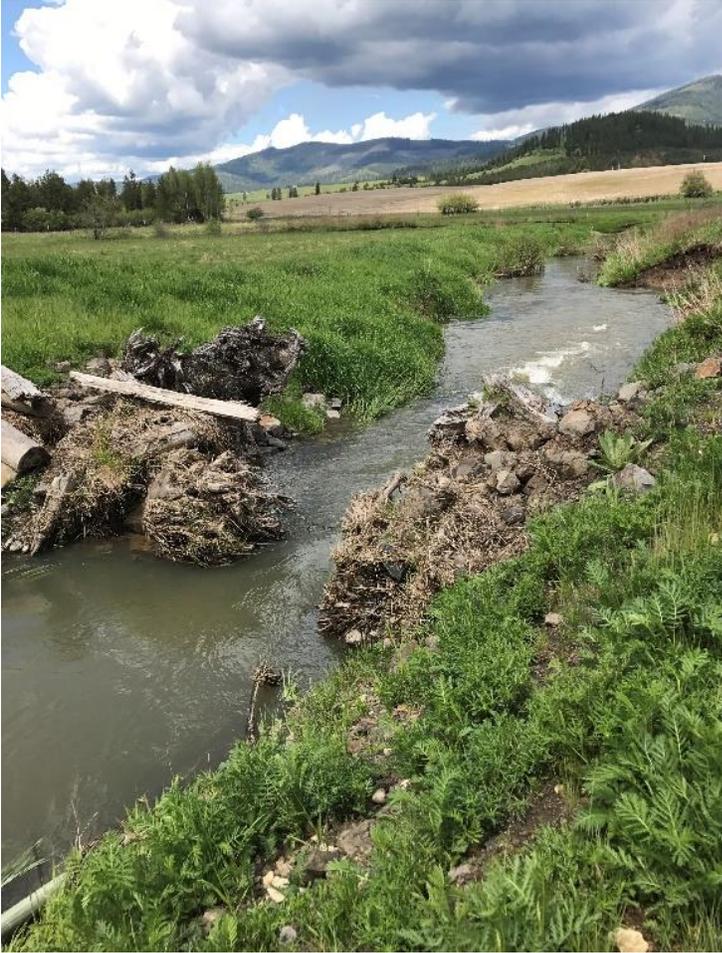
Picture 16. Choke structure on Phase 2 at Rkm 24.7 in June 2018.

In 2015, two engineered logjams were constructed within Hangman Creek (Picture 16) designed to force water out onto the floodplain during winter and spring runoff. However, the water level during the summer is still well below the top of banks and riparian plantings have largely failed due to a lack of shallow groundwater. Additionally, access to the southern side of the stream in this reach was still needed. Immediately downstream of the engineered logjams, an artificial riffle was therefore constructed which increased the elevation of the channel by 30 inches and provided for access across the stream (Picture 17). The aerial photo shows the area that has raised water levels that will support future riparian enhancement efforts (Picture 18).

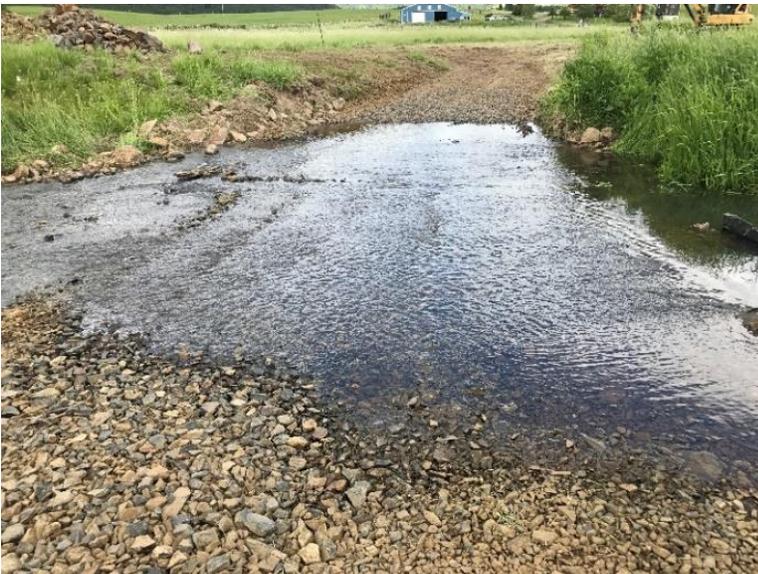
Picture 17. Artificial riffle constructed at Rkm 24.6.

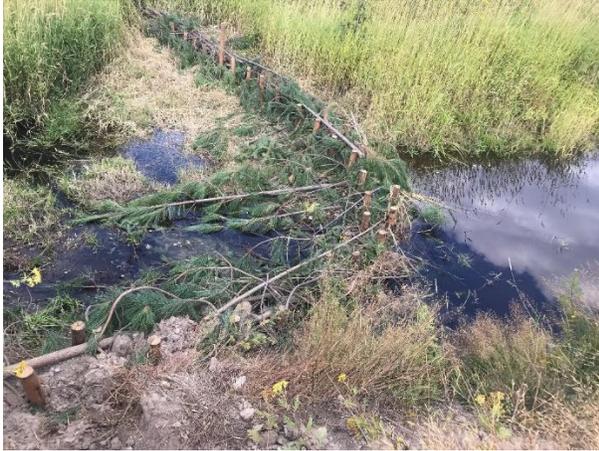
Picture 19. Construction of an Analog beaver dam one year later.

During the summer of 2018 a less intrusive method to the landscape was initiated to aggrade the stream channel and facilitate overbank flow while supporting existing riparian plants. This was accomplished the same way we supported natural beaver dams, by driving in 4-inch diameter posts into a picket fence formation and weaving in willows or timber slash. Three structures were installed upstream above the confluence with Smith Creek in Phase 4 (Picture 19) at Rkm 26.2. As of December, 2019 all three structures are intact and have required no maintenance (Picture 20). Three additional structures were installed in Phase 2 adjacent to the three willow patches as shown in Picture 18 at Rkm 24.7. High flows thru this reach are severe but did not disturb the posts. However, much of the brush woven into the posts was washed downstream. Successful analog beaver dams have raised the base flow elevation 1-2 feet at Rkm 26.2 which helps to support freshly planted willow patches and potted trees. The difference in the stream power between the two sites is duly noted for future application of this method on a larger scale.

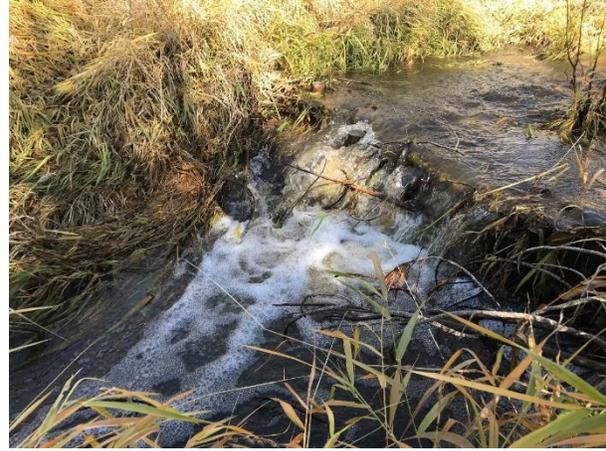
Picture 20. Functioning analog beaver dam one year later.

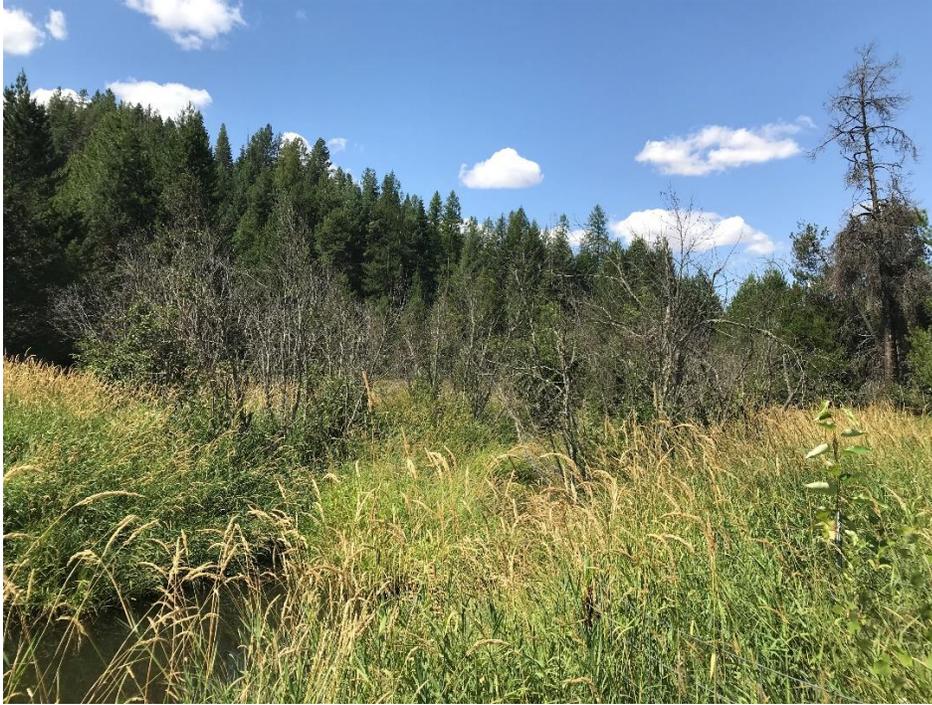
Picture 22. After relict channel was reactivated and beaver built several dams in Phase 1, existing alders began to die off.

Thinleaf alder and Douglas hawthorn were found throughout the length of the relict channel within this reach of Hangman Creek upon reactivation in 2014. Since that time however, beaver colonization and the resulting dam construction have increased water elevations and killed the majority of these plants along the stream bank (Picture 22). Replacing this lost canopy with alder and additional species of hardwood has been a primary objective throughout the three years of this reporting period.

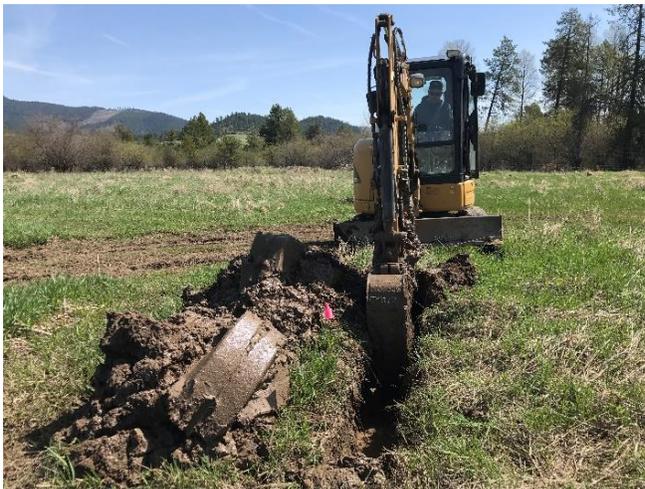
Picture 29. Trenching willow.

Each Trench is dug 4 feet deep with an 8" bucket. If trenching in late May, water should be at the bottom of trench

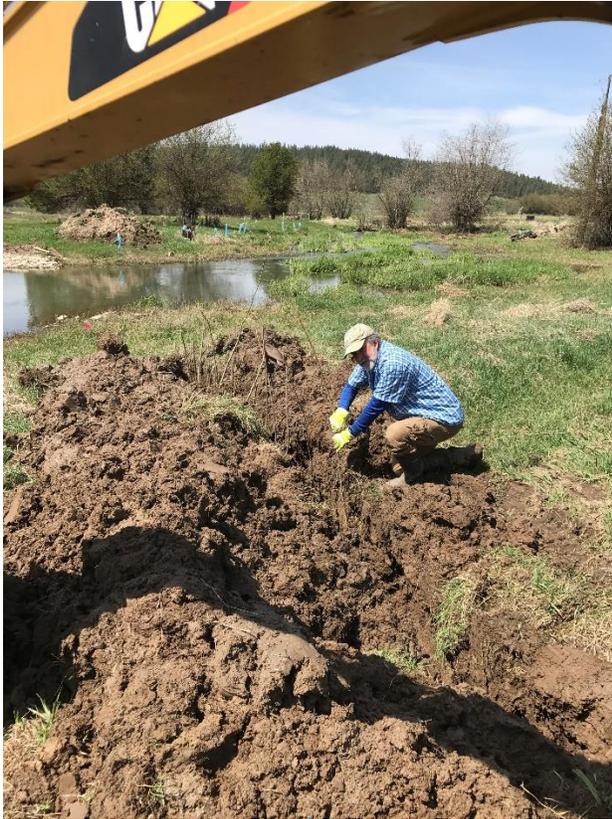
Picture 30. Placing willows:

5'-7' willow poles are placed every 6" -12" apart and excavator back fills trench

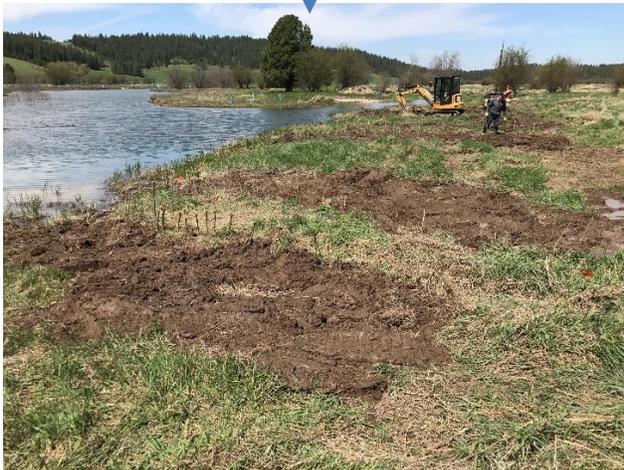
Picture 31. Finished willow trenches

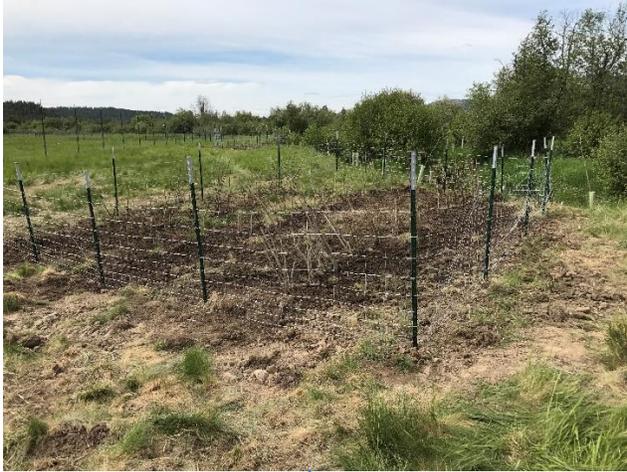
Picture 32. Protecting willows

Section of trenches is then protected with 42" fencing and lined with chicken wire at bottom to discourage burrowing by beaver

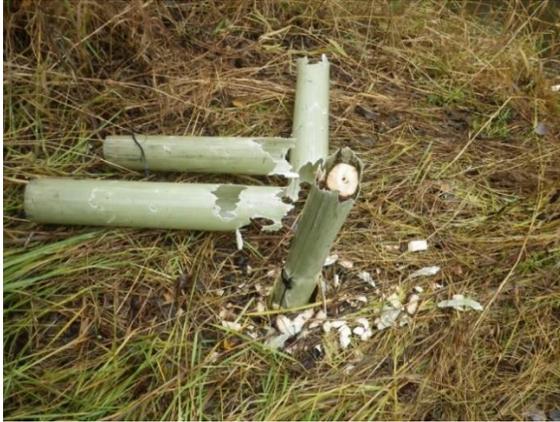
Picture 43. Beaver damage at Rkm 20.0

Beaver previously occupied the area in low numbers. However, after major restoration actions occurred, they appear to have expanded their distribution into this reach, acting as both a nuisance and partner. Live trapping beaver for relocation was tried in 2010, and is no longer an option (Picture 41 and Picture 42) proving to be too time consuming as it is preferred to capture and relocate an entire family. Secondly, tribal elders prefer to not trap beaver, regardless of the reason for trapping. The delivery of aspen brush (Section 4.3) has really helped to deter beaver from harvesting newly planted vegetation. Installing cones has also helped to deter beaver. However, beaver have been known to go after well-established trees only protected by cones (Picture 43), as well as potted trees staged in areas immediately before we plant them! (Picture 44). Maintenance and protection of riparian enhancement will continue to be necessary until a self-sustaining riparian ecosystem is established.

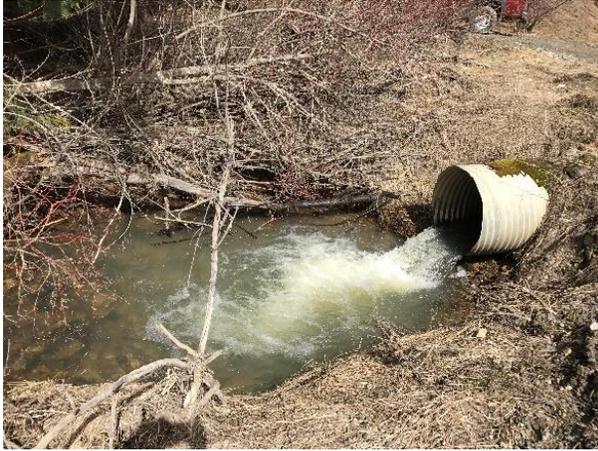
Two damaged culverts along the Sanders-Imida road at Rkm 30.6 were classified as barriers to fish migration. The 36” Hangman Creek culvert had a 16” drop from the outlet and a rusting hole on the top (Picture 49 and Picture 50). Hill Creek, a tributary of Hangman at Rkm 30.6 had a failing culvert that was comprised of two 24” pipes that were frequently plugged with debris.

Picture 49. Migration barrier at Rkm 30.6.

The Coeur d'Alene Tribe partnered with Benewah County to replace the Hangman Creek pipe with a new 75' long by 66" X 51" squash pipe set below grade (Picture 51), and with boulders placed downstream to back up water into the culvert to ensure fish passage. The Hill Creek culvert was also replaced the same week with a new 60" pipe and set below grade. Disturbed ground was treated with alder and willows. Fish now have unhindered access to 2.4 km of stream.

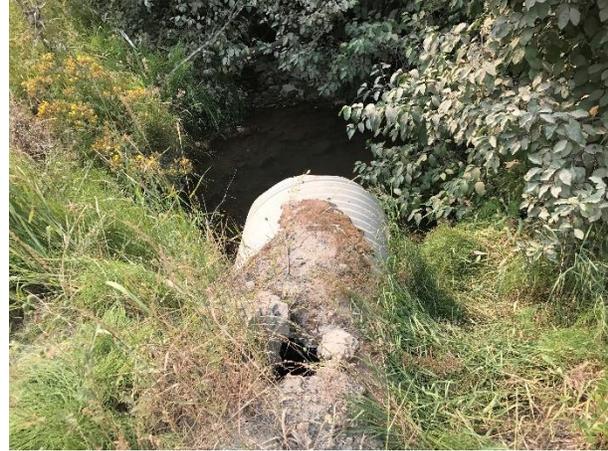
Picture 50. Hole in culvert at Rkm 30.6.

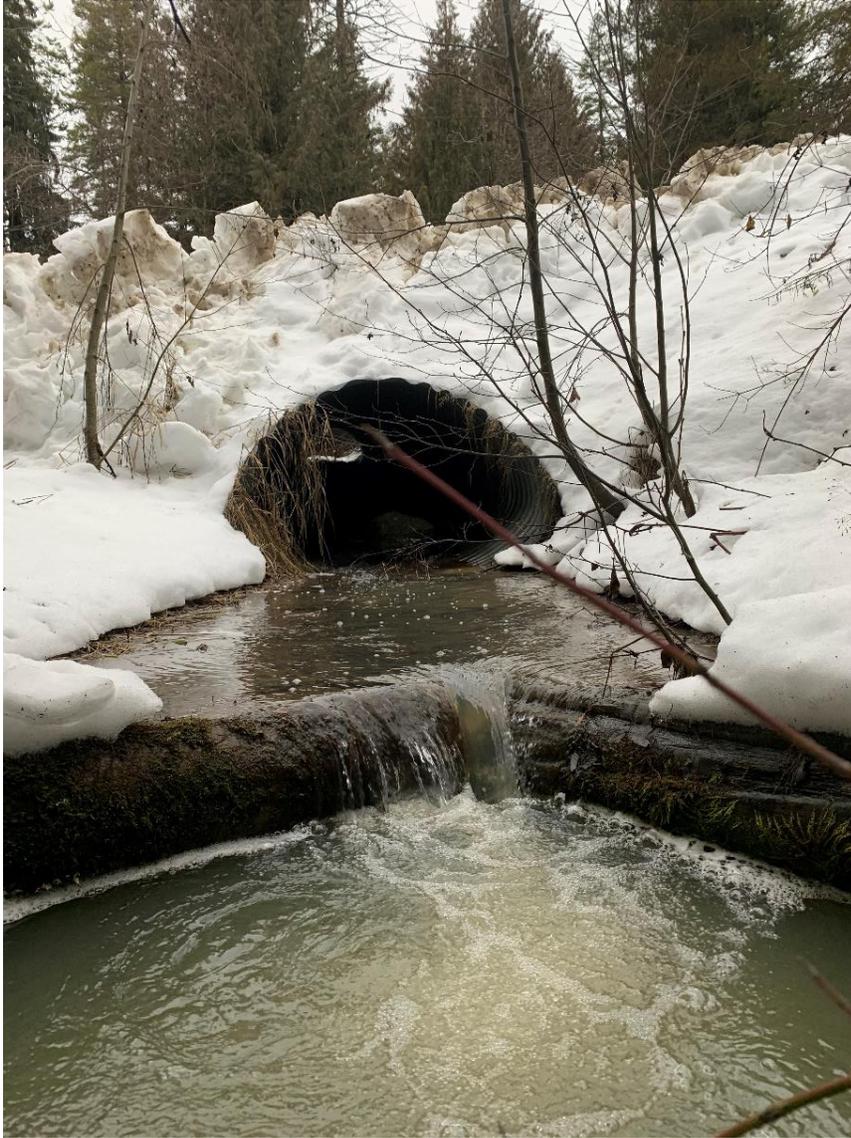
Picture 51. Completed culvert on Hangman Creek at Rkm 30.6
