**Progress Report 2012-2016: Hangman Creek Fisheries Enhancement  
Restoration Summary**

**BPA Project # 2001-032-00**

**Kinkead, B.A. and T.J. Biladeau, T. J. Coeur d'Alene Tribe, Plummer, ID 83851**

**May 2017**

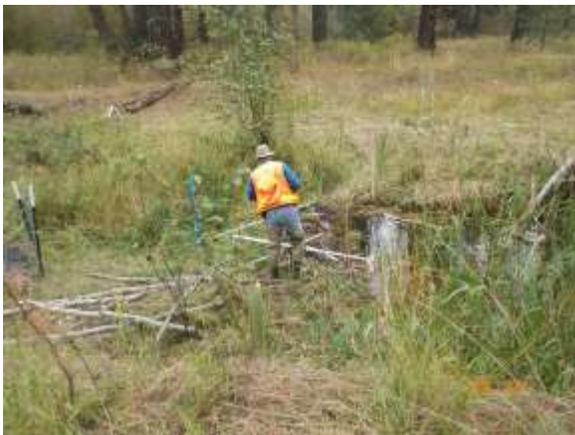
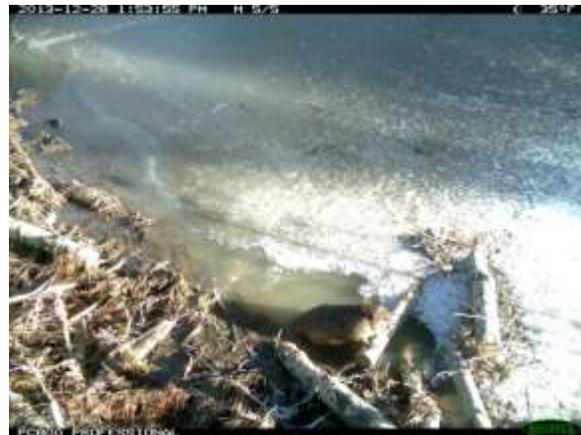
All three locations have active beaver populations which do not have access to adequate hardwoods in order to build stable dams. Beaver surveys summarized in this report indicate that mud, grass, and hawthorn are often used for building materials without incorporating any large materials as a foundation. The first stable dams found in the watershed were in the spring of 2010 in Sheep Creek. Reed canary grass dominates the riparian area with a minimal amount of alder. Aspen and cottonwood are nonexistent prior to riparian enhancement associated with the restoration project. Hangman Creek (HA11) has deeply an incised channel with little connection between the stream and riparian area. Sheep Creek (SH02) has moderately incised channels where peak flows occasionally spill out into the floodplain. Mission Creek (MI04) lies within an extensive beaver dam complex with a wide floodplain filled with side channels caused by beaver activity. However, it has been noted by Herrera (2011) that inadequate supplies of hardwood and willow exist.

*Picture 8A & 8B. Aspen cuttings have been cut and a dropped off in areas of high beaver activity for use in dams and for supplementing food.*

Hardwood clippings consisting of mostly aspen along with some cottonwood and alder were cut and placed at existing beaver dams in 2011 to supplement food and building supplies. A total of 6,100 ft<sup>3</sup> of dam building materials were provided in 3 general locations, with 3 specific dam locations on each stream reach. This amounts to an equivalent of 1,151 pieces of 2 inch diameter by 10 feet long hardwood pieces, roughly enough materials to build twenty dams four feet high, ten feet long, and fifteen feet wide. Materials were offered on Mission Creek R4, Sheep Creek R2, and Hangman Creek R11. Brush offerings were made in May, July and September of 2011. The initial offering disappeared the first night on Mission and Sheep Creek with all sizes utilized. A six foot tall dam was repaired on Sheep Creek within 24 hours of the offering of aspen cuttings (Pictures 8A and 8B). Utilization of brush by beavers in July and September were more selective with all pieces <2" diameter taken within 48 hours, while the larger pieces 2 – 4" diameter were picked up within 2 week.

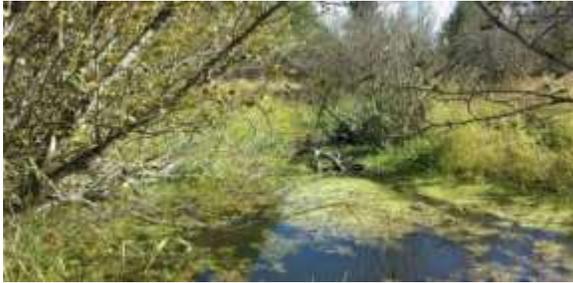
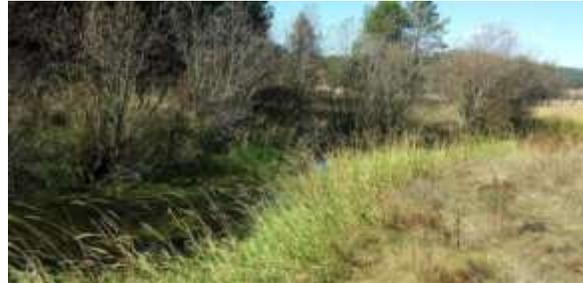
The southern and northern relict channels, although grown-in with significant amounts of vegetation, were intact and did not appear to show any signs of erosion (Picture 10A & 10B). Cross-sectional measurements throughout the channel(s) exhibit a carrying capacity that is consistent to an estimated bankfull flow (1.5 year interval). Bed elevation corresponded to the underlying cobble-gravel layer evident sporadically throughout the valley bottom. Channel preparation was limited to minor amounts of vegetative “grubbing” within the channel. A 100 meter long reach of channel required excavation to connect with the southern relict channel and the active ditch (Picture 11A & 11B, Picture 12) in 2014. A temporary rock riffle was constructed at the outflow of the southern relict channel to maintain connection to the channelized ditch prior to the activation of the northern relict channel during phase 3. The relict channel in Phase 3 was activated in summer 2016 (Picture 13)

*Picture 10A & 10B: Portions of the relict channel in Phase 1 prior to reactivation in 2015.*

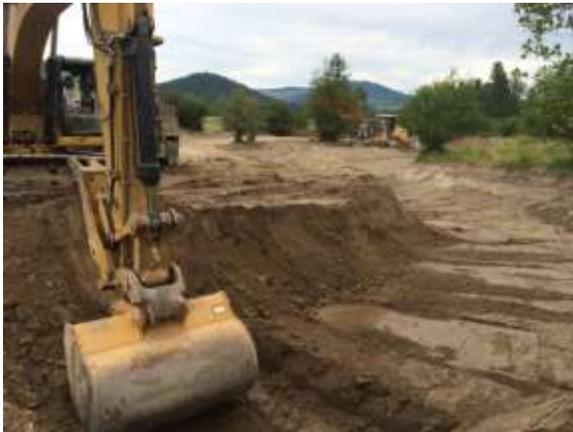
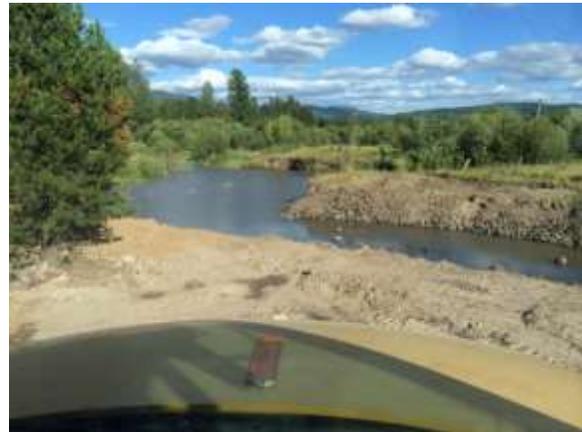
*Picture 11A & 11B. Construction and activation of the engineered connection channel, 2014.*

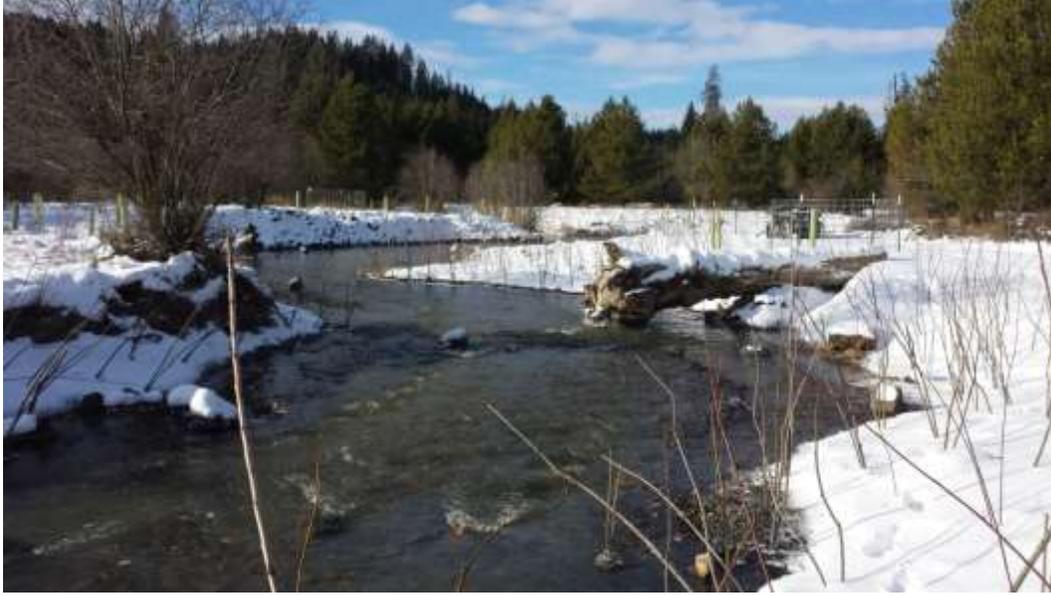
*Picture 12: Engineered channel post-activation for connecting the southern relict channel to the channelized ditch.*

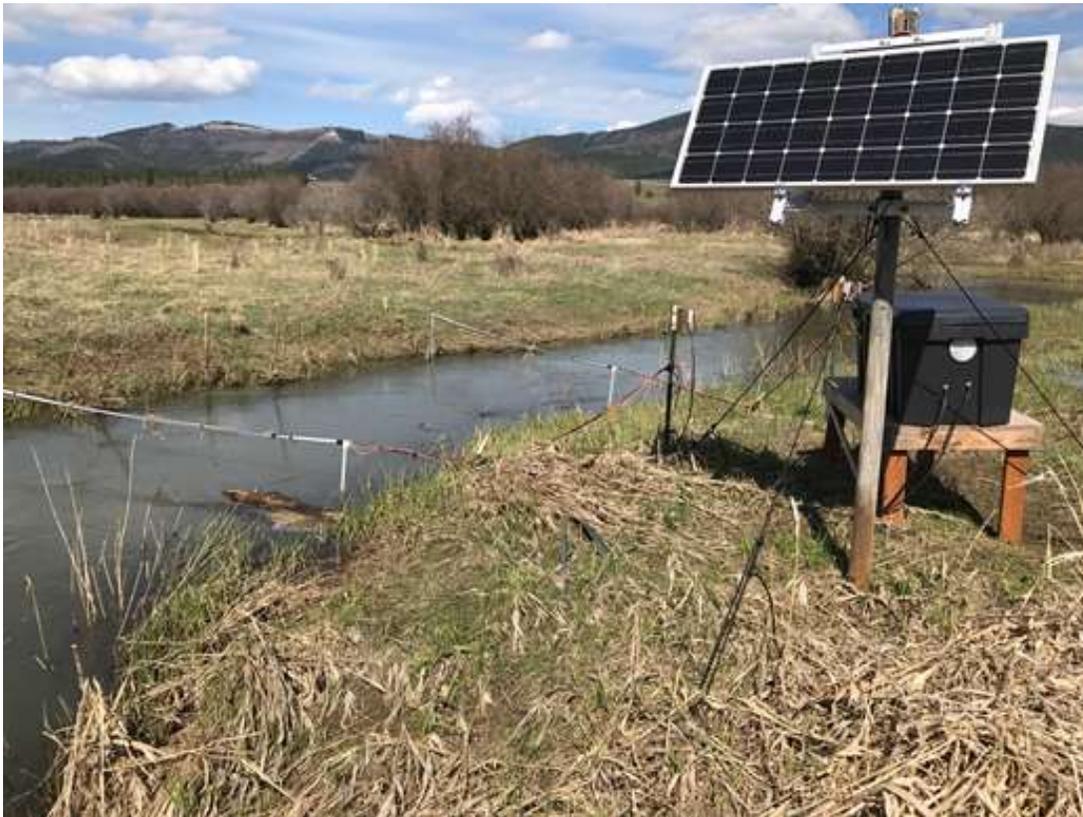
*Picture 13. Activated channel in Phase 3 during spring 2017.*

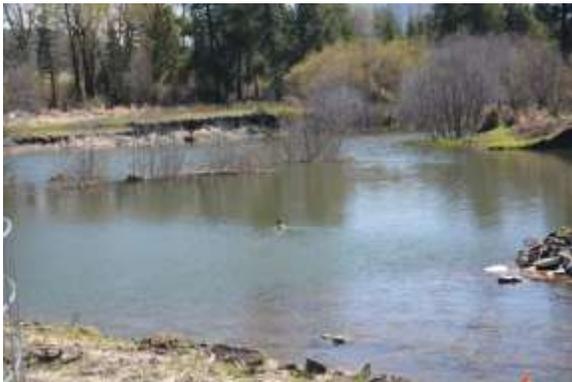
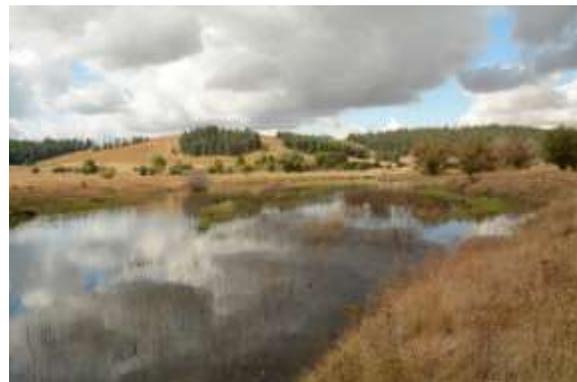
This resulted in large ponded areas of stream directly upstream of the earthen plugs (Pictures 15A & 15B and 16). These areas will likely serve as sediment basins into the future until a consistent gradient and channel aspect ratio is naturally formed.

*Picture 15A & 15B. Ponded area between Phase 1 and Phase 3 relict channels creating additional wetlands.*

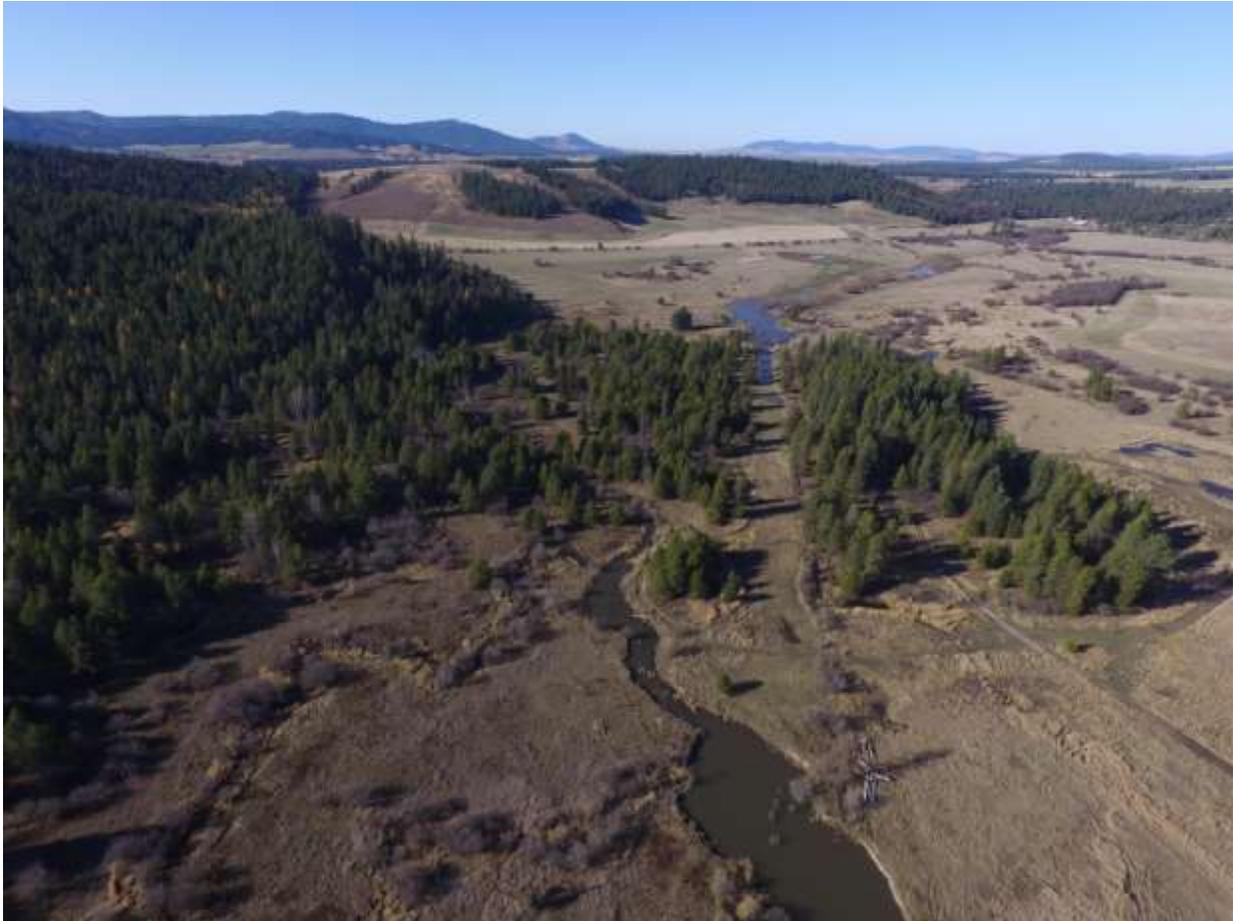
*Picture 16: Aerial photo facing downstream post-relict channel reactivation (Phase 1 & 3). Ponded areas are shown immediately upstream of the earthen plugs used to divert water back into the relict channels.*

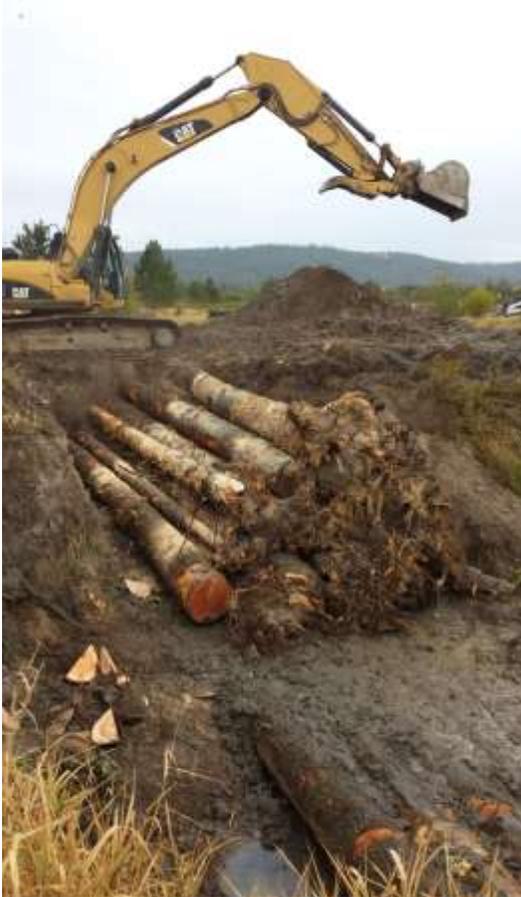
*Picture 17: Engineered log jam structure during construction showing sill logs across the stream bottom and one-half of the logs/root wads incorporated into the bank.*

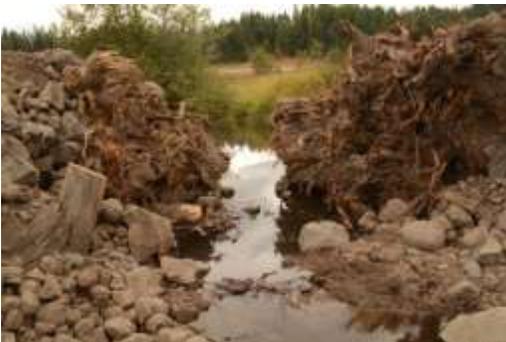
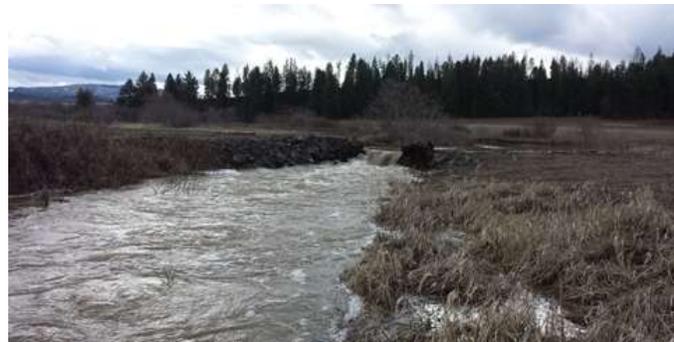
The project element portion of phase 2 allows for more frequent and extensive floodplain connection during annual runoff, and is a natural analog alternative to large scale riffle construction that helps maintains connectivity with cooler groundwater during summer months. Engineered log jams such as these are incorporated into the stream bank (Picture and result in a “choke” of stream flow, where only a pre-designed amount of runoff is allowed to pass through the opening (Pictures 18A & 18B)**Error! Reference source not found.** This type of rehabilitation approach also creates a mosaic of water velocities throughout the matrix of multiple structures. This in turn can lead to sediment retention and sorting, as well as protection from mass wasting of stream banks within an incised channel (Shields et al 2001). Locations have been selected strategically to facilitate connection of floodplain swales during high flows (Picture 19). The structures would be porous such that low flows would not be backed up to the extent that groundwater flow would be reduced due to head differences between the water table and the stream channel. This element is also designed to be an adaptive application, where the backwatering control needs at some locations can be adjusted through removal or additions of large wood to modify the cross-sectional area, and therefore the transport capacity, of the structures as needed to meet the restoration objectives for the larger reach.

*Picture 18A. Newly completed engineered log jam structure, Picture 18B during runoff. Structure is allowing flows equivalent to a 1.5 year interval to pass through.*

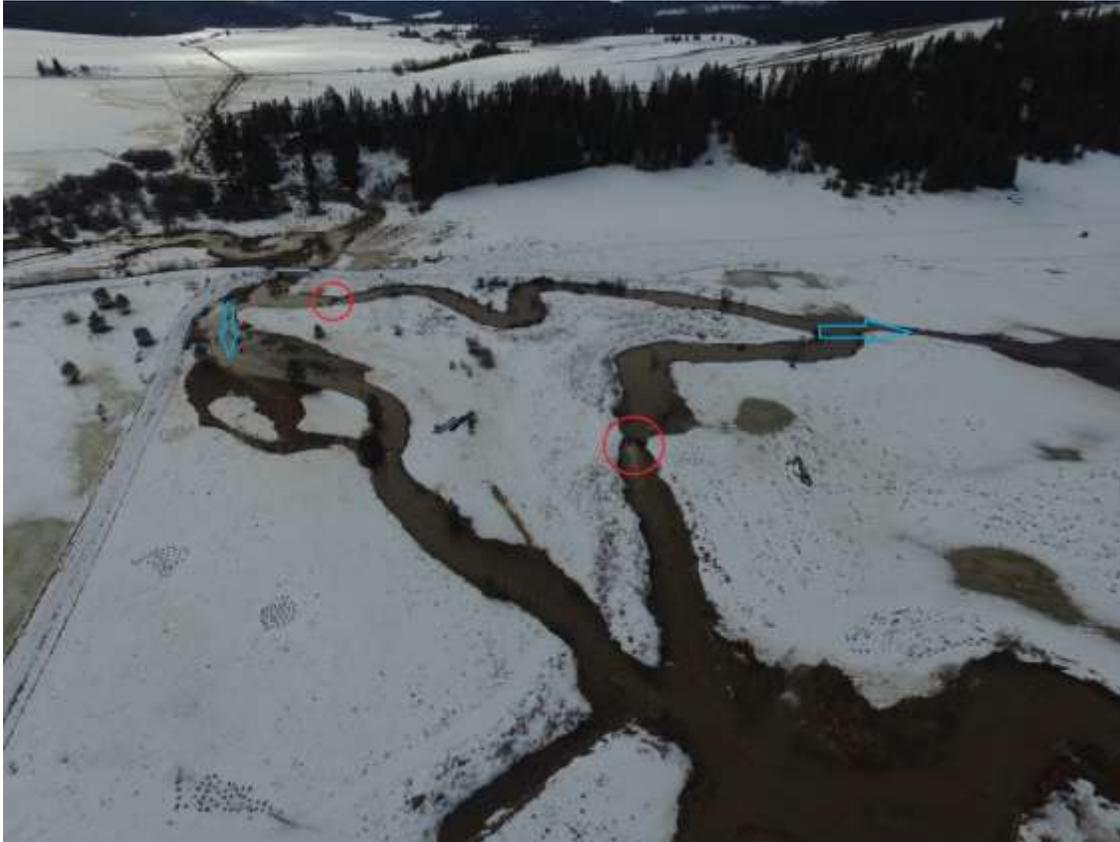
*Picture 19: The 2 engineered log jams (red circles) diverting flows out of the incised stream channel during runoff (blue arrows).*

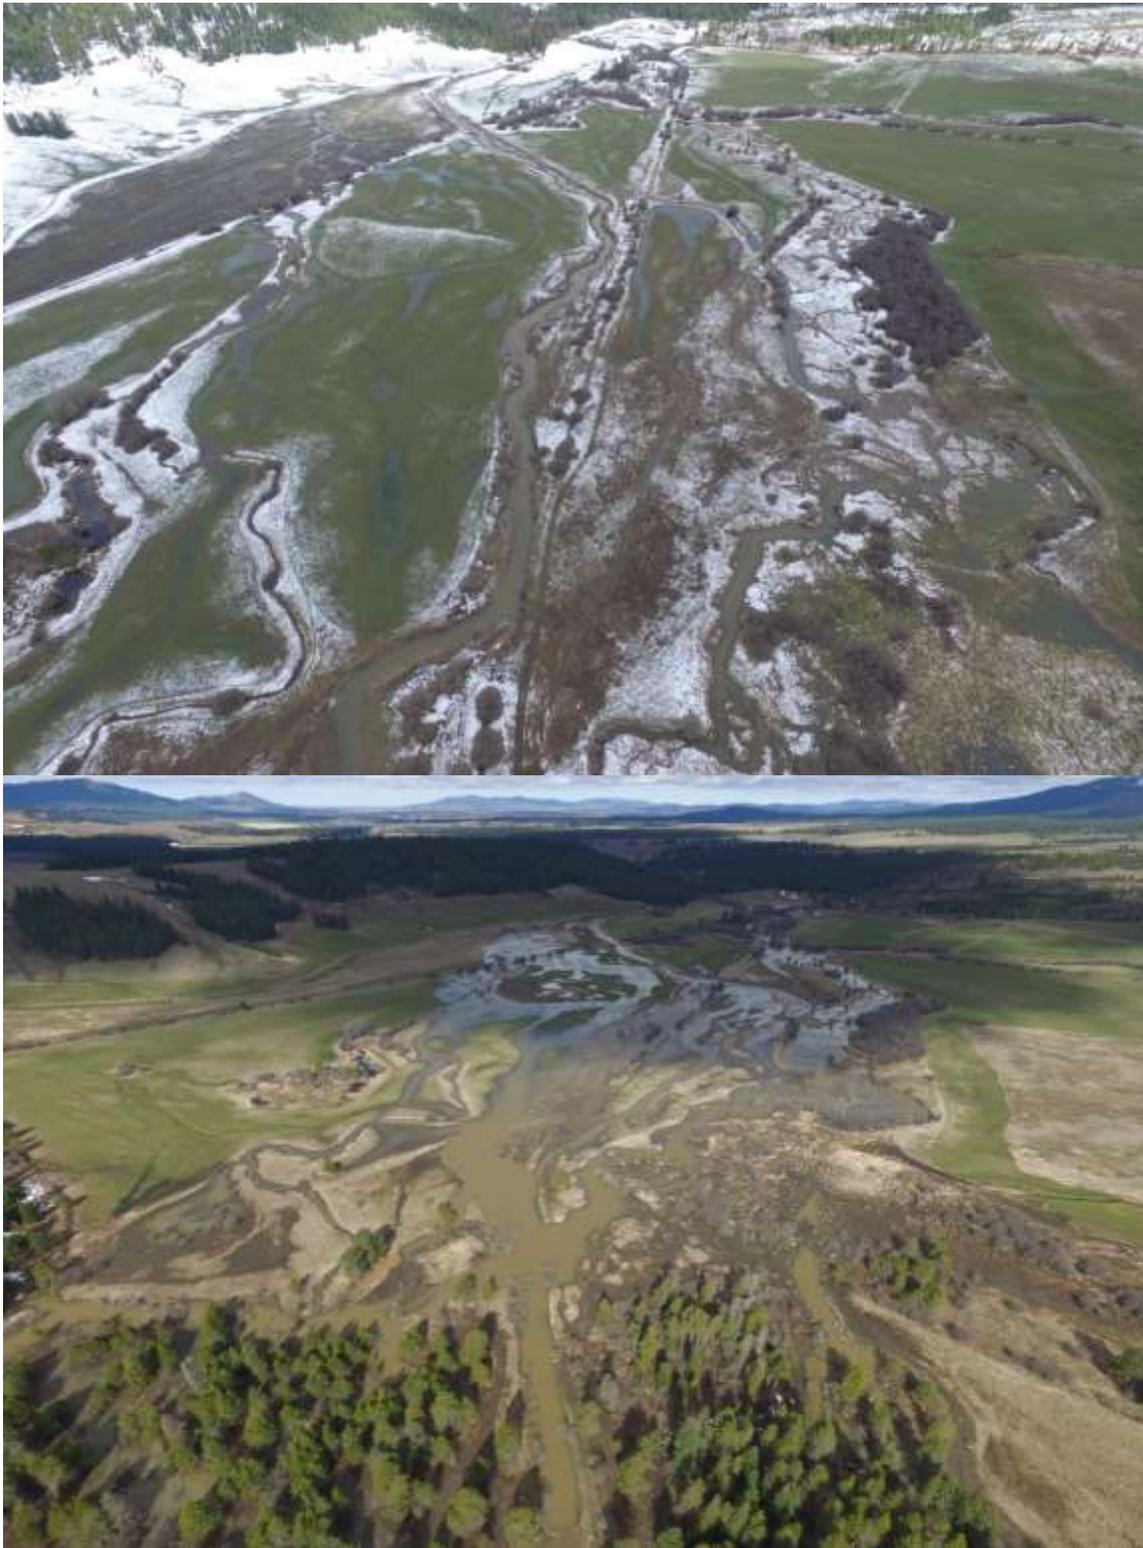
The upstream end of several floodplain channels were excavated and re-contoured to an inlet elevation that begins to flow at the 1.5 year return interval flood. The wetland swales will be used as a nursery area for propagation of black cottonwood and willow whips and live stakes for riparian zone restoration throughout the reach. Significant differences in overbank flow occurred over the winter 2016/7 (Picture 20).

*Picture 20: Before and after aerial photos of the floodplain within phase 3 of the project area. Both photos are during runoff events with equivalent flows.*

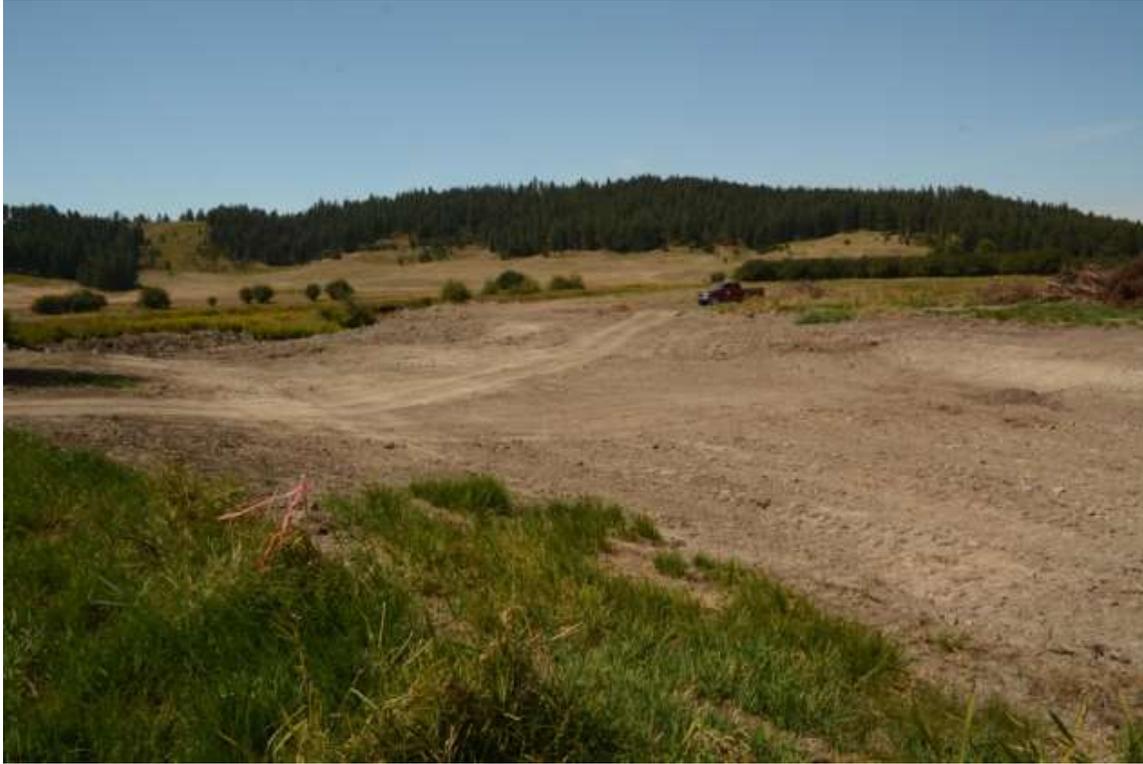
A relief channel designed to carry flows in excess of 450cfs was constructed within phase 3 of the project area (Picture 21). This was built to provide flood relief for the adjacent landowner's infrastructure directly downstream of the project area. During periods of runoff, flow is metered out of the northern relict channel, through the relief channel, and back into the channelized ditch downstream of the earthen plug. The excess flow returns to Hangman Creek directly downstream of the project area and the landowner's property.

Picture 21. Construction of relief channel in 2016, and high flows in spring 2017.

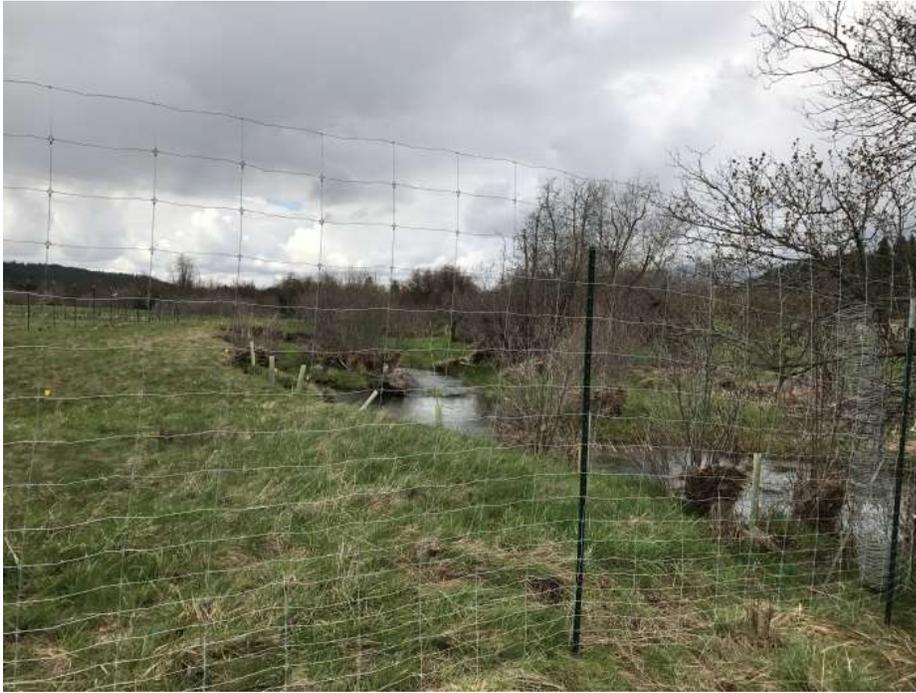
*Picture 22: Wildlife exclusion fencing on Phase 4 of k'wne' ulchiyark'wmtsut.*

Phase 4 was the only area that did not need stream channel work prior to riparian enhancement. A wide variety of hardwood shrubs and trees were planted, and enclosed by 2,000 feet of eight foot tall wildlife exclusion fencing (Picture 22).

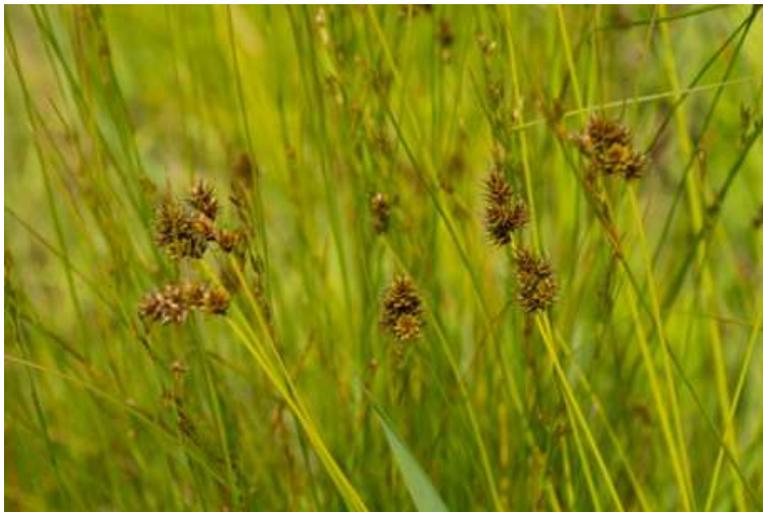
Herbaceous plants were used exclusively in barren areas after heavy equipment use (Picture 23).

*Picture 23: Short-beaked sedge (Carex brevior) in Phase 1 restoration.*

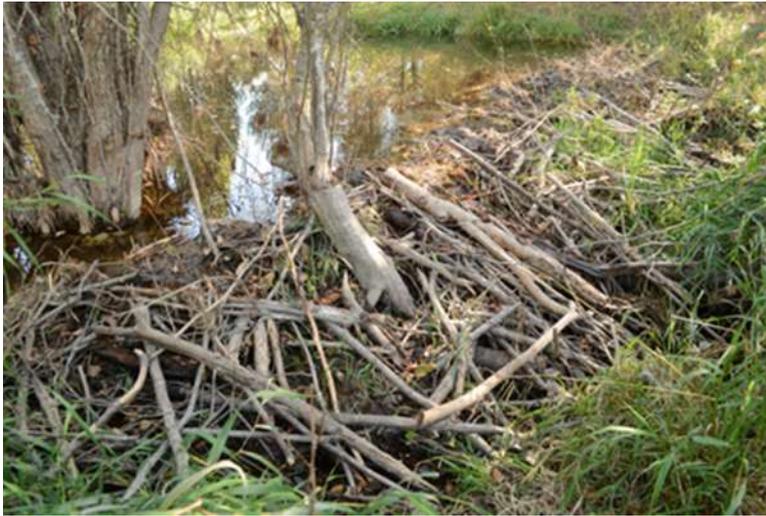
Within weeks of activating the Phase 1 relict channel beaver built 3 dams in fall 2014, and have and maintained a total of 4 dams through 2016.

*Picture 24: Beaver dam established in Phase 1.*

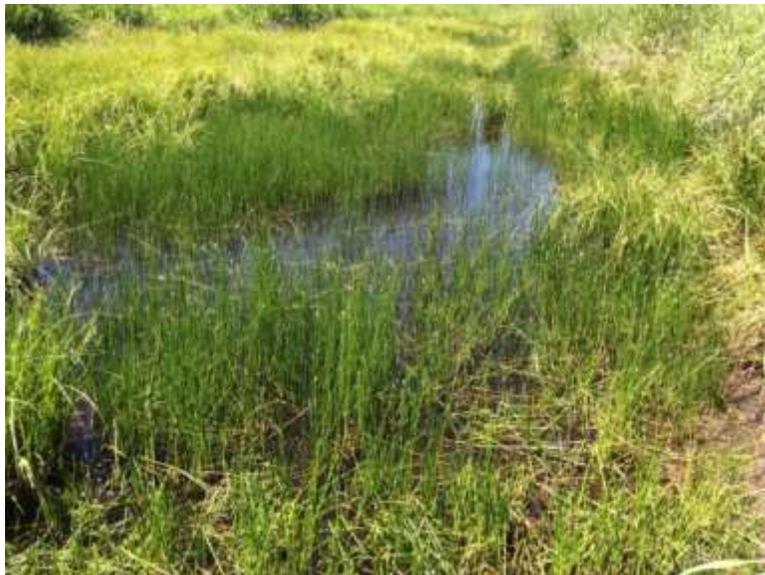
The choke flow structures have been successful in getting water out onto the floodplain with high success of willow and herbaceous in the exiting swales (Picture 25). Upland plants that have had good survival is hawthorn (*Crataegus douglasii*) and serviceberry (*Amelanchier alnifolia*) planted at the top of the raw banks

*Picture 25: Creeping spikerush (Eleocharis palustris) and other herbaceous plants and willows doing well in activated swales*

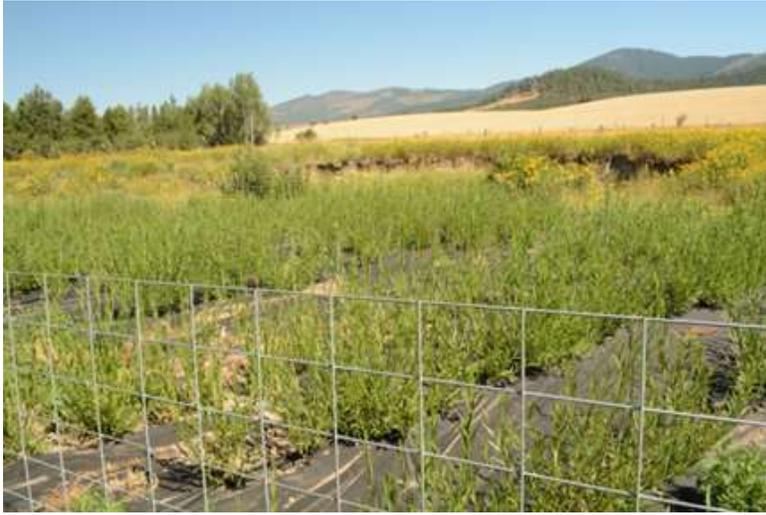
Floodplain benches were trenched down to wet gravelly soil layers, and willow poles were installed and backfilled (Picture 26). Cattle panels were built around the enclosure for protection because of the difficulty getting willow established with heavy beaver grazing at other locations. Extensive work is planned in the future in this reach that was devoid of any native vegetation prior to 2015.

*Picture 26. Willows installed by trenching and backfilling with cattle panel enclosures.*
