# **Implementation of Fisheries Enhancement Opportunities on the Coeur d'Alene Reservation**

**BPA Project # 1990-044-00**

**1/1/2015 – 5/31/2017**

**A. J. Vitale and S. H. Hallock**

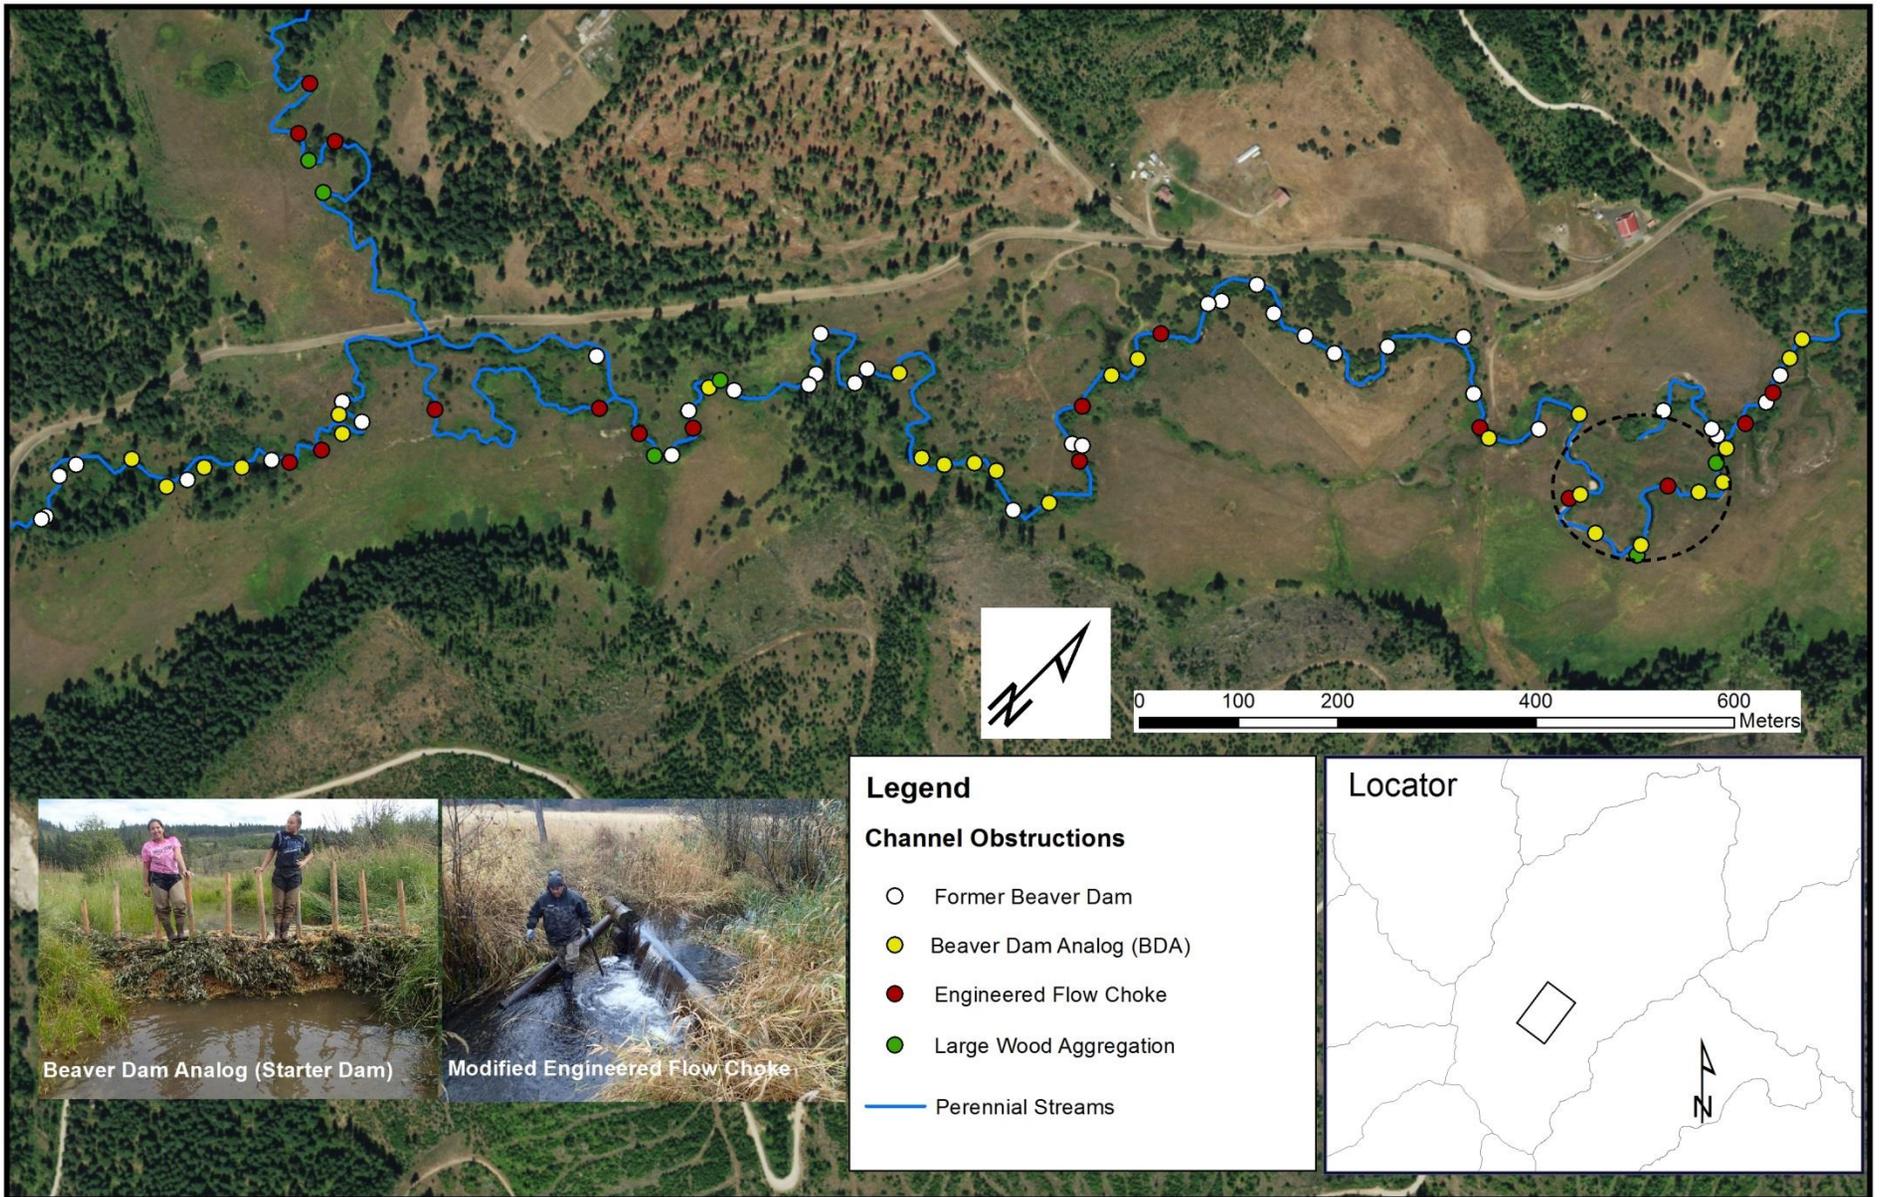
The past mapping and monitoring of beaver dams in upper Benewah Creek identified nearly 50 specific locations where construction of BDAs may be appropriate (Figure 5). Starter dams were established in three of these locations in 2015, wherein a line of wooden posts was installed using a hydraulic post pounder, followed by weaving branches in between the posts, after Pollock et al. (2012) (Photo 3.). In all cases the posts lines remained intact across several high flow periods and several dams functioned in much the same manner as log flow-choke structures that mimic the hydraulic function of stable natural beaver dams during flooding. Post lines were installed at 22 additional locations in the reach in 2016 to allow for establishing willow weaves at a later date; willow weaves were completed at 11 of these sites.

Figure 5. Locations of former beaver dams and restoration structures in the D2 reach of the Eltumish Project in upper Benewah Creek. Examples of a completed starter dam (a type of Beaver Dam Analog) and a modified engineered flow choke structure are shown in the inset photos. The area highlighted at the right of the photo is the location of fencing and planting that was completed in Spring 2017.

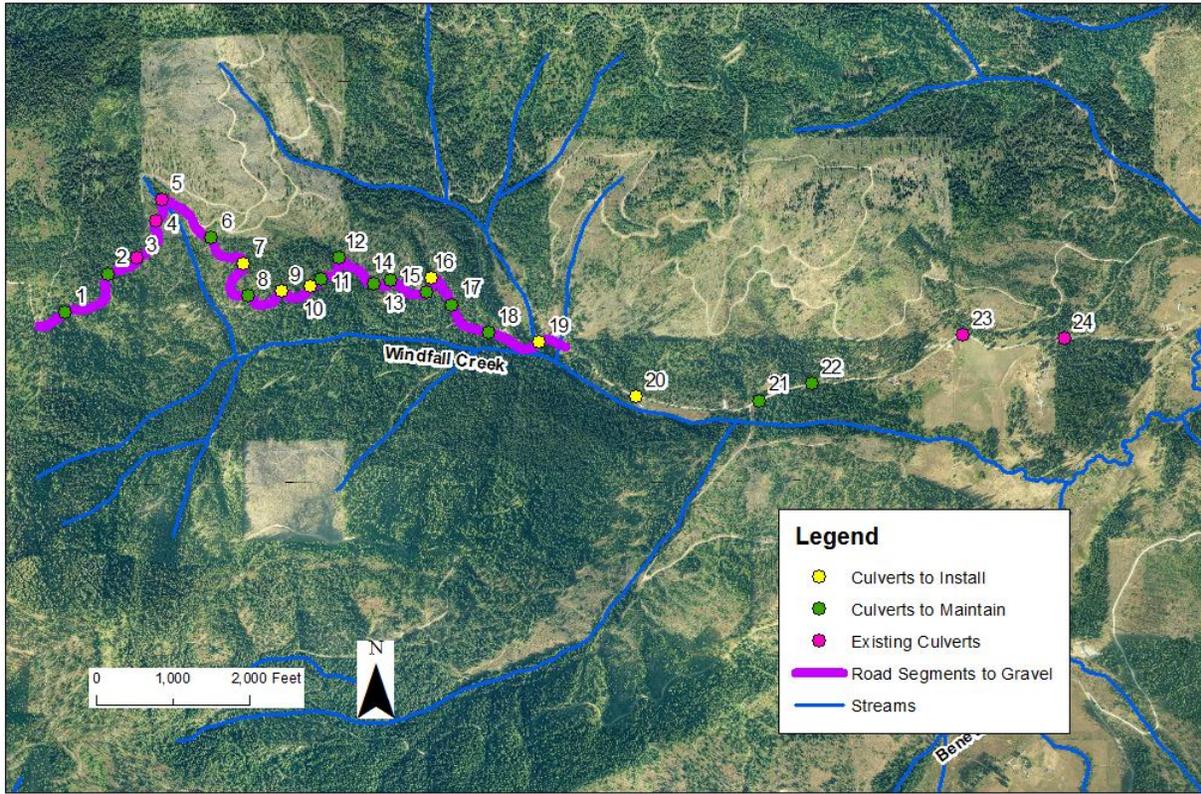
Figure 6. Map of road treatments area on Windfall Pass Road.

Road resurfacing was completed on 2,574 meters of native surface road along the upper sections of Windfall Pass Road (Figure 6). Prior to resurfacing, road segments were re-graded and ditches repaired. Two rock sources were used to resurface the road. A base of courser 6" minus rock (3204 CY) was placed first, followed by a surface cover of ¾" minus rock (2746 CY). A roller and a grader were used to complete this work.

A total of six culverts were installed using a Cat 303 mini-excavator to cross drain the resurfaced road segments and prevent water accumulation in roadside ditches. In addition, maintenance work was completed on 13 ditch relief culverts so that they would function properly.

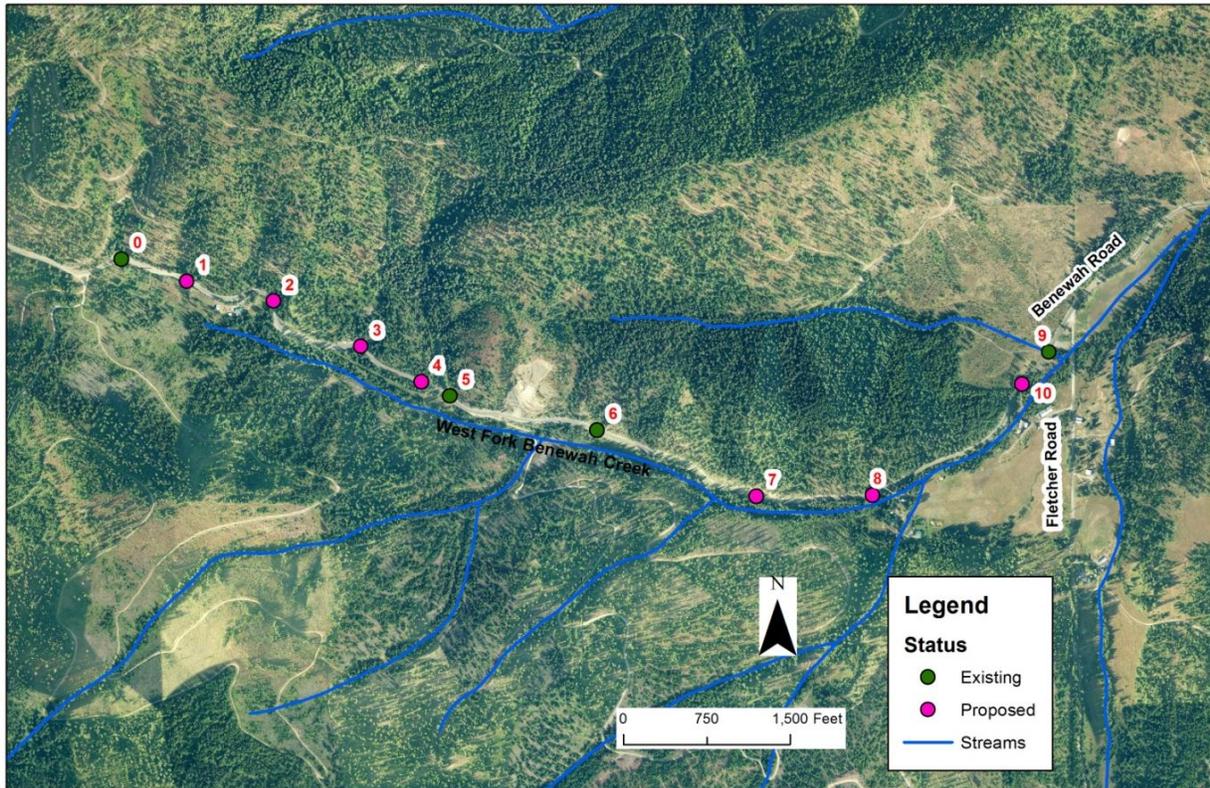
Figure 7. Location of cross-drains that were added to the Benewah Road from the top of Lolo Pass to Fletcher Road.

Before treatment, only four relief culverts were present along 3,167 meters of the steepest sections of the Benewah Road from the top of Lolo Pass to Fletcher Road. A total of seven culverts were installed using an excavator to cross drain the road segments and prevent water accumulation in roadside ditches (Figure 7). The new cross-drains were located where springs or other small channels drained into the streamside ditch on the Benewah Road. Also during construction, the ditches were repaired and the road was re-graded. This work was completed in spring/summer 2015.
