**Implementation of Fisheries Enhancement Opportunities on the  
Coeur d'Alene Reservation  
Habitat Restoration Report**

**BPA Project # 1990-044-00**

6/1/2017 – 12/31/2019

Coeur d'Alene Tribe, Plummer, ID, 83851

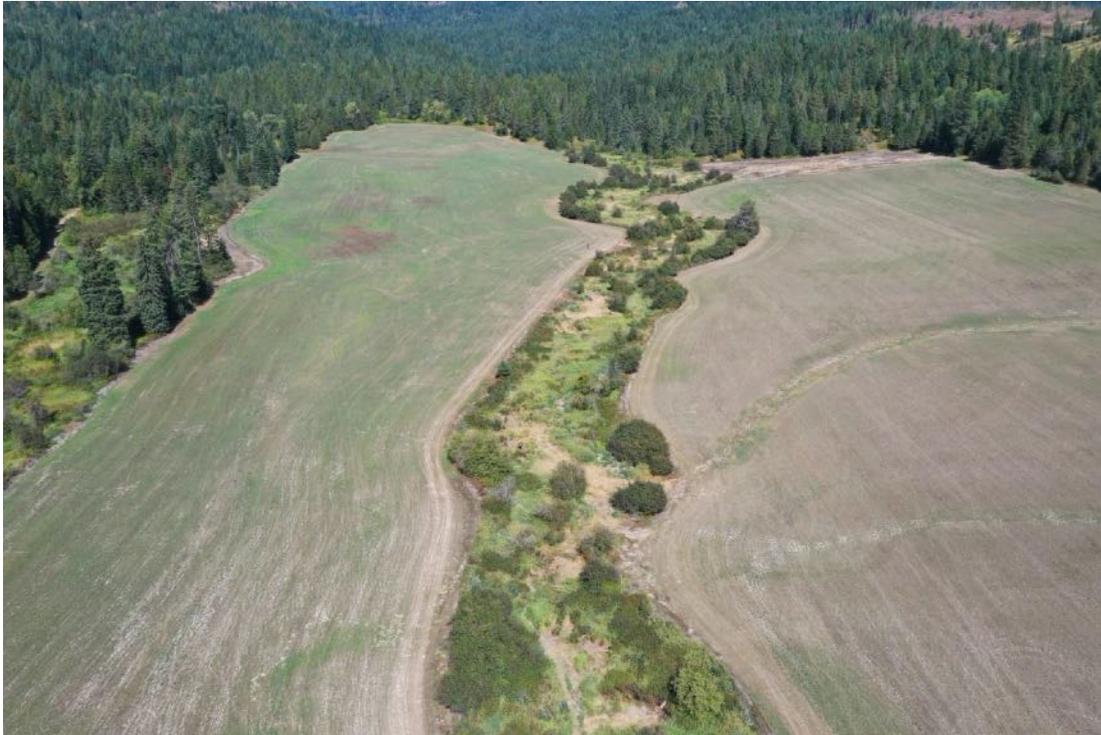
Currently, approximately 87% of the total stream length within the Upper Lake Creek sub-watershed falls below the target threshold for wood loading of 6 m<sup>3</sup>/100 m. Riparian vegetation within the treatment reach was significantly altered dating back to the 1940's when native floodplain forest communities were altered by logging, grazing and agriculture (Photo 10). The riparian community is now dominated by reed canary grass and douglas spirea - which provide sufficient root mass to maintain streambank stability - but generally lacks woody species capable of providing shade or contributing large wood to the channel. Habitat surveys completed in 2017 confirmed that instream large wood was absent in measurable quantities and therefore the reach lacked much of the positive functions attributable to in-channel wood.

*Photo 10. Treatment reach in the upper Lake Creek subwatershed targeted for LWD placements. Riparian vegetation has been significantly altered in the past by logging, grazing and agriculture, leaving few woody species capable of providing natural recruitment of wood to the channel.*

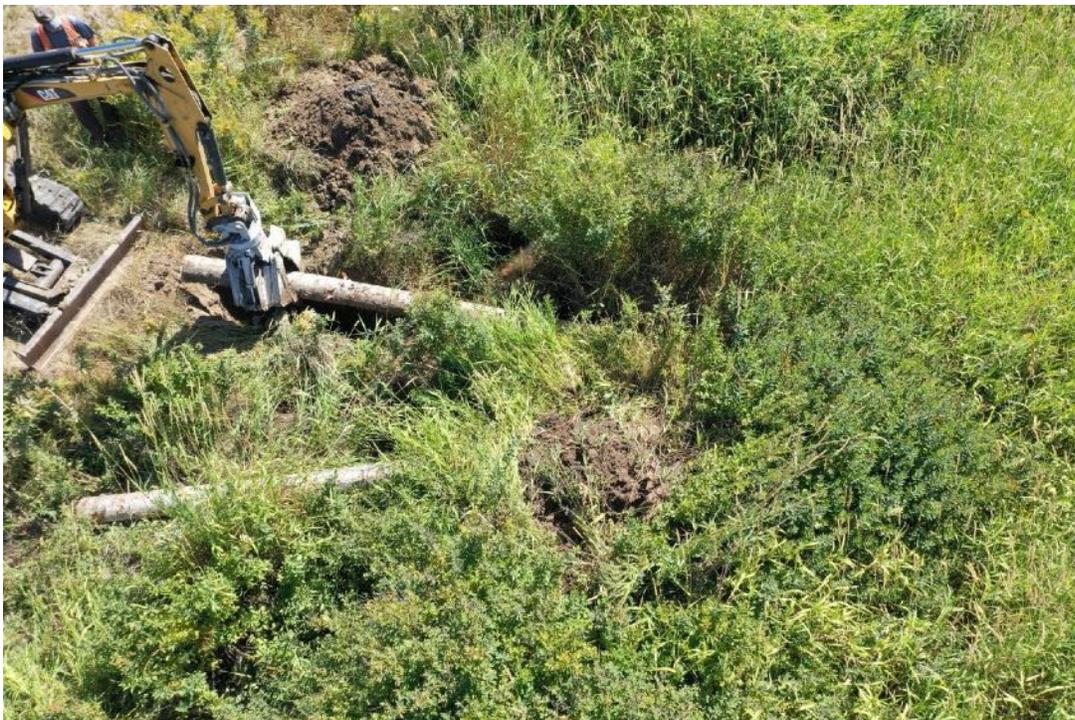
*Photo 11. A 303Cat mini-excavator equipped with a rotating grapple was used to place wood in a variety of configurations within 964 m of the upper Lake Creek subwatershed.*

A Cat 303 mini-excavator equipped with a rotating grapple was used to place 145 logs, ranging in size from 0.15 – 0.51 m diameter and 4.2 – 7.3 m long (2-3 times the bank-full width), and 27 whole trees, totaling approximately 42 cubic meters (14 MBF). The wood was placed in a variety of configurations within the bankfull channel and floodplain during base flow conditions in late August. Placements included (in relation to the bankfull channel) parallel, transverse, bridged, partial- and fully-buried, as well as complex, channel spanning log jam structures. Forty-three individual treatments were installed. Both the locations and configurations were deliberately selected to achieve specific hydraulic effects, including: scour, deposition, and sorting of stream gravels; increase roughness to reduce near-bank sheer stress and improve bank stability; provide grade control (i.e., vertical/horizontal stability); create backwater effects comparable to natural beaver dams where floodplain channels diverged/converged from the primary flow path; and to provide overhead and instream hiding cover for fish (Photo 11). Existing vegetation was preserved as much as possible, and especially mature woody vegetation, which was often used to provide stable anchor points for wood placements.

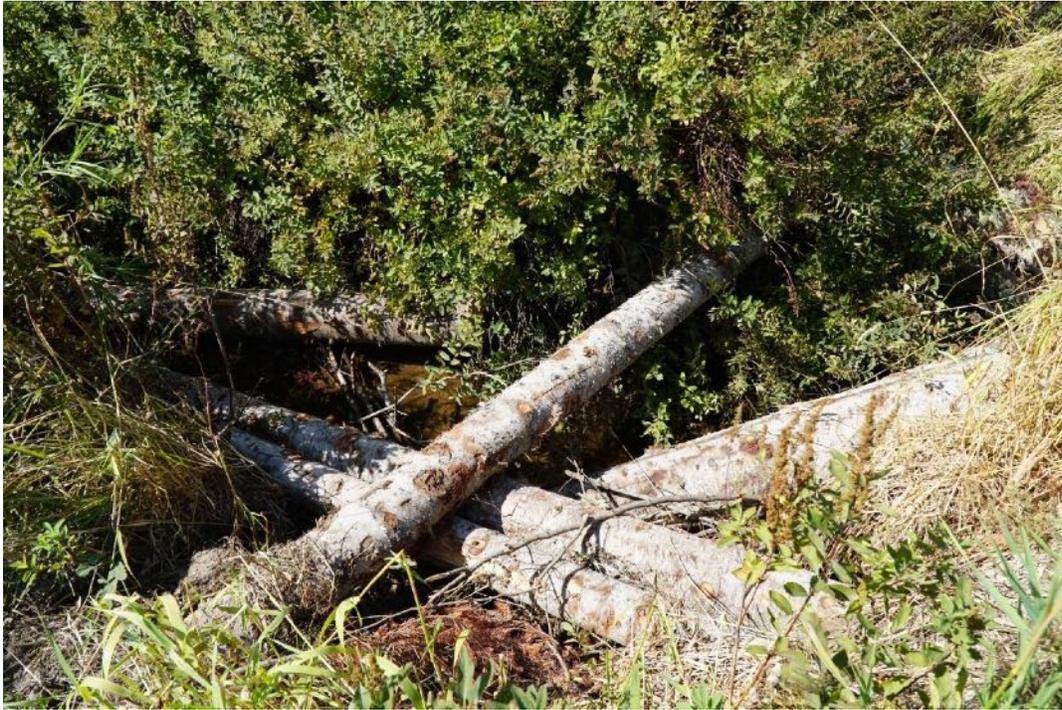
*Photo 12. Large wood was placed in a variety of configurations within the treatment reach, including this log crib jam, that was placed to reduce shear stress and redirect flows away from an eroding bank. Bankfull channel width is 2.7 meters.*

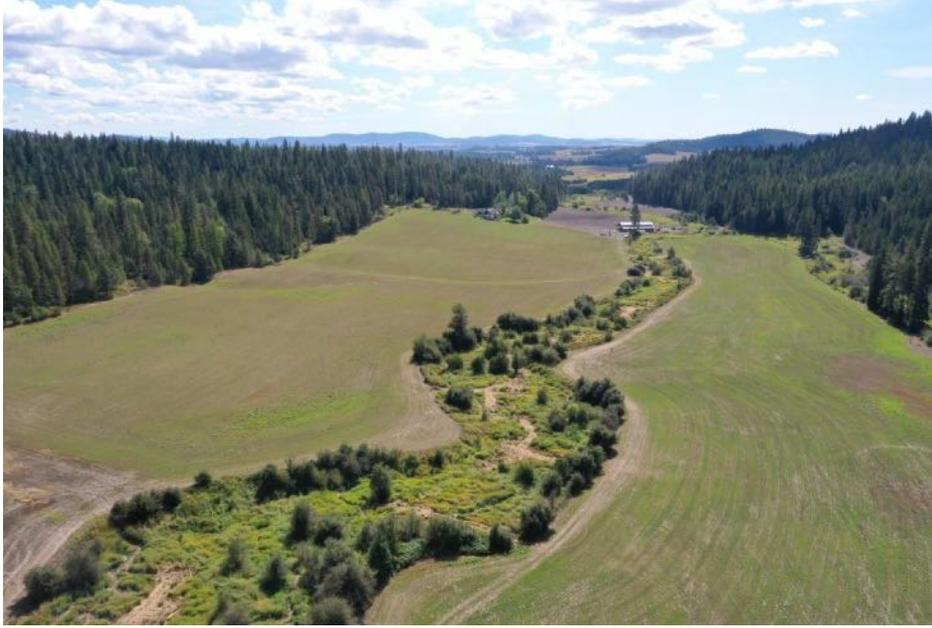
*Photo 13. Riparian vegetation within the treatment reach is dominated by reed canary grass and douglas spirea and lacks sufficient woody species capable of providing shade, contributing large wood to the channel, and sustaining beaver.*

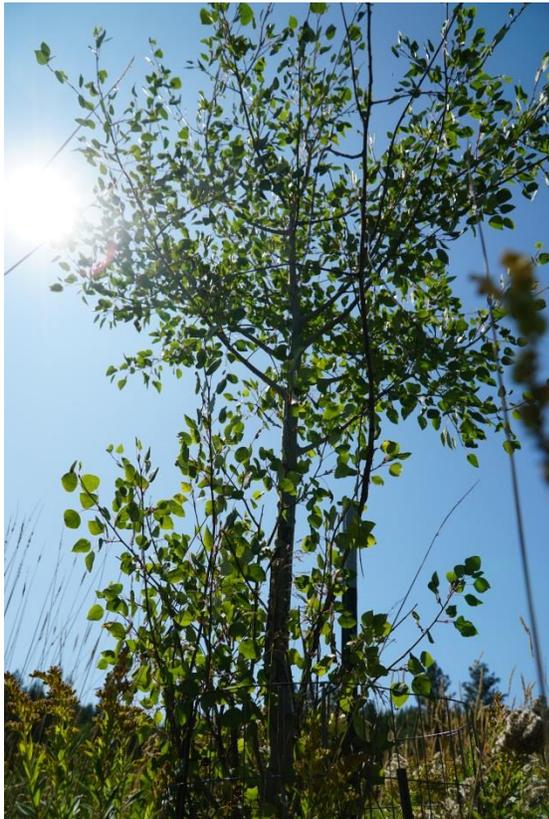
*Photo 14. Survival of aspen planted in test plots exceeded 95% and grew rapidly during their second season in the ground. All planted trees were fenced with 6-foot tall welded wire to discourage animal browse while they become established.*

The stream buffer bounded by agricultural production, where woody vegetation is generally lacking, is scheduled to be planted over several years. A small test plot encompassing an area adjacent to the ponded water upstream of the primary access road was planted in Spring 2018 utilizing 60 containerized aspen trees. Survival of these trees exceeded 95% during the first growing season and the limited browse that was observed over winter should not affect long-term survival and growth (Photo 14). A second treatment utilizing 500 aspen trees was planted in Spring 2019 adjacent to approximately 964 meters of channel lying north of the ponded area and extending upstream to the ag/forest boundary. All of these plantings were fenced with 6 foot tall welded wire to discourage animal browse while they become established.

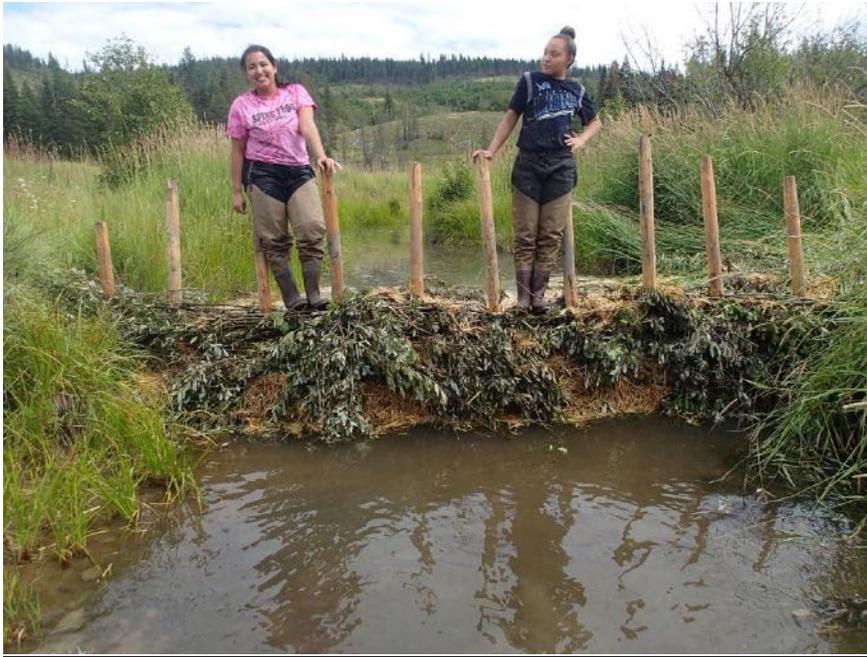
*Photo 22. Starter dams were established in a total of 14 locations during 2015 and 2016, wherein a line of wooden posts was installed using a hydraulic post pounder, followed by weaving branches in between the posts and incorporating straw and mud to create a semi-permeable structure mimicking a natural beaver dam.*

The past mapping and monitoring of beaver dams in upper Benewah Creek identified nearly 50 specific locations where construction of BDAs may be appropriate (Map 5). Starter dams were established in three of these locations in 2015, wherein a line of wooden posts was installed using a hydraulic post pounder, followed by weaving branches in between the posts, after Pollock et al. (2012) (Photo 22). In some cases the posts lines remained intact across several high flow periods and several dams functioned in much the same manner as log flow-choke structures that mimic the hydraulic function of stable natural beaver dams during flooding. Post lines were installed at 22 additional locations in the reach in 2016 to allow for establishing willow weaves at a later date; willow weaves were completed at 11 of these sites.

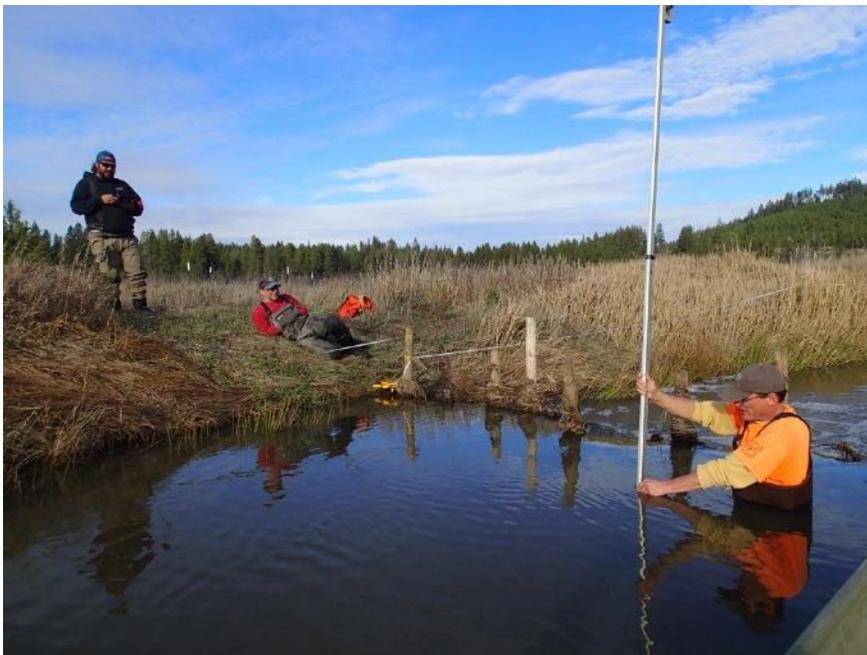
Preliminary monitoring of the BDAs installed in 2016 indicated that the structures maintained a high degree of integrity during summer low flows and effectively elevated stream water levels, and presumably ground water levels as well, through the growing season (Photo 23). However, only a fraction of these same dams remained intact and functional at high flows and significant maintenance was required to rebuild the BDAs in order to sustain these functions over a period of several seasons.

*Photo 23. Beaver Dam Analogs (BDAs) installed in 2016 maintained a high degree of integrity during summer low flows while elevating stream water levels and the surrounding ground water table through the growing season. Opportunities for establishing riparian plant communities are being tested in these areas with improved wet site conditions.*

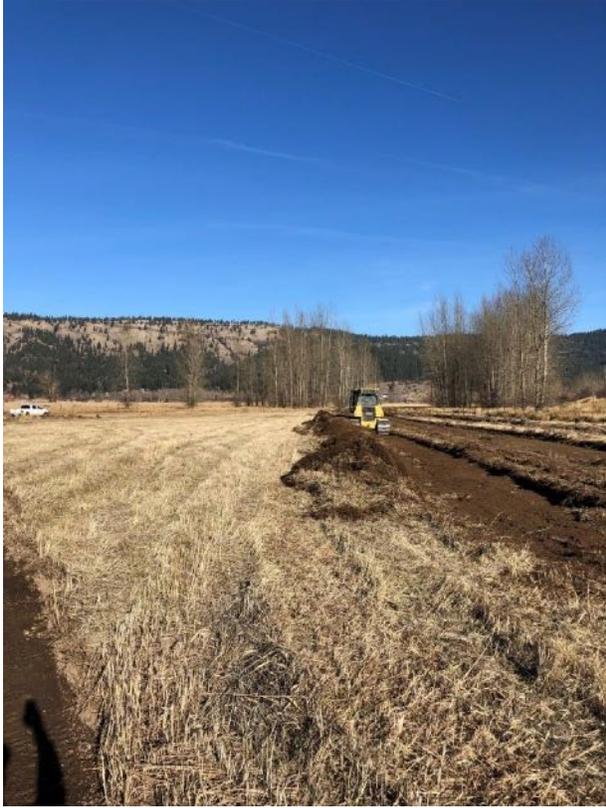
*Photo 26. Site preparation included removal of canarygrass using a small dozer.*

**Project Timeline:** Initial site preparation occurred in October, 2018 (Photo 26 and Photo 27). Final plantings are scheduled to be completed by spring, 2021. These additional plantings will

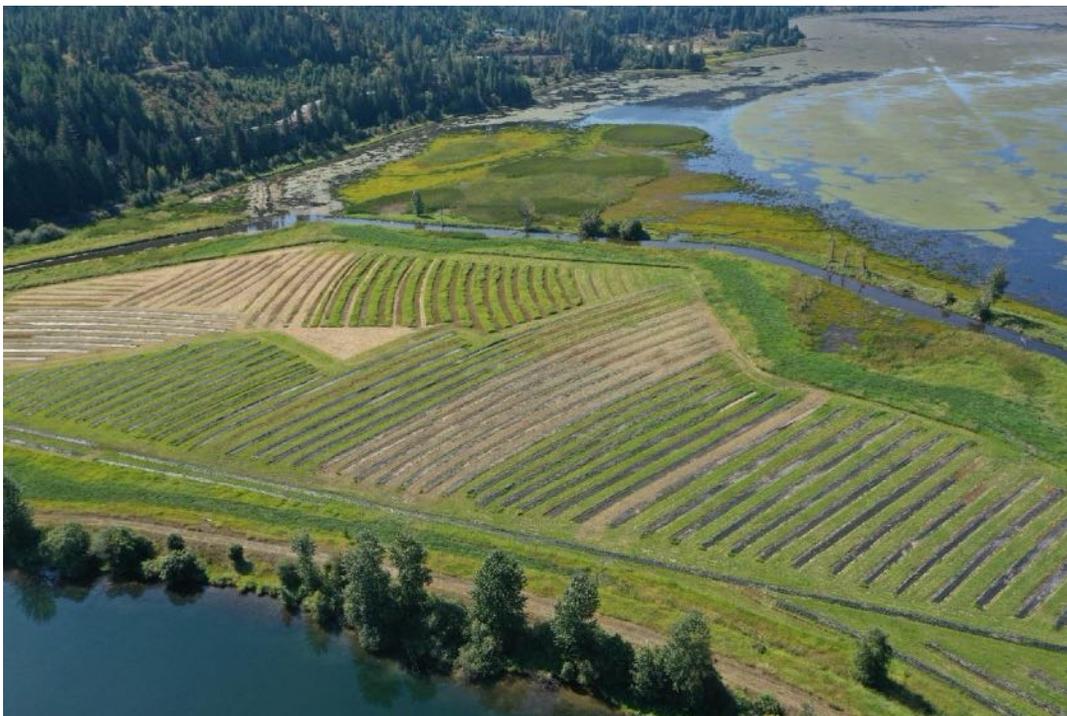
*Photo 27. Aerial photo of the native willow nursery September, 2019.*

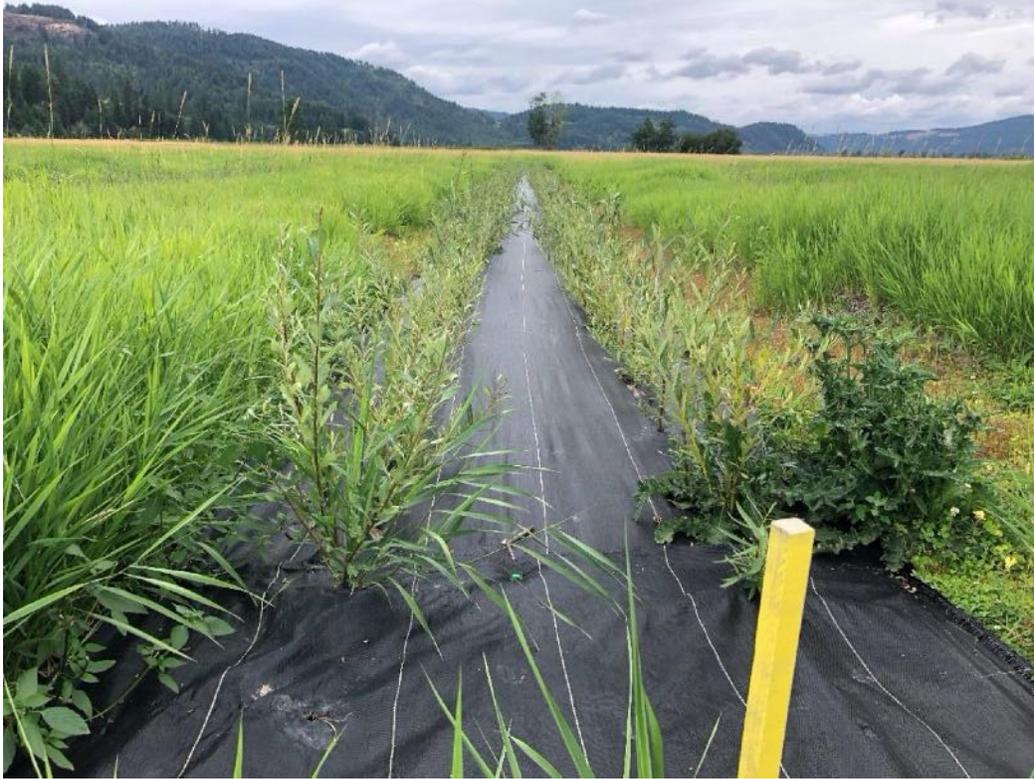
*Photo 28. Rows of planted Drummond willow*

include 3 more endemic species of willow which include bebb *S. bebbiana*, geyer *S. geyeriana* and sandbar *S. exigua*, scheduled for 2020, along with other native deciduous plants such as black cottonwood *Populus trichocarpa* and native birch species *Betula spp.* to be planted in 2021 in a separate 2 acre enclosure within the same project location. Photo 28 and Photo 29 shows the planted rows in summer 2019.

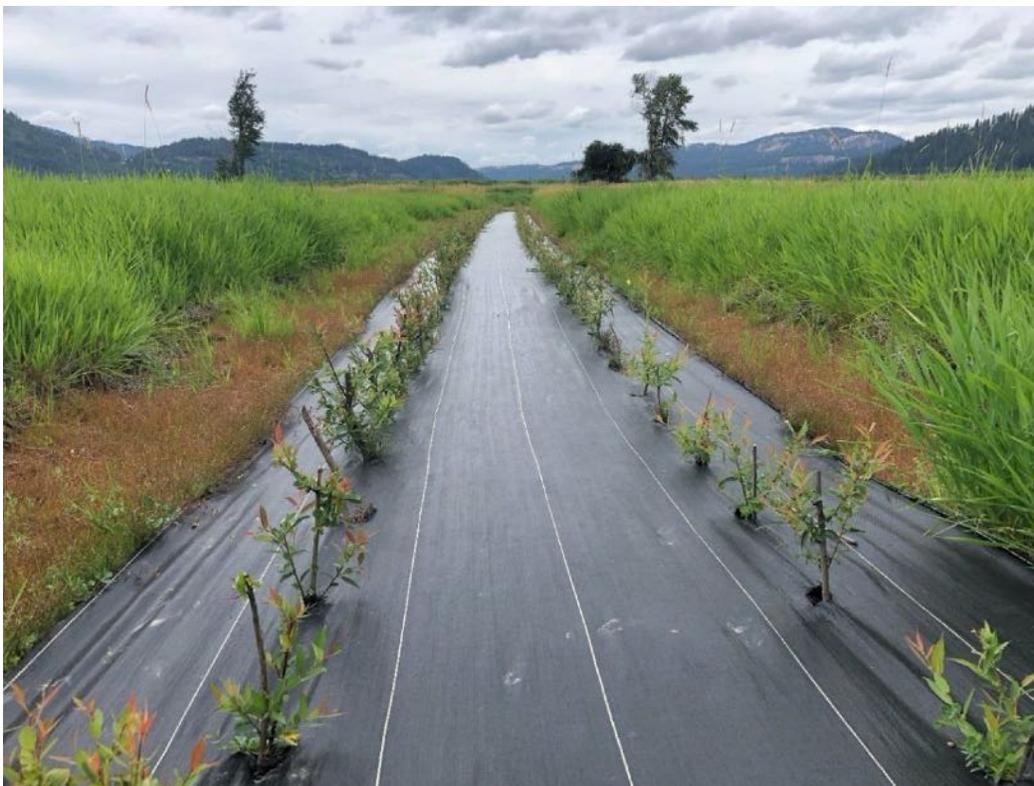
*Photo 29. Rows of planted Makenzie willow.*

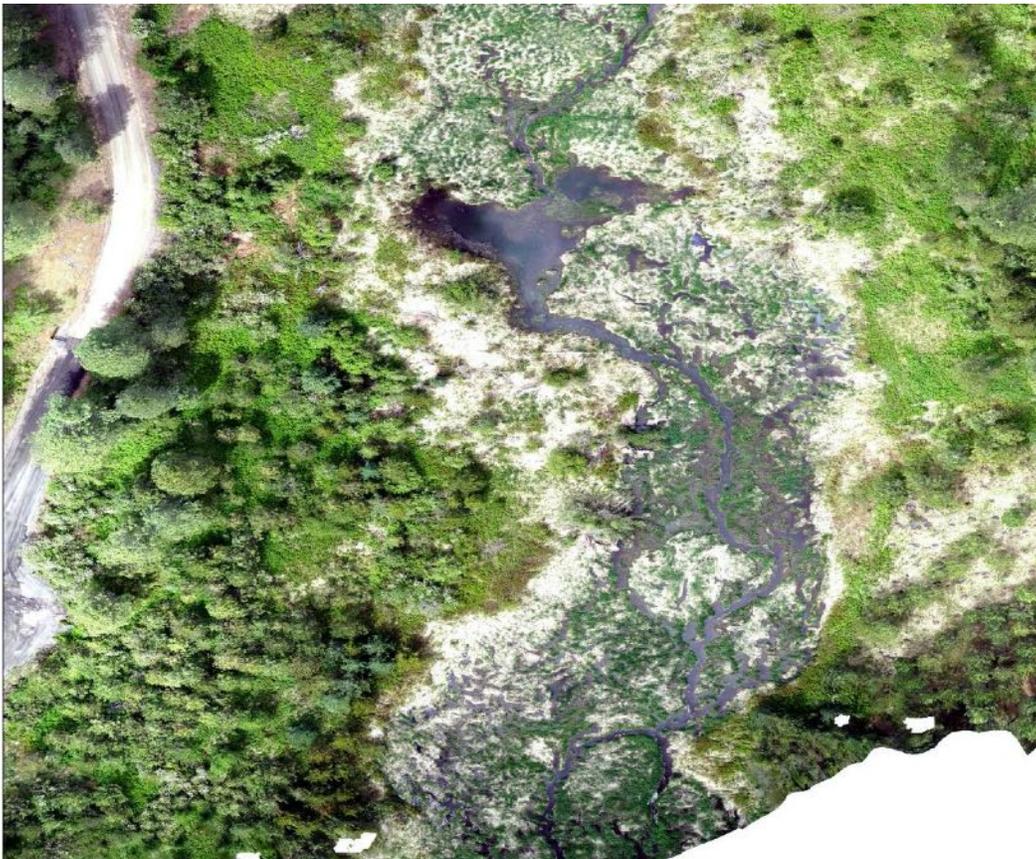
*Photo 30. Example of a Stage-0 anastomosing channel network in the upper Lake Creek watershed. The channel occupies a transition zone between an alluviated, moderate slope bound valley and a wide, alluviated valley floor (after Cupp 1989). This Stage-0 channel encompasses nearly 950 m in the valley and is bounded by managed forest and agricultural land uses.*
